FY27 CIP SUBMISSION

Select if Revised	<u>Roof Replacement</u>					Date: <u>10/3/2025</u>	
Describe revision, if applicable						Year of First Submittal:	<u>2023</u>
Project Overview:	A roof replacement plan was created to estimate the timing for roof replacement of County facilities. Estimates reflect 30-year replacements, with 20-year alternatives available.						
Requesting Department	Facilities Management	Est. Useful Life	20-25 Years				
Location (address)	7400 Justice DR.	Start Year	2027				
Magisterial District	Ware	Est. Completion Year	2030				
Annual Recurring Cost	click drop-down list	Category	Replacement/Maintenance Plan				
Number of Residents Served		Primary Board Priority	Infrastructure				
Expenditure Description	Total Project Request	5-Year CIP					
		Budget Year	Planning Years				Beyond 5 Years
		FY2027	FY2028	FY2029	FY2030	FY2031	FYI only
Land Acquisition	\$ -						
A&E	-						
Construction	1,247,400	525,000	231,000	55,650	435,750

Inspection Report

Client: Gloucester County Buildings/Grounds & Mosquito Control

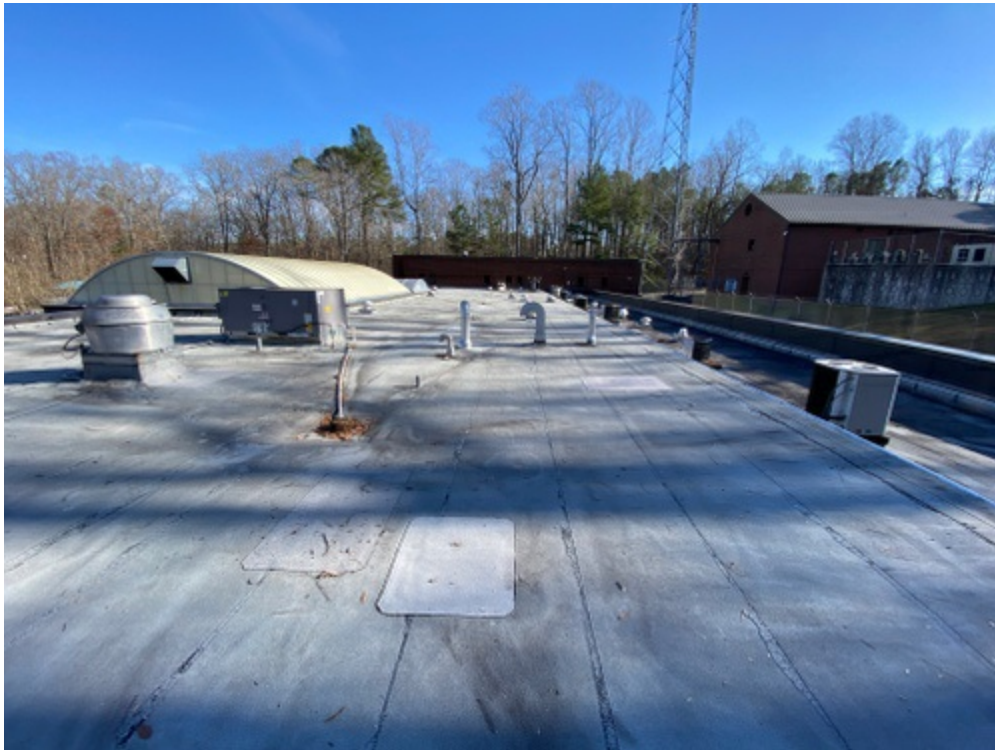
Photo 1

Overview of the Main Roof to the East.

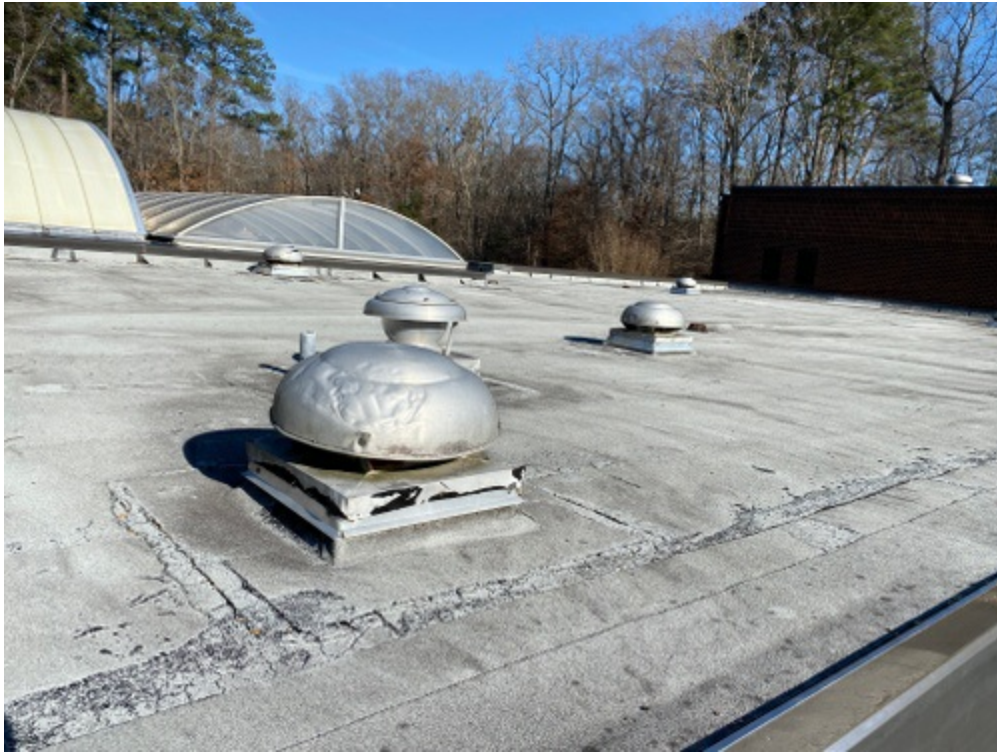
Photo 2

Overview of the Main Roof to the North.

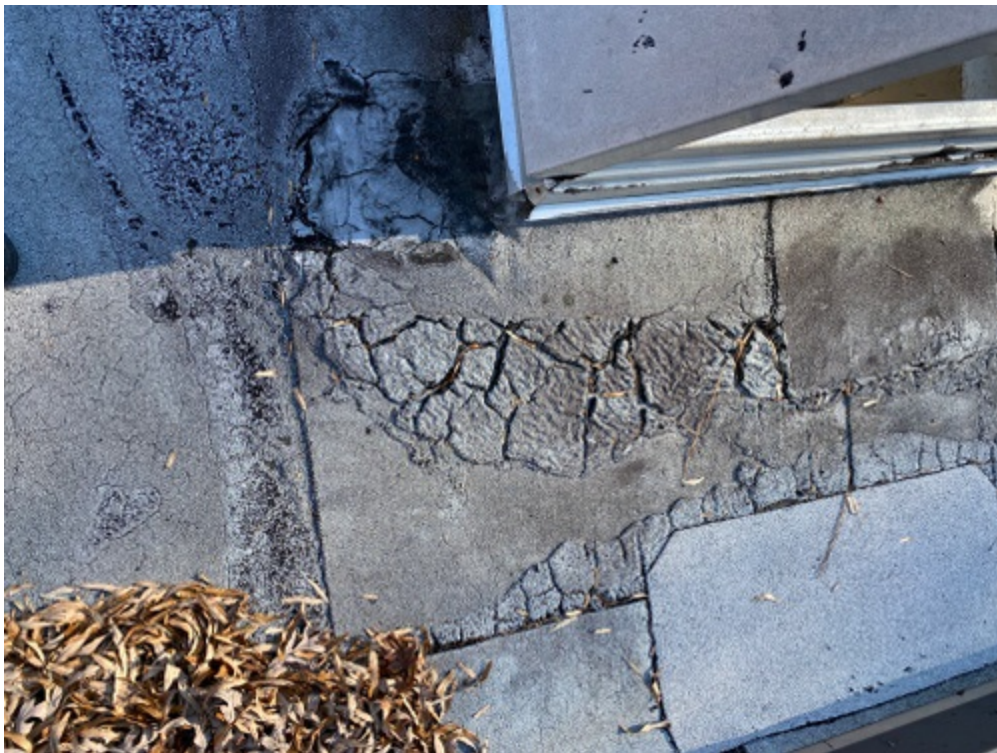
Photo 3

Alligatoring: is a result of the drying out and shrinking of the asphalt surface resulting in a "mud-cracking" pattern. The pattern is most pronounced in areas of exposed asphalt. It is caused by the heat and UV rays of the sun beating down on the exposed asphalt surface. If left untreated, the alligatoring condition can develop into splits in the roof membrane. As the surface continues to shrink and dry out, cracks will develop down to the depth of felts and may stress-crack the membrane in cold weather. These crack channels will allow water to penetrate and damage the roof system.

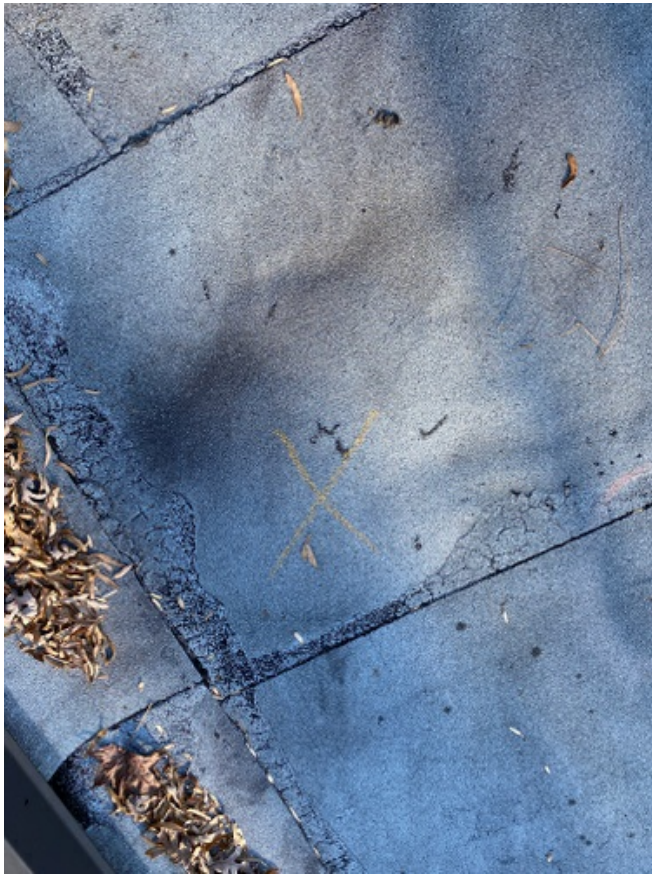
Photo 4

Blisters: Soft spongy pockets or swellings in the roofing material. They occur between layers of felt or between the roof membrane and substrate. Air or moisture vapor entrapped within a blister expands as the roof and outside air temperatures rise. This results in sufficient pressure to push the roofing felts upwards and apart. Blisters may be ruptured by roof traffic, expanding frozen water, or hail (especially during colder weather). Some blisters may become so large as to affect drainage, which may then cause ponding water. Laps could also be pulled apart, resulting in leakage. A ruptured blister will immediately allow water to penetrate and damage the roof system.

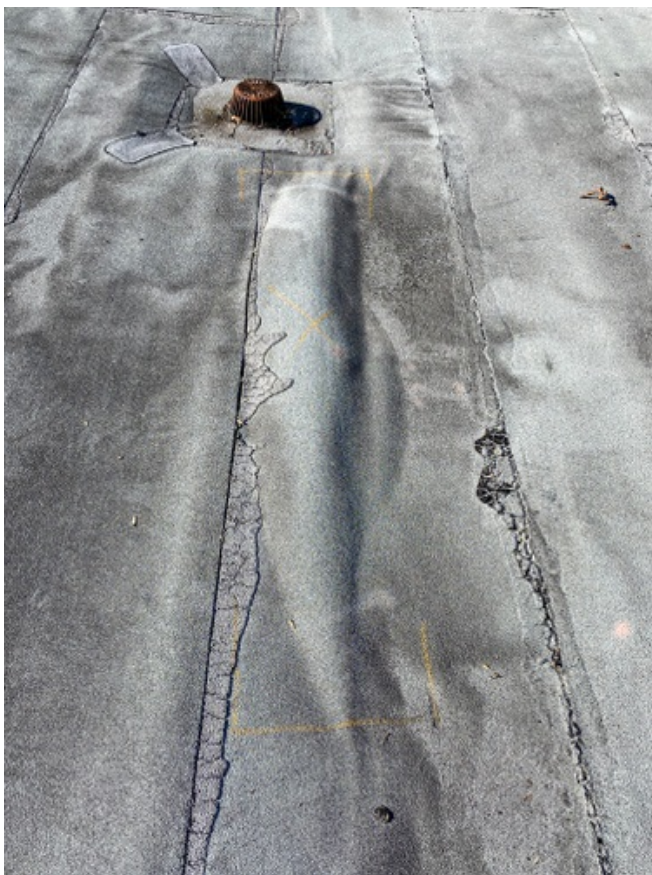
Photo 5

Blisters continued.

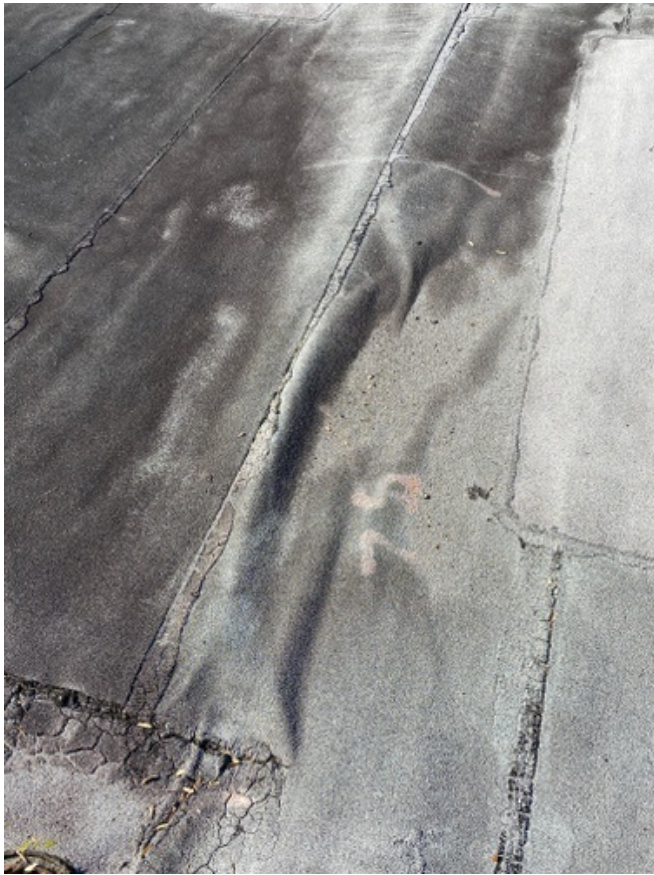
Photo 6

Blisters continued.

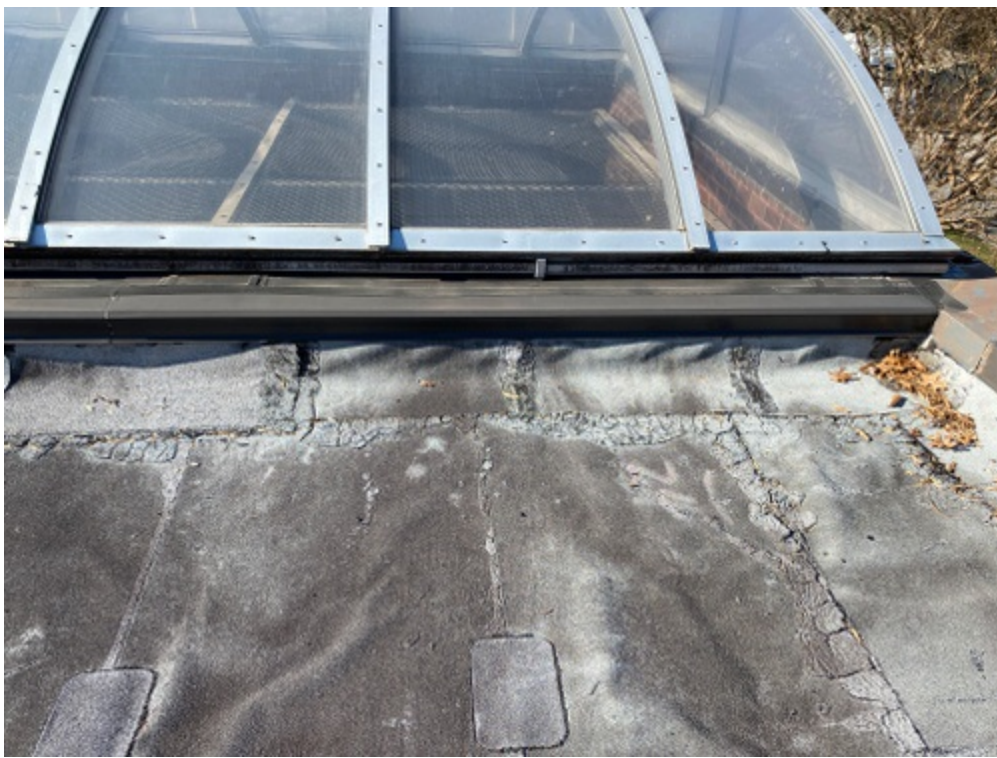
Photo 7

Membrane Buckling: An upward, elongated tenting displacement of a roof membrane frequently occurring over insulation or deck joints. A buckle may be an indication of movement within the roof assembly. Buckles may interfere with drainage, and can also cause premature failure in the membrane from creasing in the material.

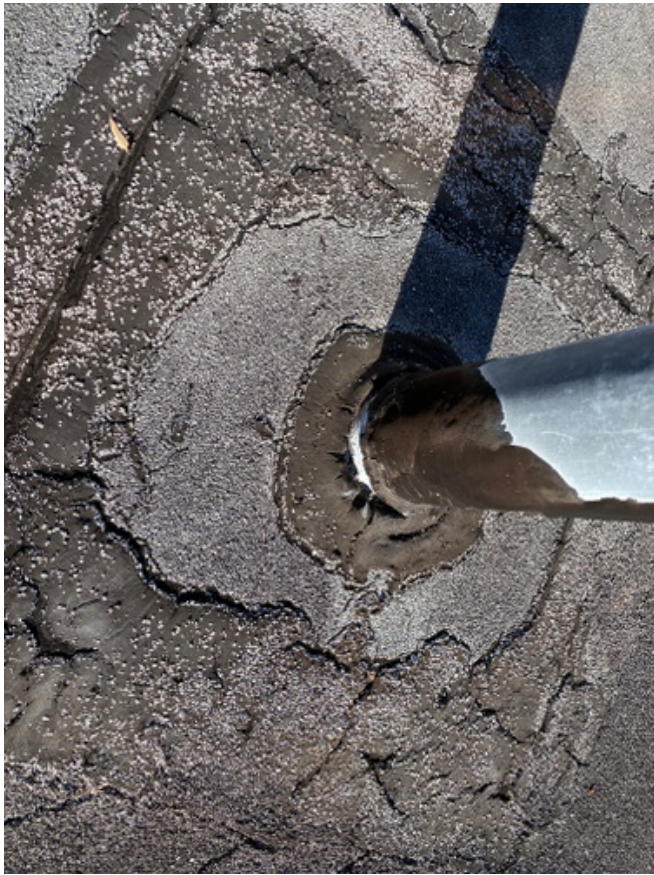
Photo 8

Sealant around the roof penetration has deteriorated to the point of failure.

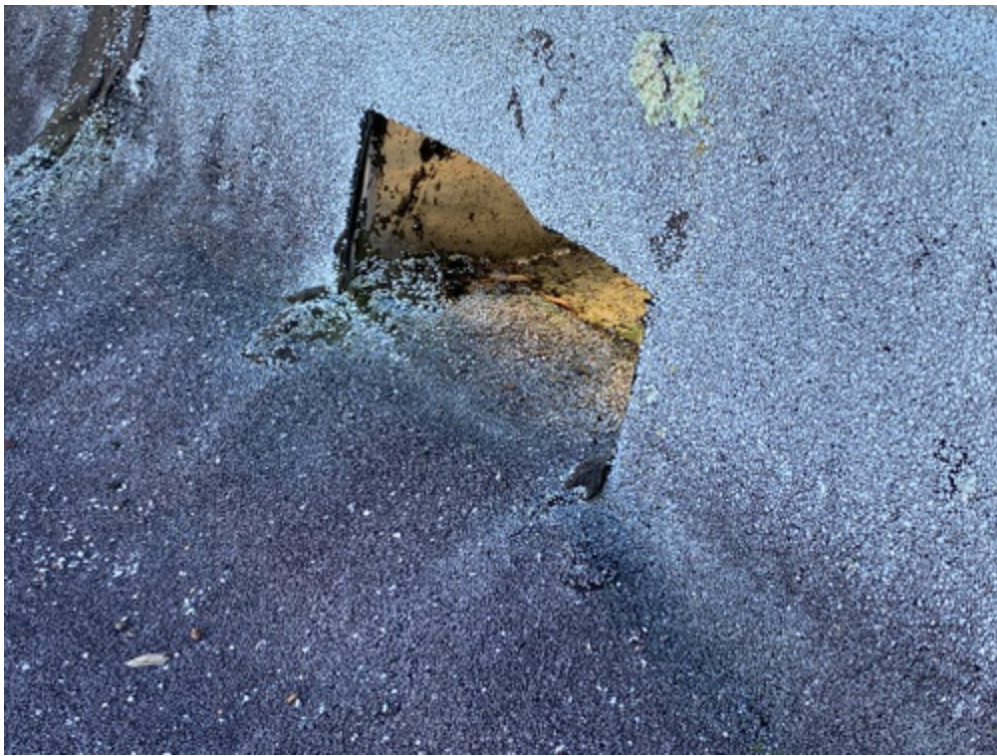
Photo 9

Improper detail of the roof's scupper. The membrane should extend into the scupper to prevent reliance on sealant as the only protection from water intrusion.

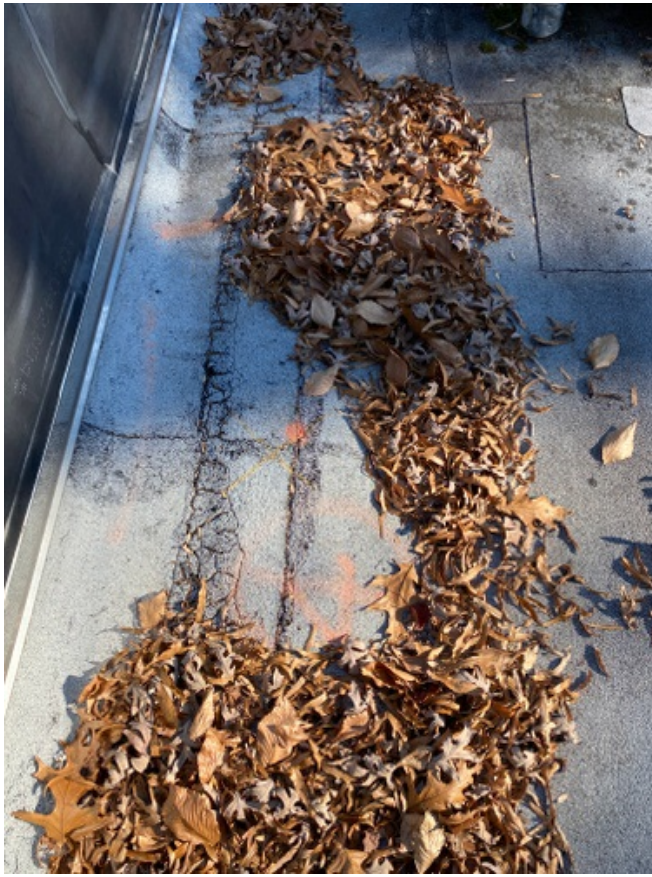
Photo 10

Debris – Leafs and Pine Needles: Pine needles and other leaves build up on the roof membrane causing plugged drains and scuppers thereby causing ponding water and structural weight loading. As the leaves and pine needles rot a "compost effect" occurs, this in effect causes soil to form on top of the roof membrane. This soil creates a perfect medium for plant and weed growth. When seeds take hold the roots will often penetrate through the membrane causing immediate leaks and damage internally.

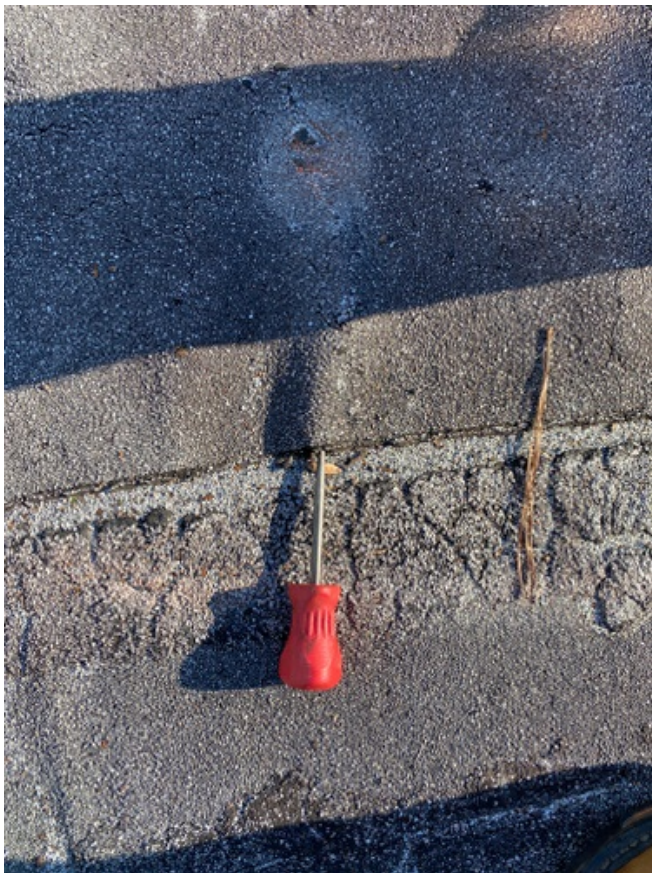
Photo 11

Fish mouths: Wrinkles or openings at the edge of the membrane caused by poor adhesion or installation. Fish mouths are a common cause of early failure on 2-ply torch down and single ply roof systems. These systems are prone to workmanship error due to two factors (1) the manual heating/welding of the adhesive, which is very unpredictable for constant heat, and (2) the roof system only consists of 1 to 2 plies, which translates in to a very thin layer of water protection.

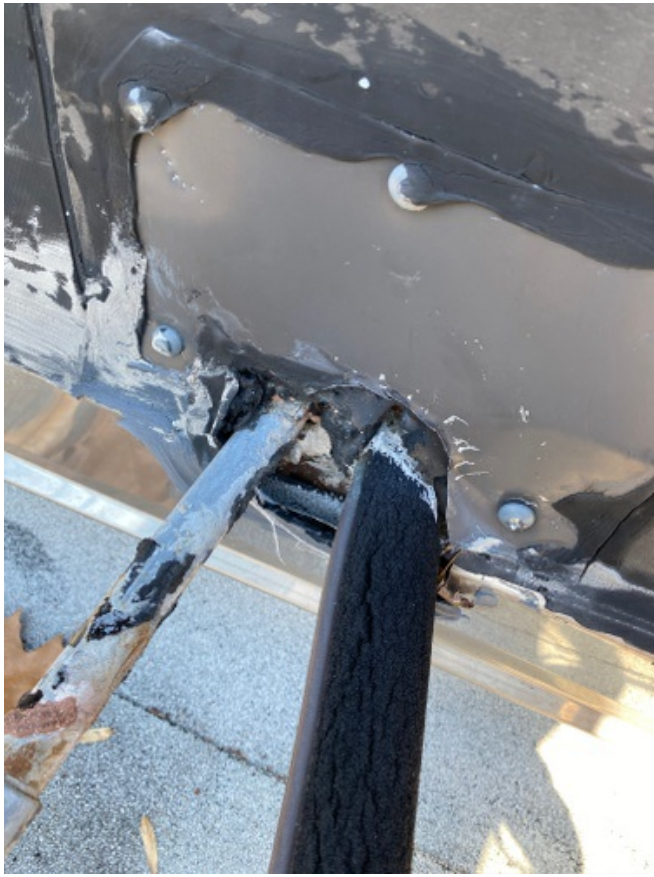
Photo 12

Roof penetration needs sealant and a pitch pocket to maintain watertight integrity.

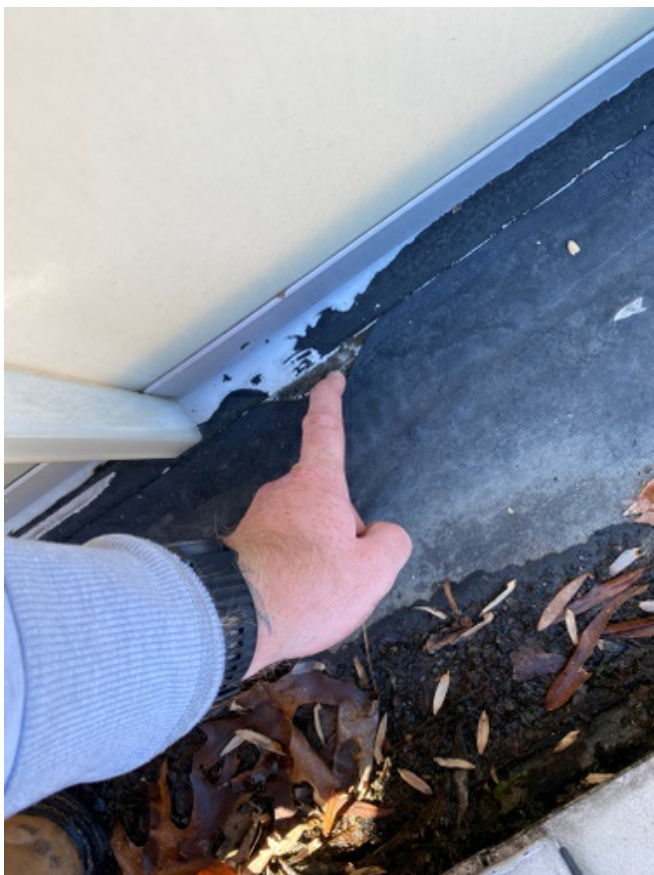
Photo 13

Flashing Failure: The flashing along the parapet wall was not properly terminated & has come loose from the masonry. This may allow water to leak into the building.

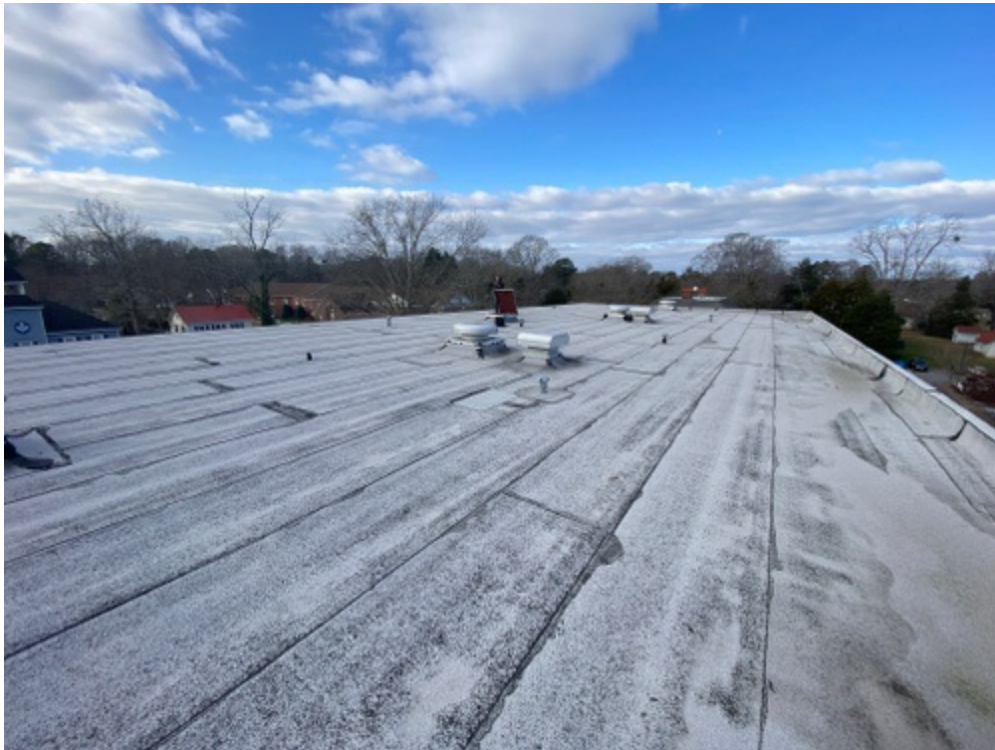
Photo 1

Overview of Building #2 main roof.

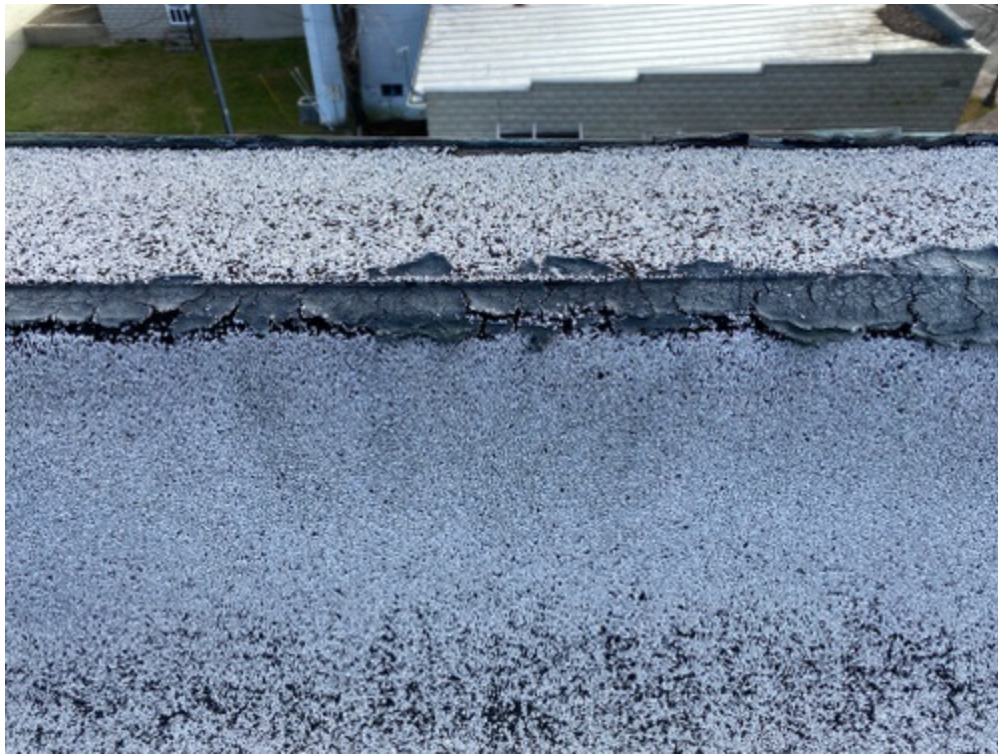
Photo 2

Modbit Flashing Seam

Deterioration: Rising wall flashing seams had previously failed & opened allowing moisture penetration into the system. Roof cement has been applied to the seams as a repair; however over time UV exposure will cause the cement to fail & allow the seams to reopen.

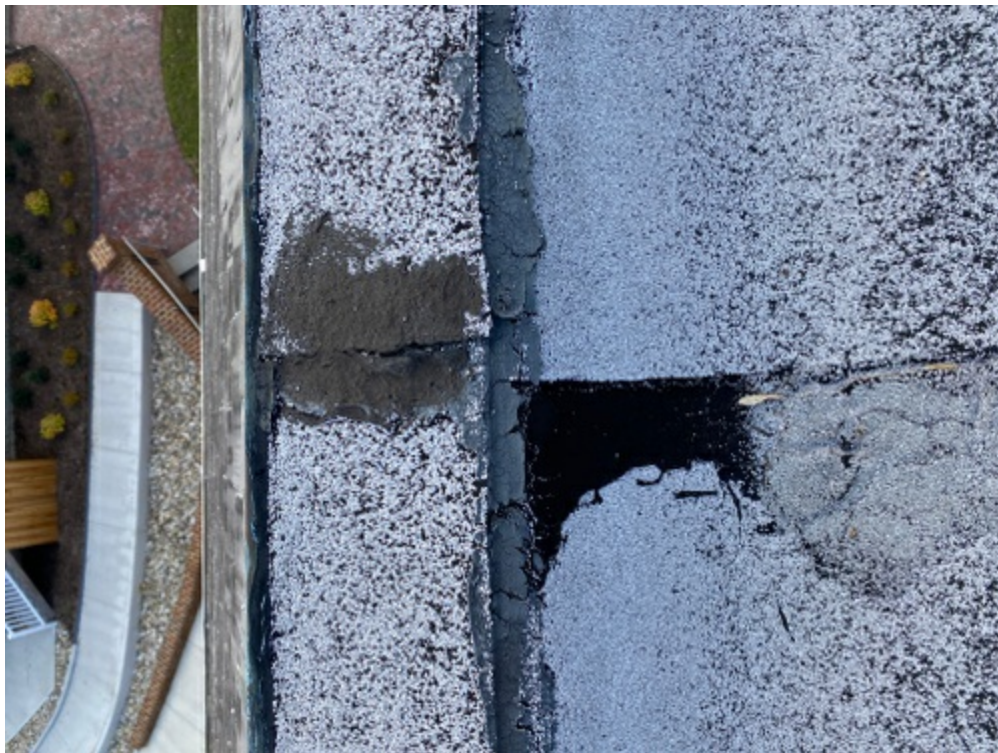
Photo 3

Modbit Flashing Seam
Deterioration continued.

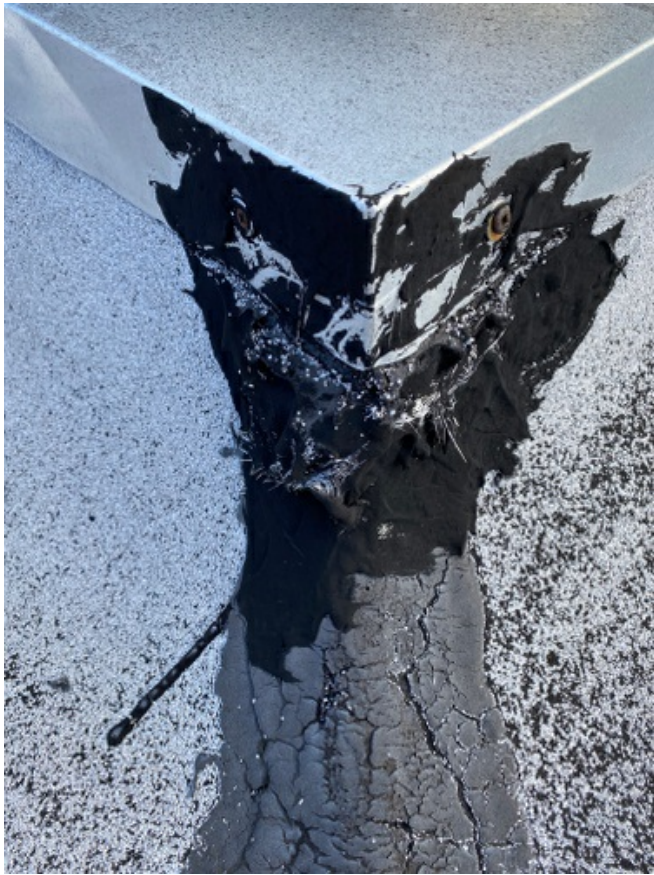
Photo 4

Flashing Seam Failure: The flashing seam has split open, a credit card has been inserted into the seam to establish depth & size. This condition is a common cause for moisture penetration, and may be actively leaking.

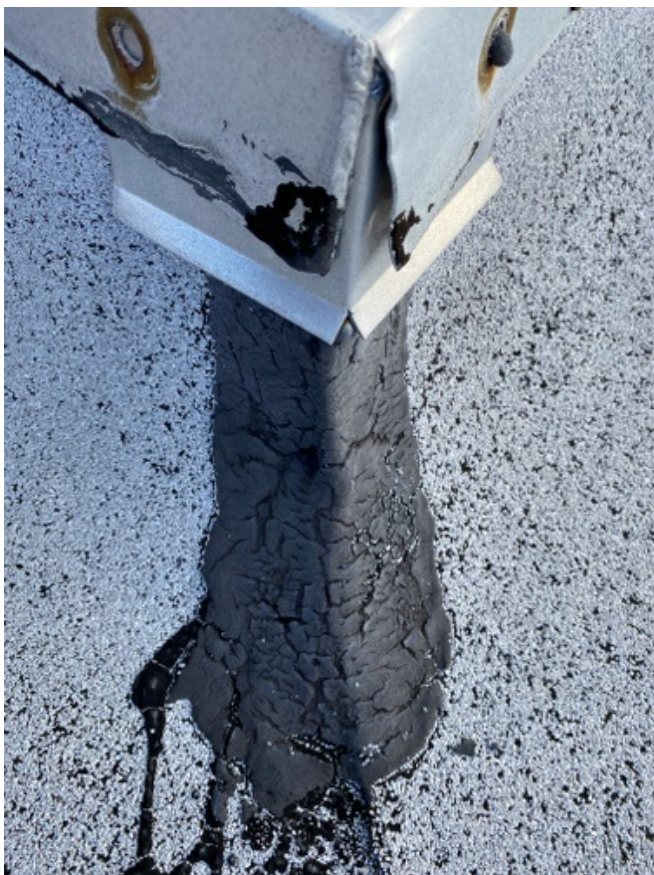
Photo 5

Flashing Seam Deterioration: The mastic used on the flashing seams is deteriorating from age and UV exposure. As this condition progresses the seam will open allowing water to penetrate the system causing structural decay & interior damage.

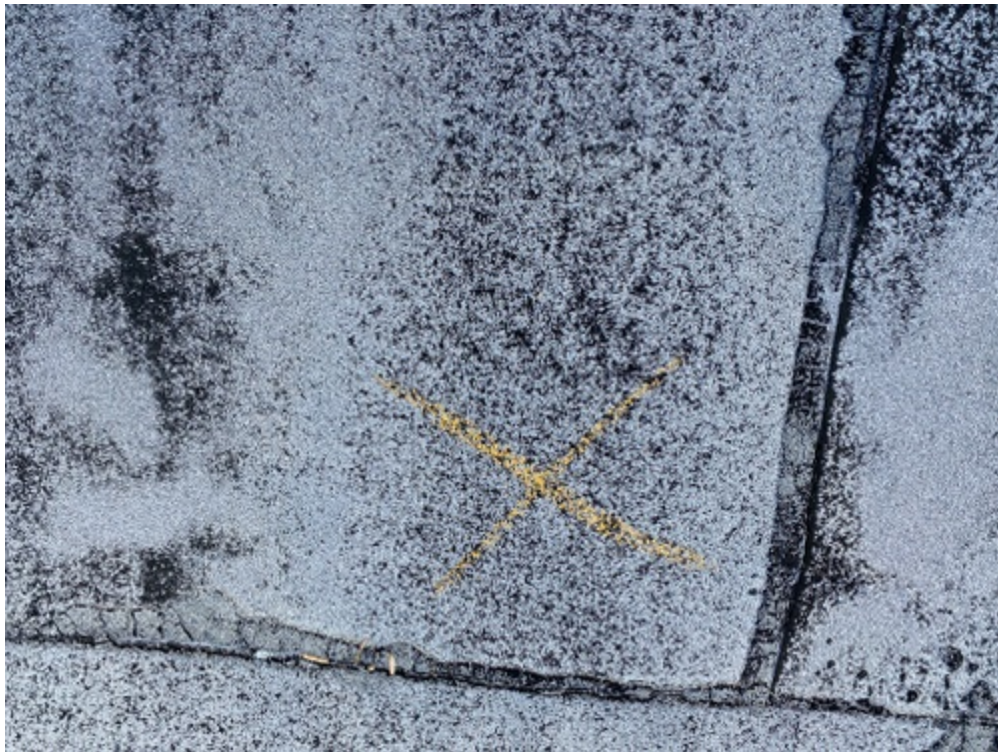
Photo 6

Blisters: Soft spongy pockets or swellings in the roofing material. They occur between layers of felt or between the roof membrane and substrate. Air or moisture vapor entrapped within a blister expands as the roof and outside air temperatures rise. This results in sufficient pressure to push the roofing felts upwards and apart. Blisters may be ruptured by roof traffic, expanding frozen water, or hail (especially during colder weather). Some blisters may become so large as to affect drainage, which may then cause ponding water. Laps could also be pulled apart, resulting in leakage. A ruptured blister will immediately allow water to penetrate and damage the roof system.

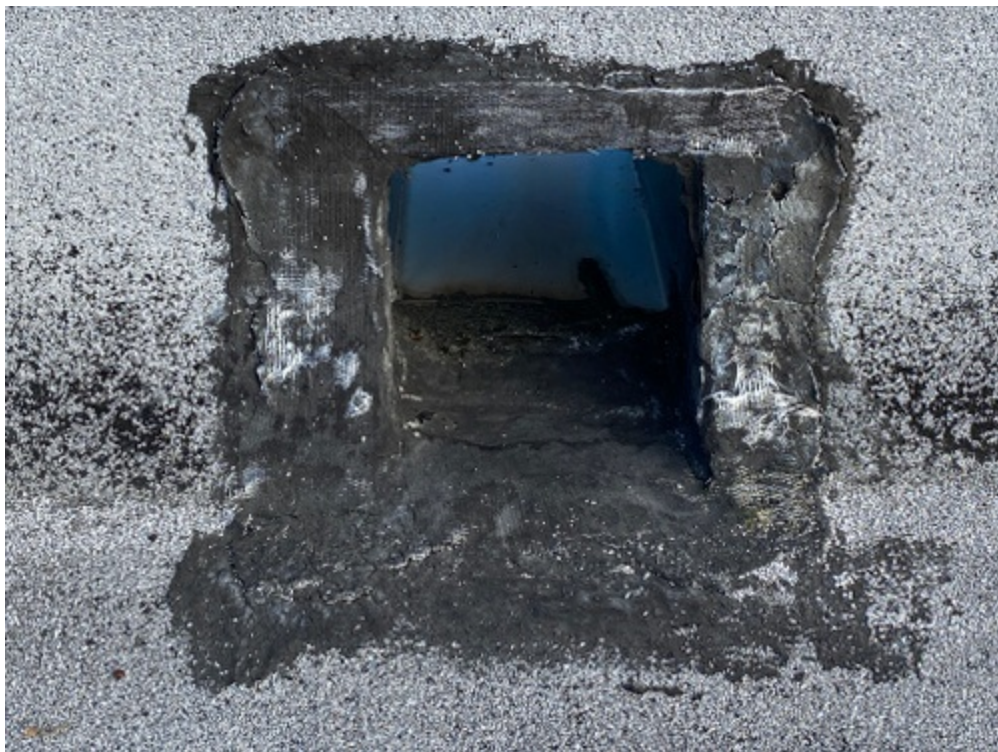
Photo 7

Membrane Deterioration: In this photo we can see where the membrane has deteriorated, leaving the scrim reinforcement exposed. In a single-ply membrane the primary waterproofing layer sits on top of the scrim which acts as a reinforcement for the elastomers. For this reason an exposed scrim indicates that a membrane is offering little protection from moisture penetration into the substrate.

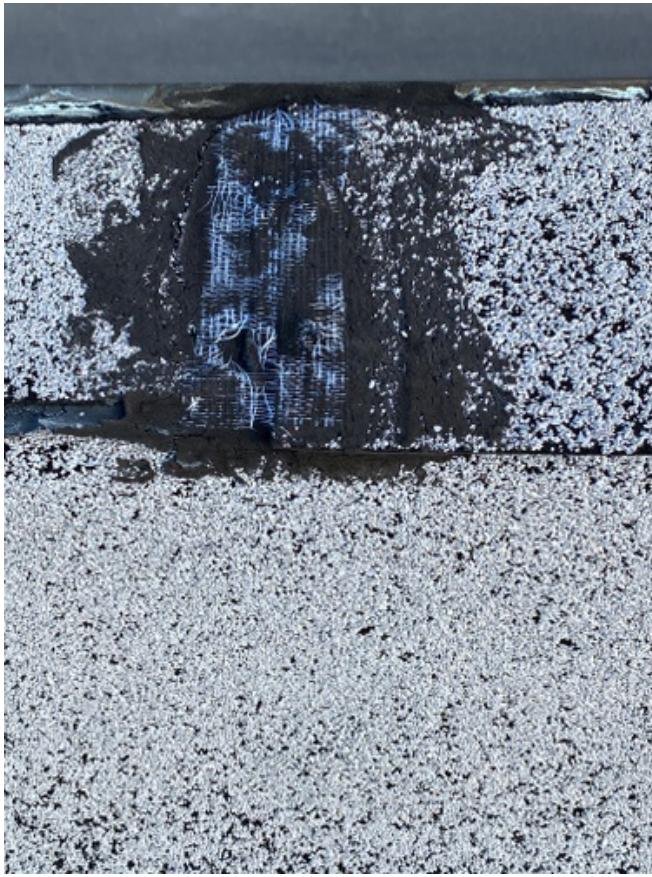
Photo 8

Membrane Deterioration: In this photo we can see where the membrane has deteriorated, leaving the scrim reinforcement exposed. In a single-ply membrane the primary waterproofing layer sits on top of the scrim which acts as a reinforcement for the elastomers. For this reason an exposed scrim indicates that a membrane is offering little protection from moisture penetration into the substrate.

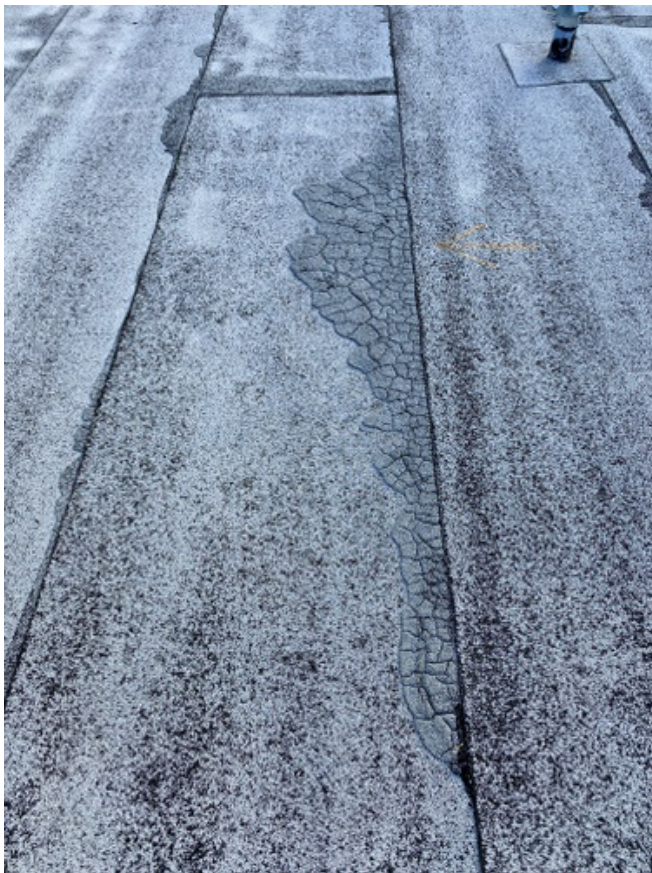
Photo 9

Alligatoring: is a result of the drying out and shrinking of the asphalt surface resulting in a "mud- cracking" pattern. The pattern is most pronounced in areas of exposed asphalt. It is caused by the heat and UV rays of the sun beating down on the exposed asphalt surface. If left untreated, the alligatoring condition can develop into splits in the roof membrane. As the surface continues to shrink and dry out, cracks will develop down to the depth of felts and may stress-crack the membrane in cold weather. These crack channels will allow water to penetrate and damage the roof system.

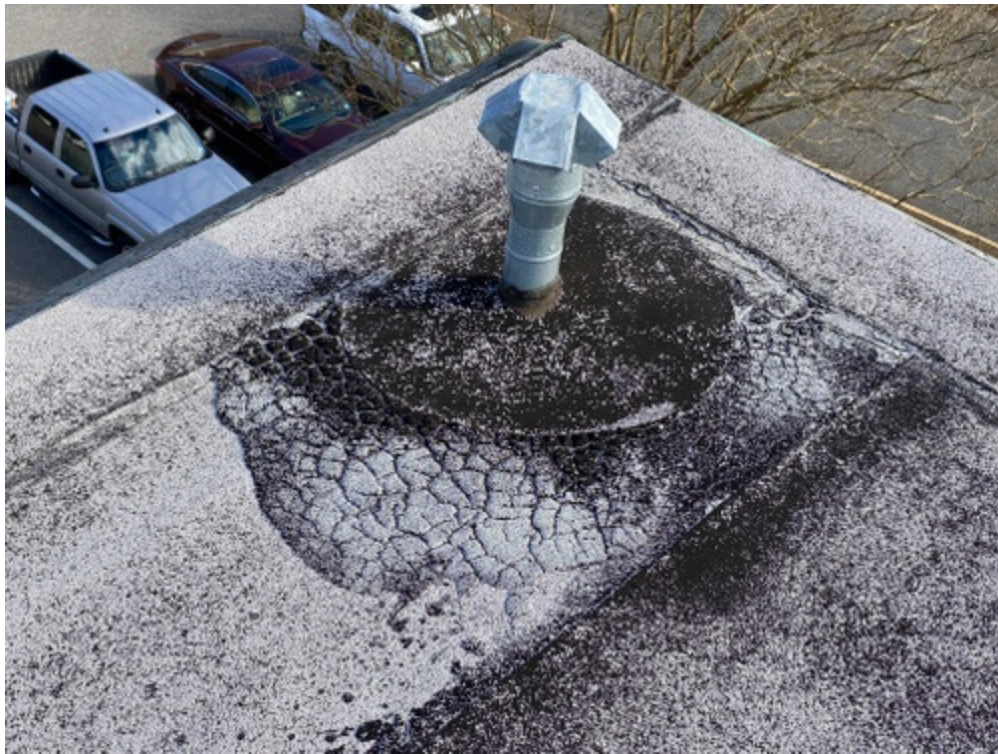
Photo 10

Flashing on the roof penetration depicted has started to deteriorate and lift away from the roof system.

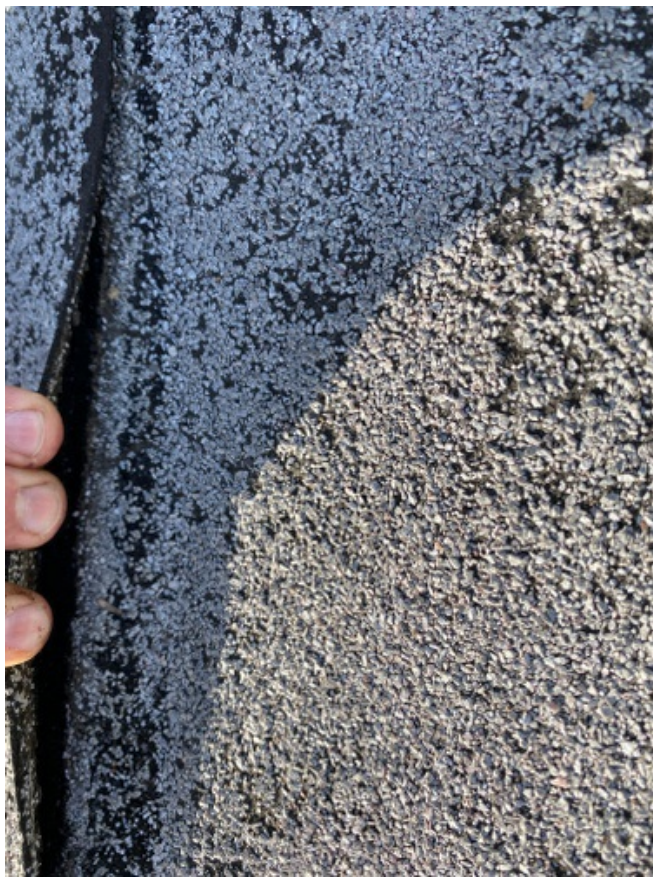
Photo 11

Lap Seam Deterioration: The lap seams are deteriorating from age and UV exposure. As this condition progresses the seams will open allowing water to penetrate the system causing structural decay & interior damage.

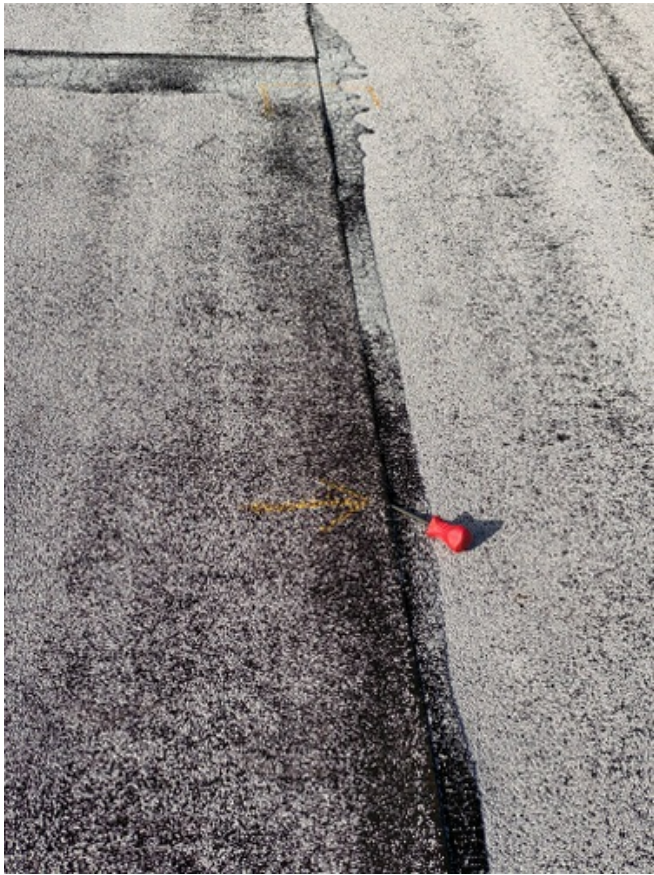
Photo 12

Lap seam deterioration continued.

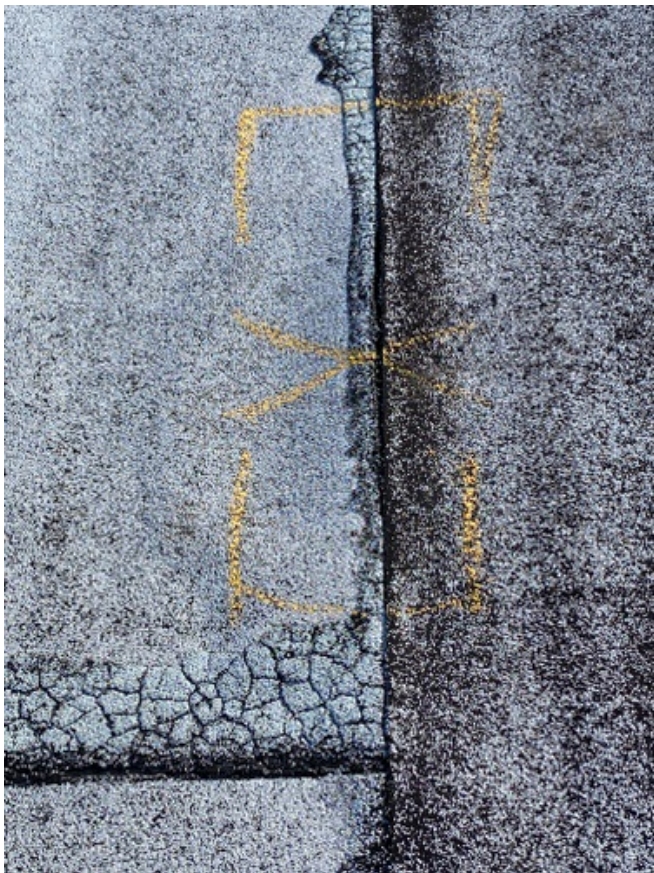
Photo 13

Lap seam deterioration continued.

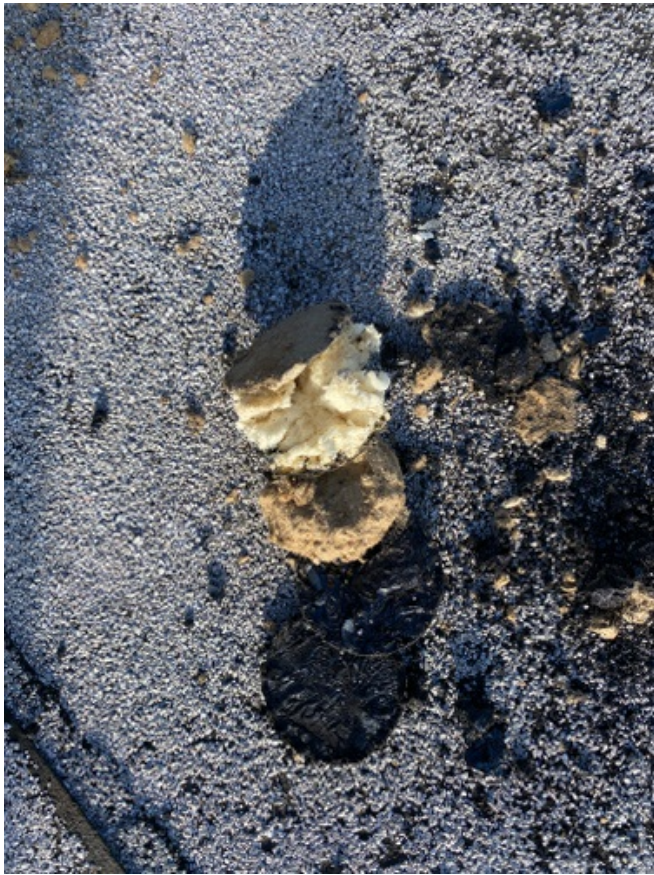
Photo 14

2-ply membrane composition.

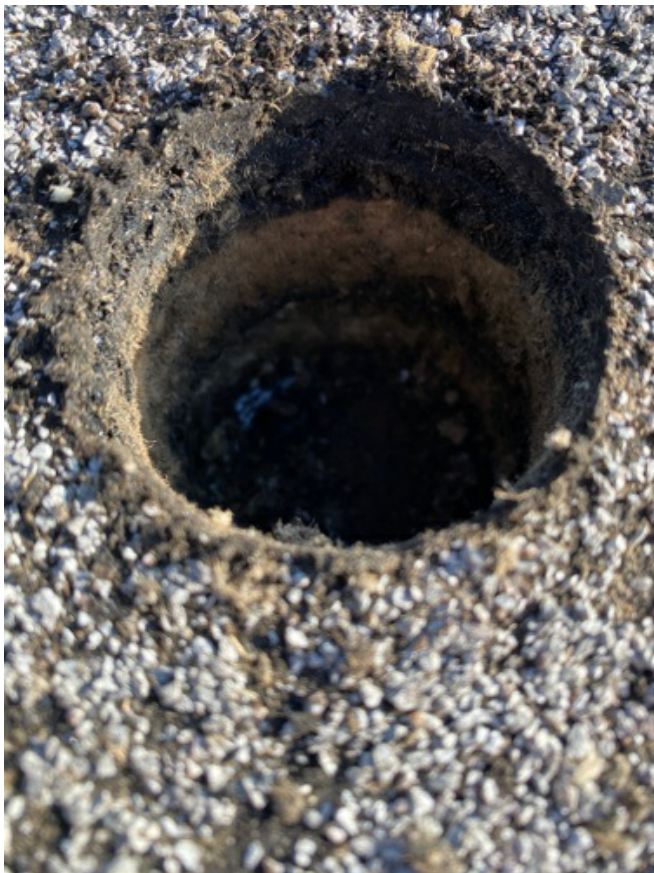
Photo 15

Exterior view of the deck.

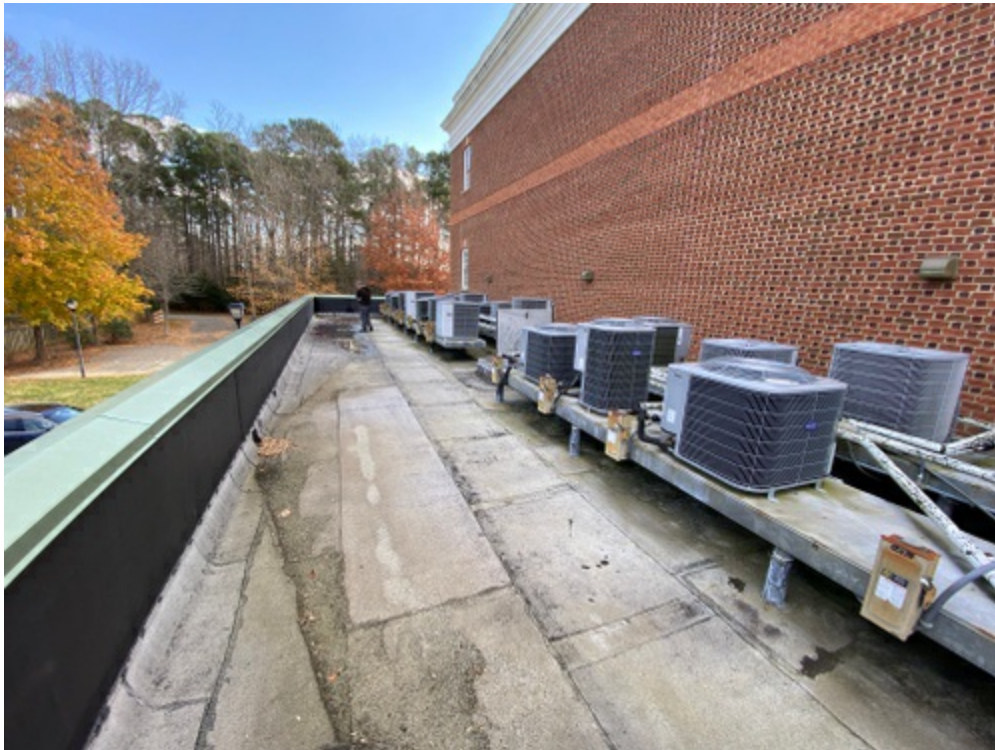
Photo 1

Overview of the Lower Roof field.

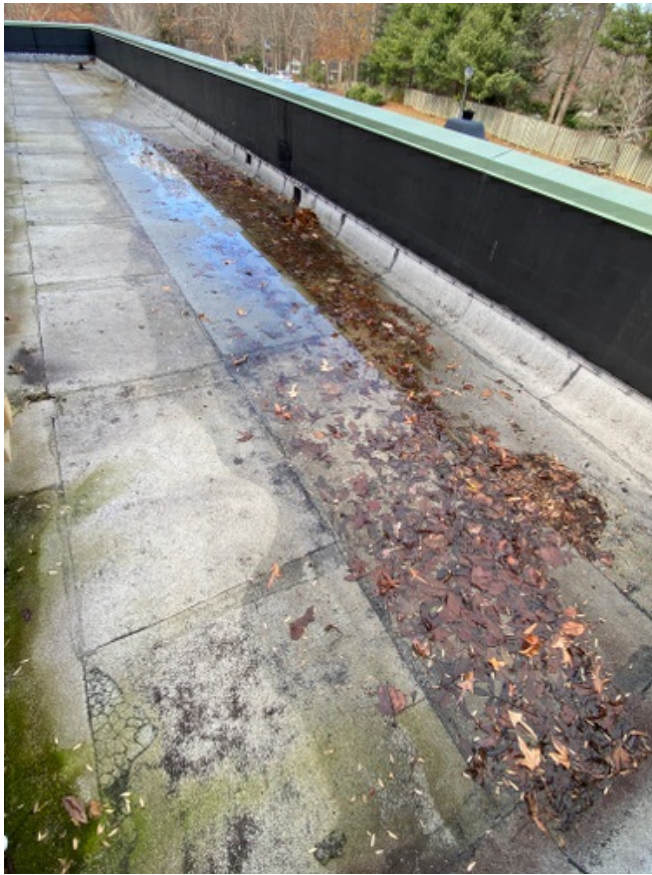
Photo 2

Ponding Water: Ponding has several adverse effects on a roof membrane. In the winter months, ponding water freezes & expands. This expansion weakens small imperfections in the roof systems. Hairline cracks and small tears will widen to the point of rupture, allowing water to leak into the building. Ponding water also accelerates the aging of a roof, as water magnifies the effects of UV degradation.

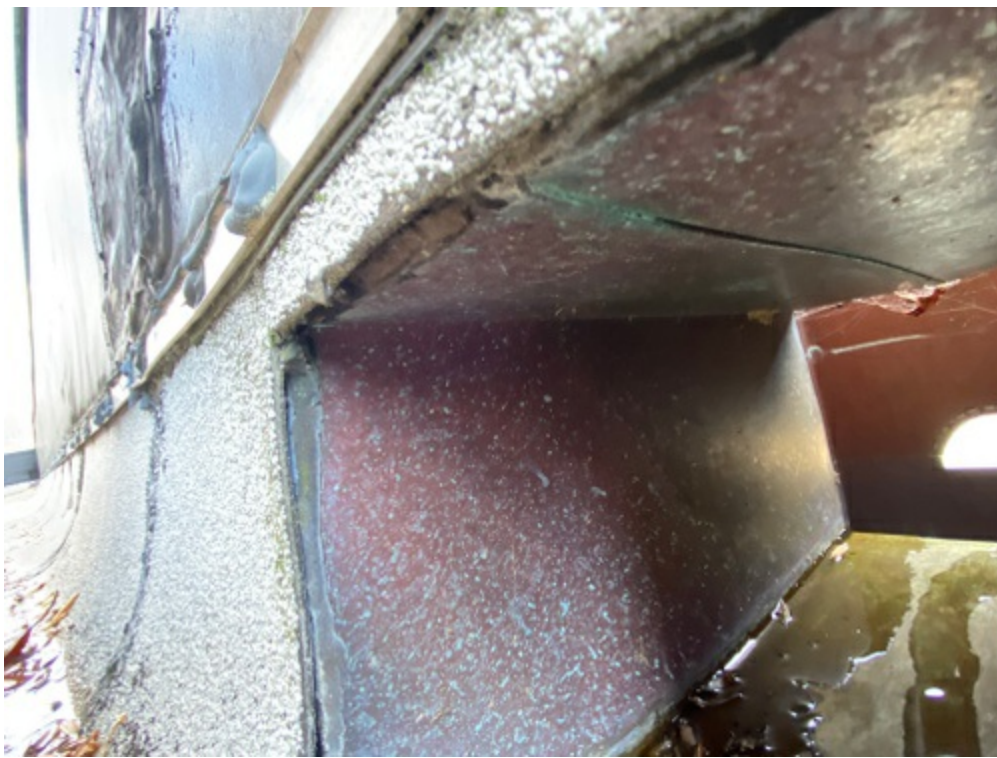
Photo 3

Membrane beginning to separate from the flashing at the scupper.

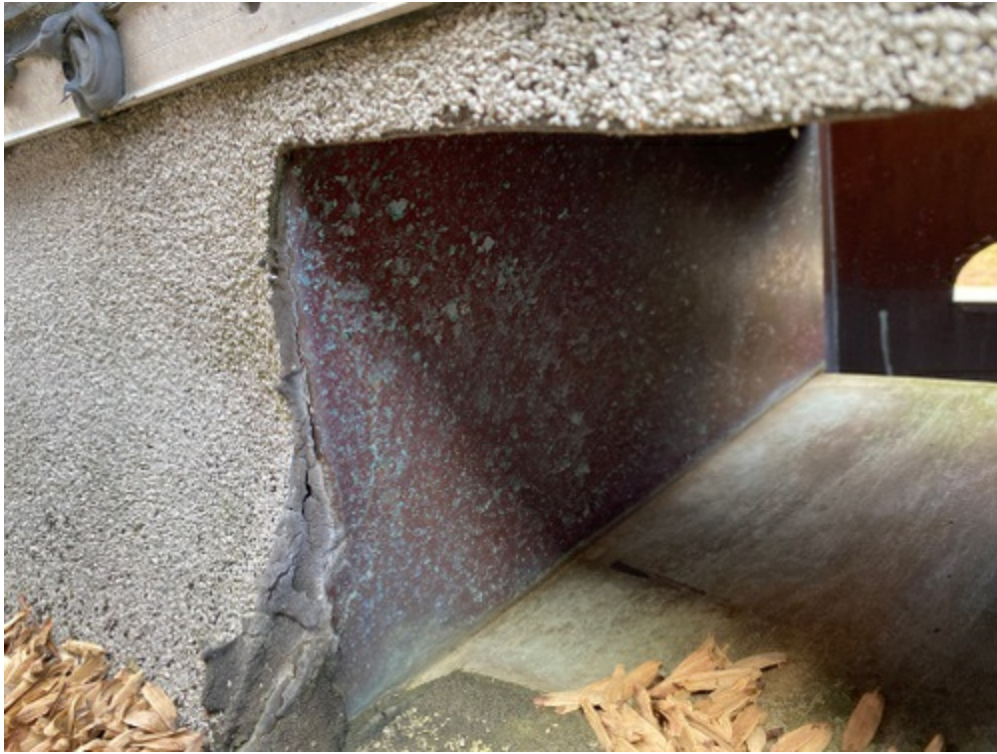
Photo 4

Improper detail of the roof's scupper. The membrane should extend into the scupper to prevent reliance on sealant as the only protection from water intrusion.
