FY27 CIP SUBMISSION

Select if Revised	<u>Roof Replacement</u>					Date: <u>10/3/2025</u>	
Describe revision, if applicable						Year of First Submittal:	<u>2023</u>
Project Overview:	A roof replacement plan was created to estimate the timing for roof replacement of County facilities. Estimates reflect 30-year replacements, with 20-year alternatives available.						
Requesting Department	Facilities Management	Est. Useful Life	20-25 Years				
Location (address)	7400 Justice DR.	Start Year	2027				
Magisterial District	Ware	Est. Completion Year	2030				
Annual Recurring Cost	click drop-down list	Category	Replacement/Maintenance Plan				
Number of Residents Served		Primary Board Priority	Infrastructure				
Expenditure Description	Total Project Request	5-Year CIP					
		Budget Year	Planning Years				Beyond 5 Years
		FY2027	FY2028	FY2029	FY2030	FY2031	FYI only
Land Acquisition	\$ -						
A&E	-						
Construction	1,247,400	525,000	231,000	55,650	435,750

Inspection Report

Client: Gloucester County Buildings/Grounds & Mosquito Control

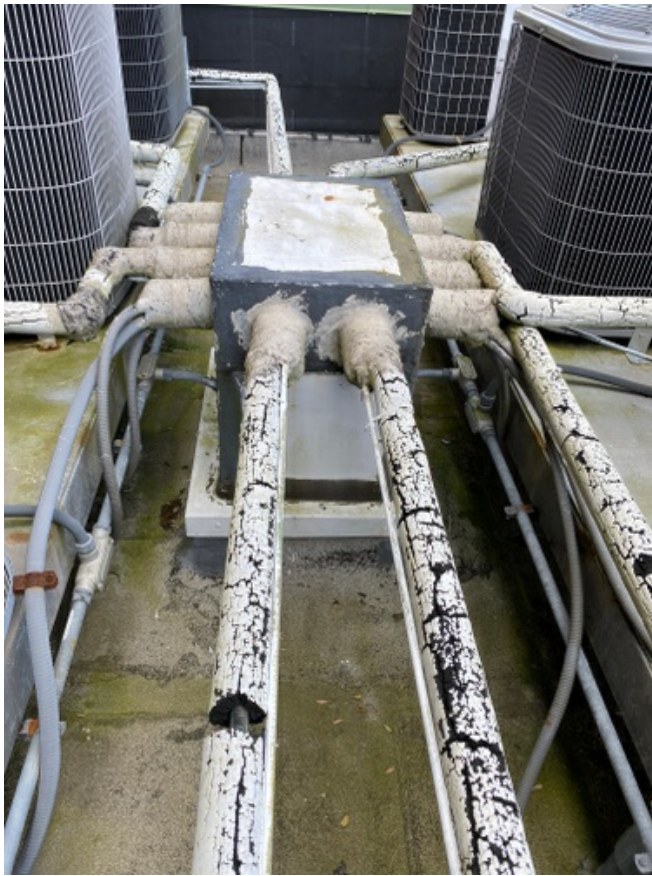
Photo 5

Pitch Pocket Deterioration: Metal protrusions that penetrate the roof system to allow conduits to run from the rooftop into the building. Movement from the protrusion can break the waterproofing compound, creating cracks. Over time, the release of solvents from the compound can cause the material to shrink, leaving gaps along the edges of the pan and around structural support. Water can enter through a defective pitch pan and find its way into the interior of the building. Moisture can also penetrate into the roof system leading to premature failure.

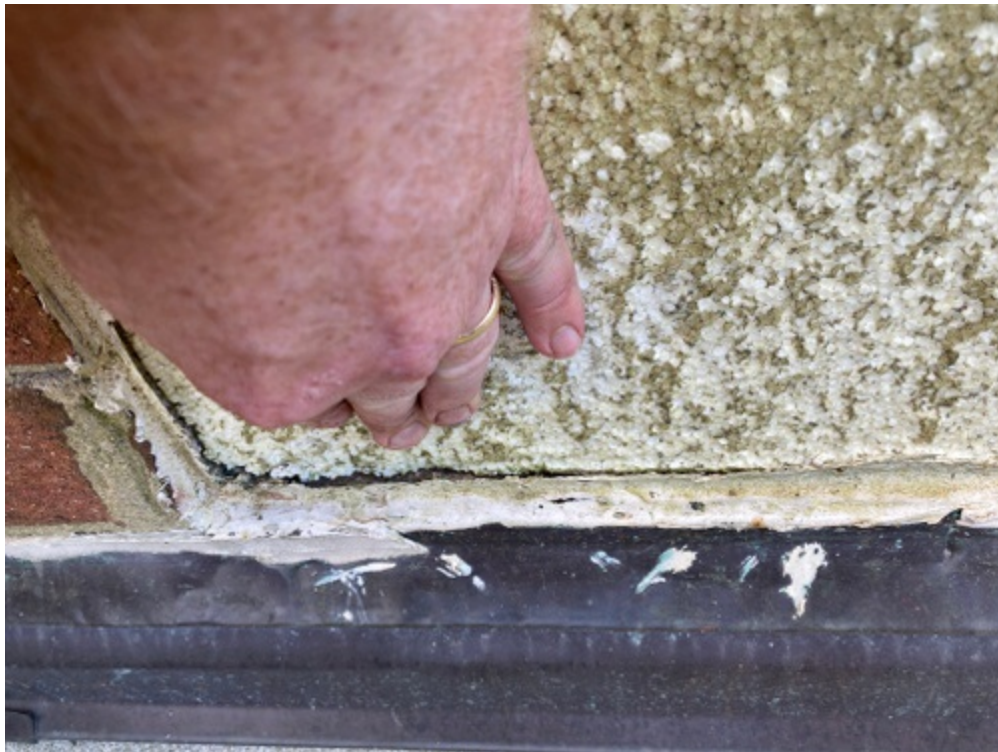
Photo 6

Previous repair to fill an opening in the brick and mortar is not water tight.

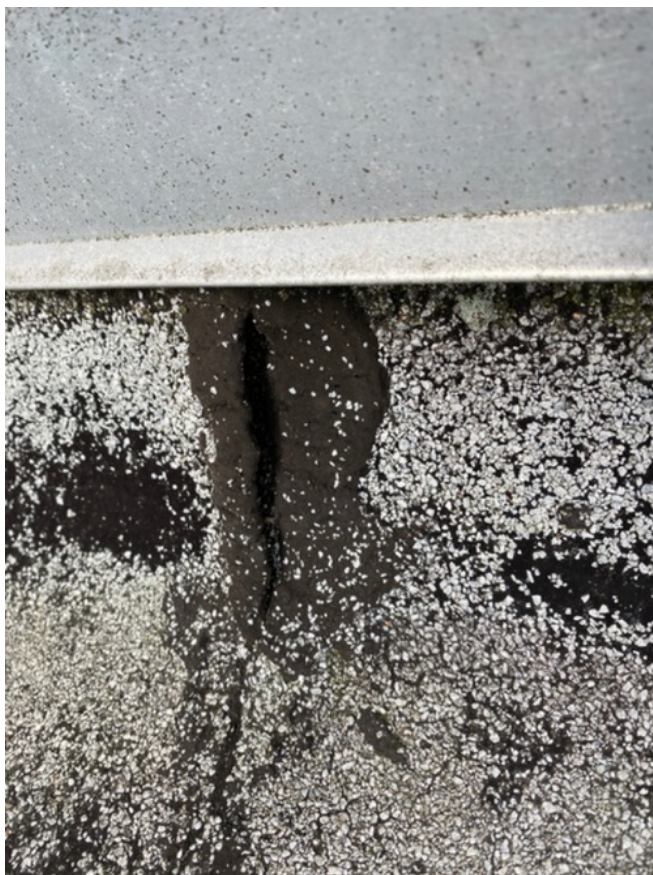
Photo 7

Perimeter Flashing Deterioration: Most roof failures start at perimeter and penetration locations. Metal edge conditions that are poorly designed and improperly installed fail due to the extreme expansion and contraction that is typical with metal. Perimeter wall flashings can also be damaged due to normal seasonal building movement and thermal shock. Additional damage can also be seen from UV degradation as well. At all of these deteriorated or failed points, moisture can gain direct access to the roof system insulation and the buildings interior.

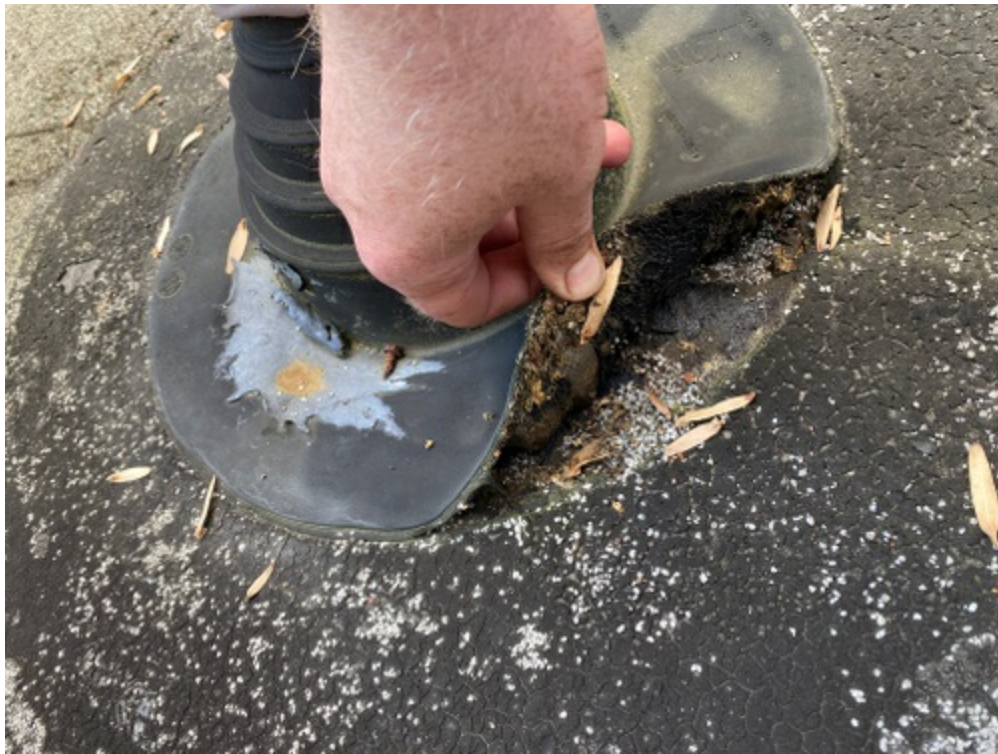
Photo 8

Improper detail: The pipe boots depicted here is the incorrect detail to waterproof a penetration. The pipe should be flashed or have a pitch pocket created to ensure that no water can get into the system.

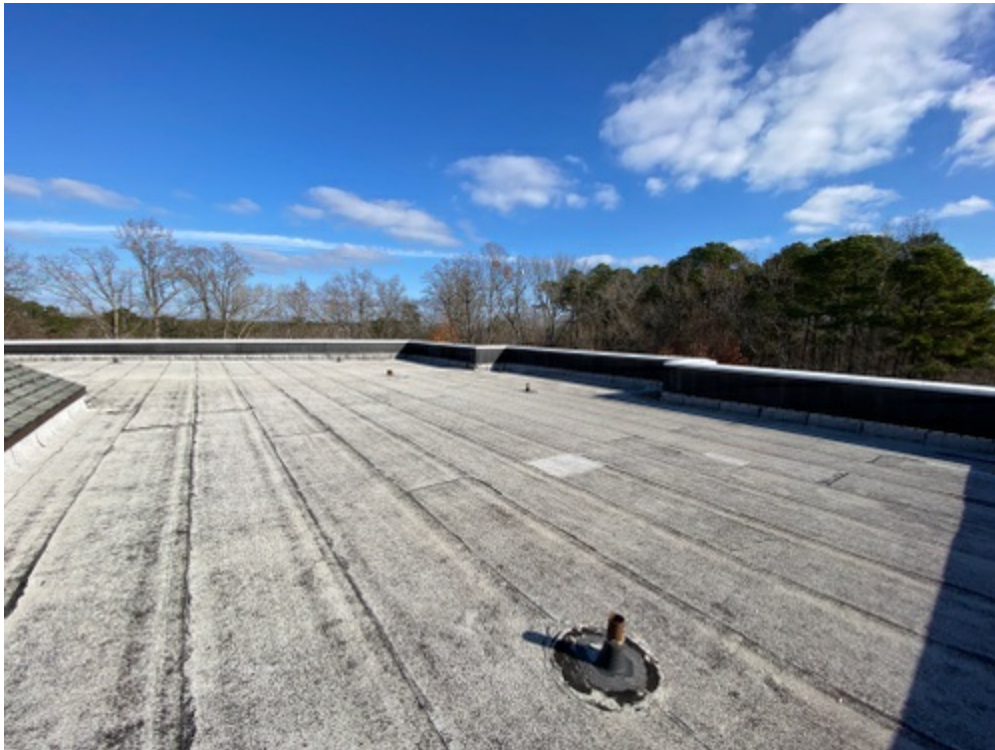
Photo 1

Overview of the Main Roof to the North.

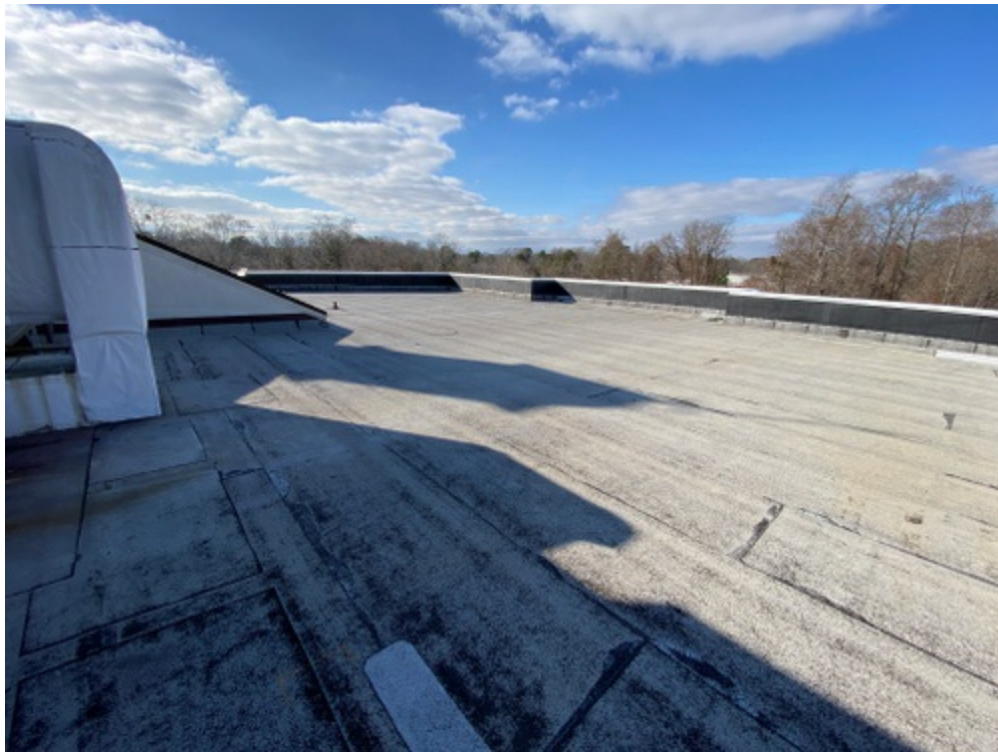
Photo 2

Overview of the Main Roof to the South.

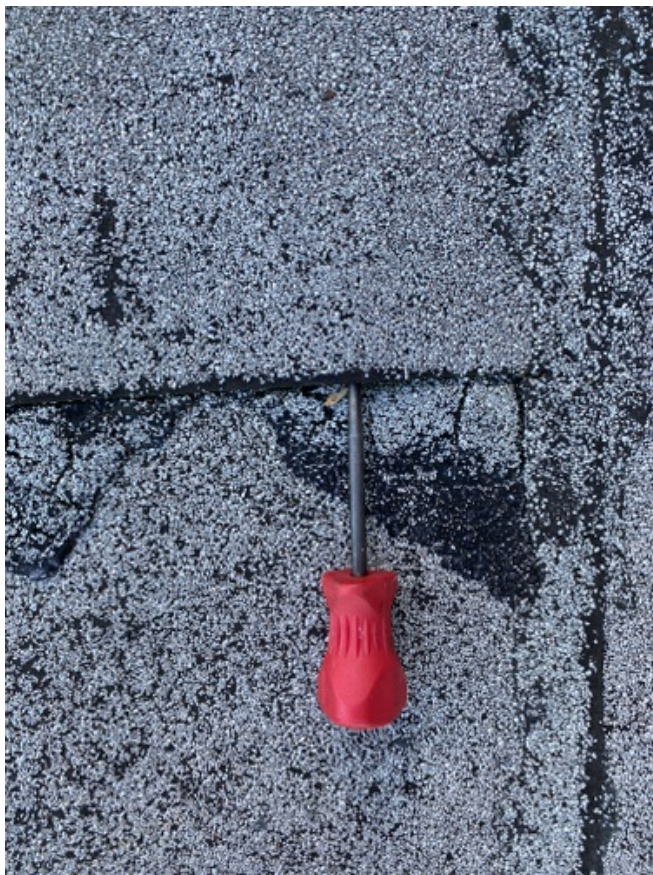
Photo 3

Lap Seam Deterioration: The lap seams are deteriorating from age and UV exposure. As this condition progresses the seams will open allowing water to penetrate the system causing structural decay & interior damage.

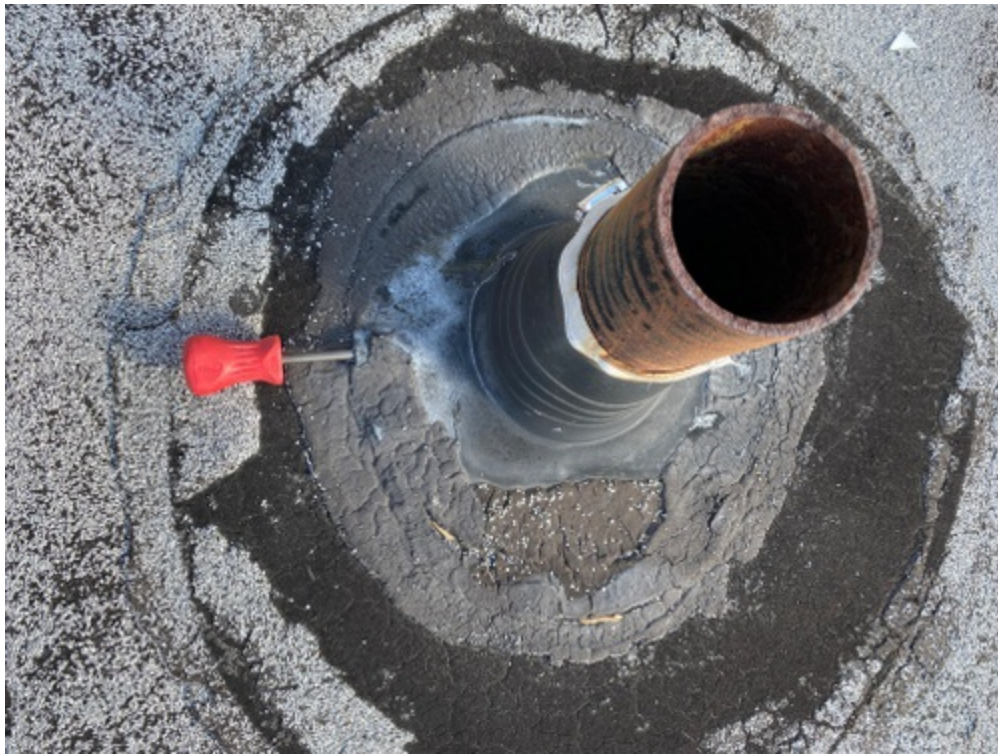
Photo 4

Improper Detail: Incorrect pipe boot. This pipe should be flashed or has a pitch pocket created to ensure water is unable to infiltrate the system.

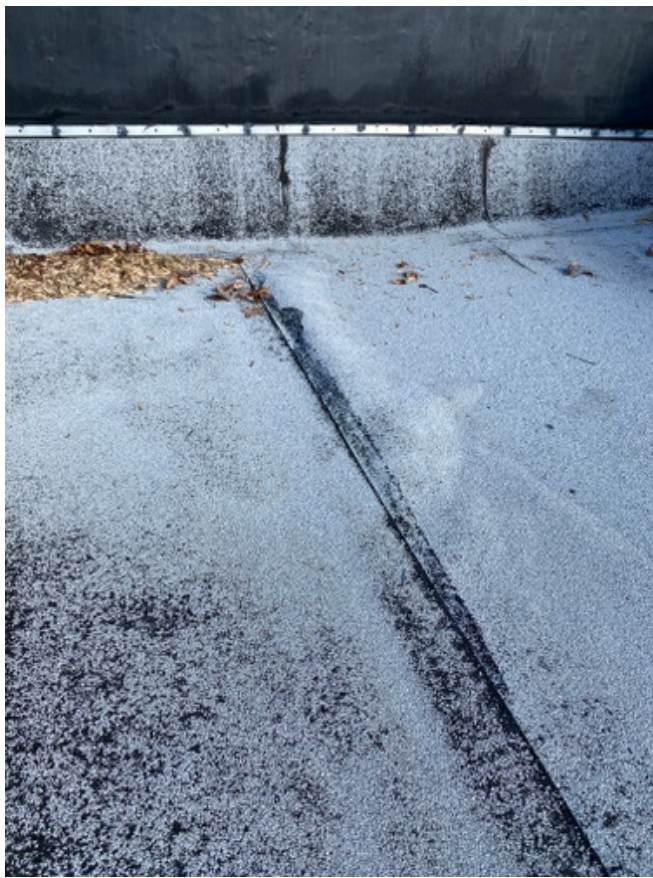
Photo 5

Blisters: Soft spongy pockets or swellings in the roofing material. They occur between layers of felt or between the roof membrane and substrate. Air or moisture vapor entrapped within a blister expands as the roof and outside air temperatures rise. This results in sufficient pressure to push the roofing felts upwards and apart. Blisters may be ruptured by roof traffic, expanding frozen water, or hail (especially during colder weather). Laps could also be pulled apart, resulting in leakage. A ruptured blister will immediately allow water to penetrate and damage the roof system.

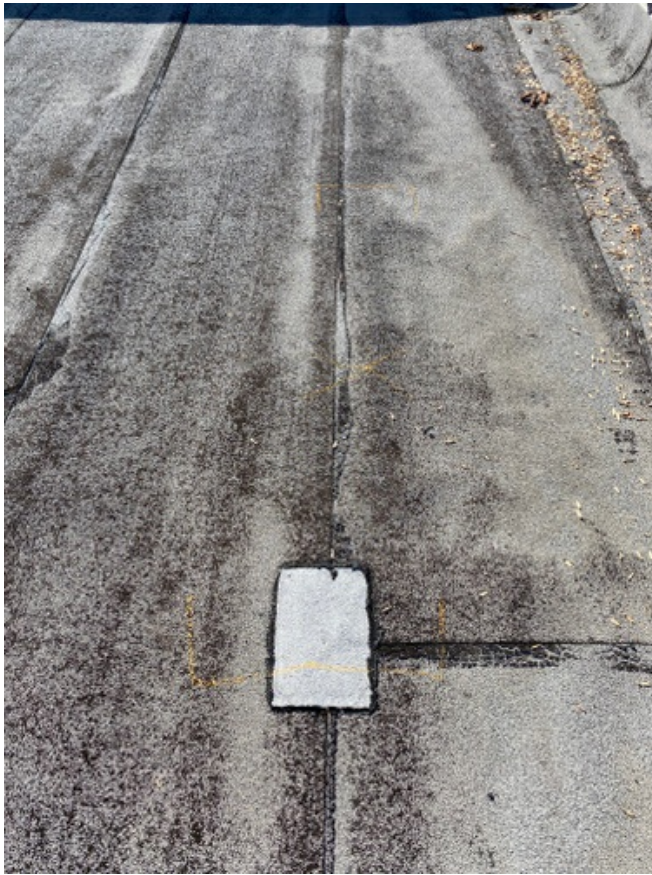
Photo 6

Blisters continued.

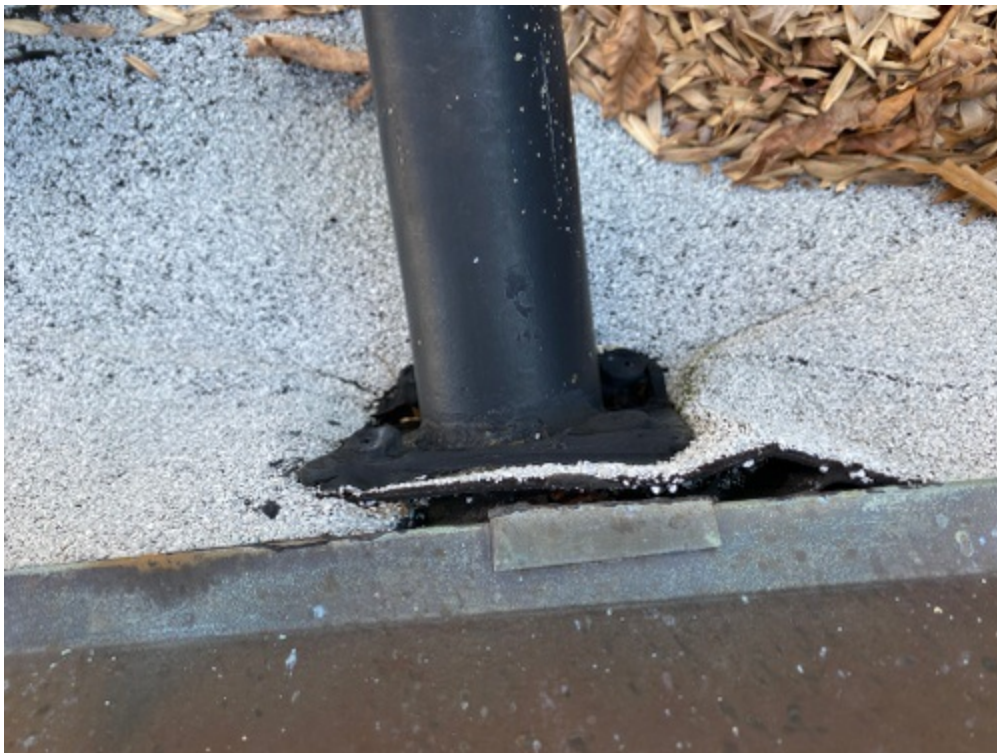
Photo 7

Penetration that may have been an antenna at one point but has now pulled the membrane flashing away from the wall allowing for runoff to go directly into the wall.

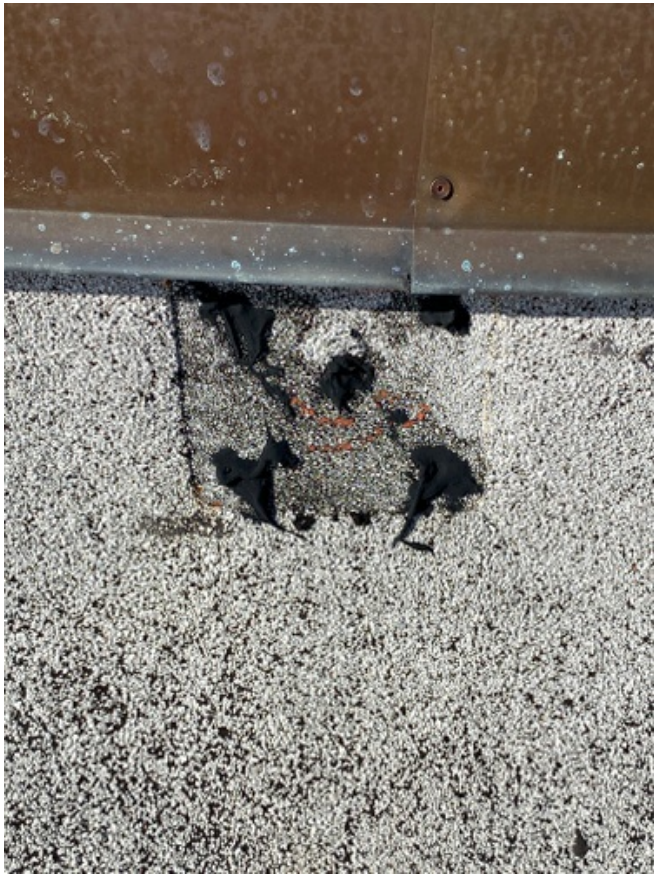
Photo 8

Similar antenna footprint from another area was removed and sealed but that sealant is starting to deteriorating.

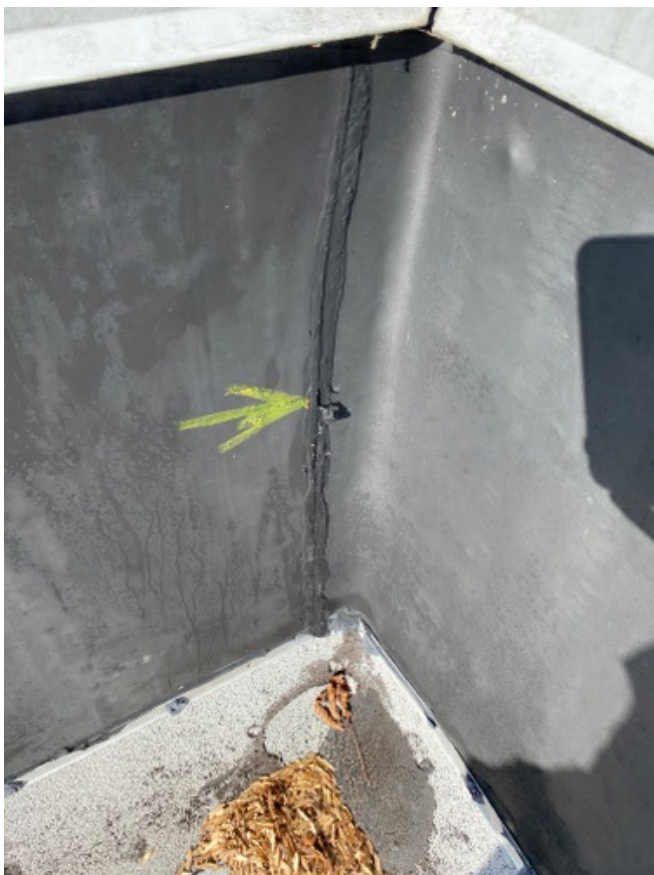
Photo 9

Single Ply Flashing Deterioration: A typical single ply EPDM rubber roof membrane is approximately 1 millimeter thick. Therefore, it is extremely easy to puncture or tear.

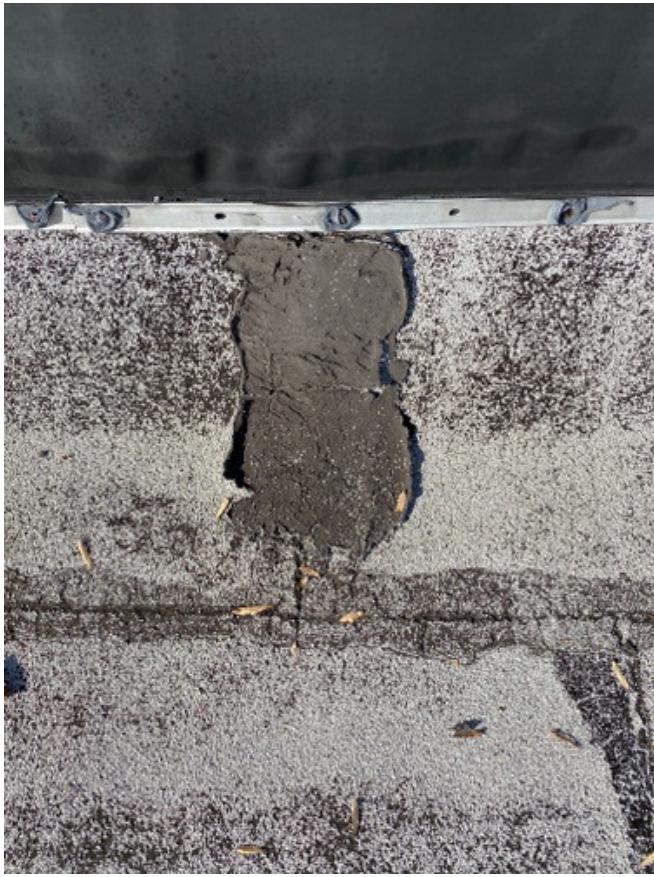
Photo 10

Flashing Seam Deterioration: The mastic used on the flashing seams is deteriorating from age and UV exposure. As this condition progresses the seam will open allowing water to penetrate the system causing structural decay & interior damage.

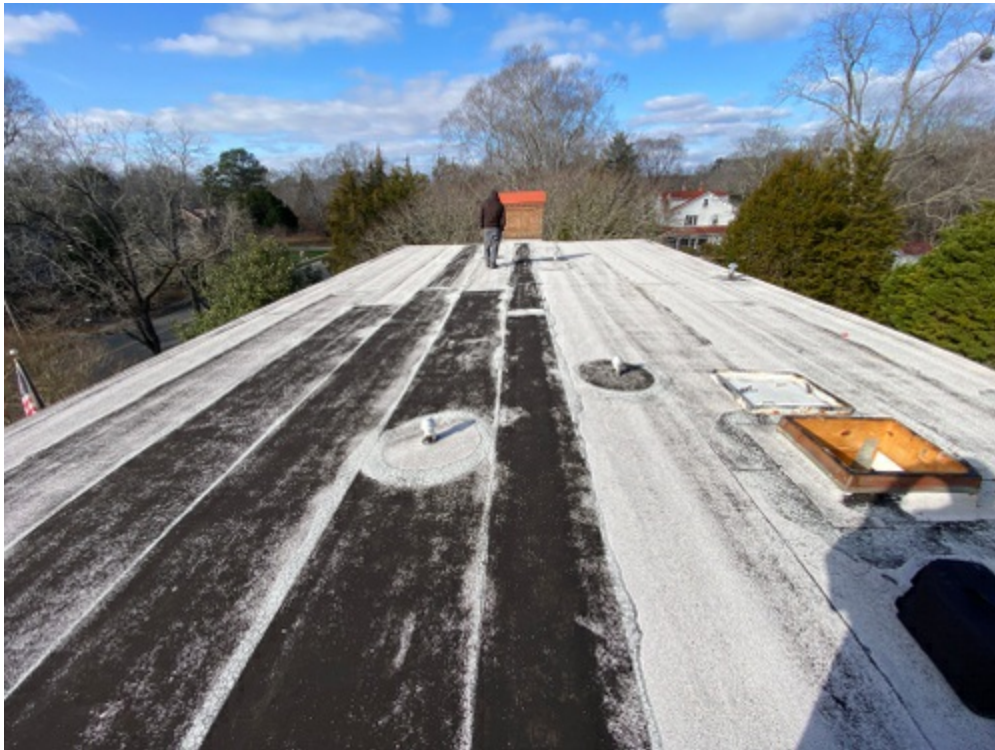
Photo 1

Overview of Building #1's main roof.

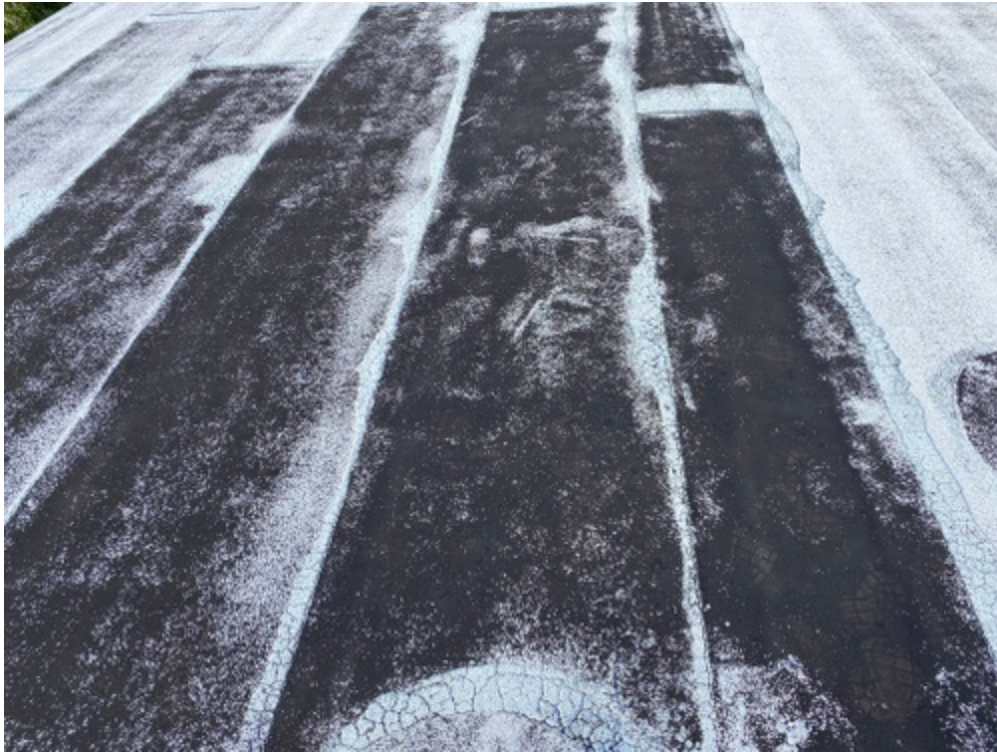
Photo 2

Mineral Roof Granule

Deterioration: It is very common for mineral finished roofs to experience bare felts as early as five years after installation. Manufacturing quality control issues as well as weather "washing off" the factory applied mineral coating causes these areas. Typically this is indicated by accumulations of mineral where ponding is present. Bare felts cause exposure of the membrane to the sun/UV rays, which cause rapid membrane deterioration. Therefore, it is extremely important to coat these areas as soon as they appear.

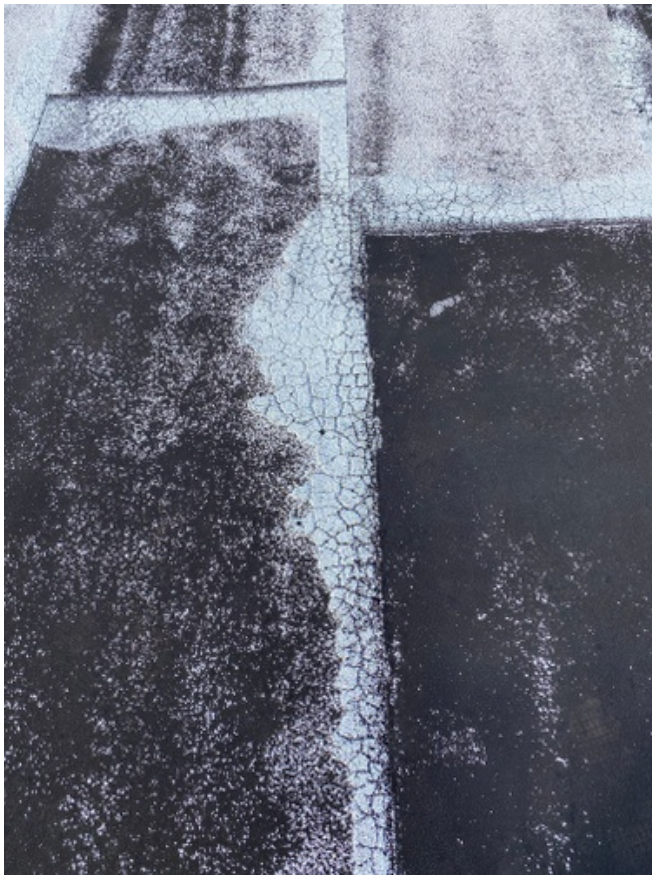
Photo 3

Alligatoring: is a result of the drying out and shrinking of the asphalt surface resulting in a "mud-cracking" pattern. The pattern is most pronounced in areas of exposed asphalt. It is caused by the heat and UV rays of the sun beating down on the exposed asphalt surface. If left untreated, the alligatoring condition can develop into splits in the roof membrane. As the surface continues to shrink and dry out, cracks will develop down to the depth of felts and may stress-crack the membrane in cold weather. These crack channels will allow water to penetrate and damage the roof system.

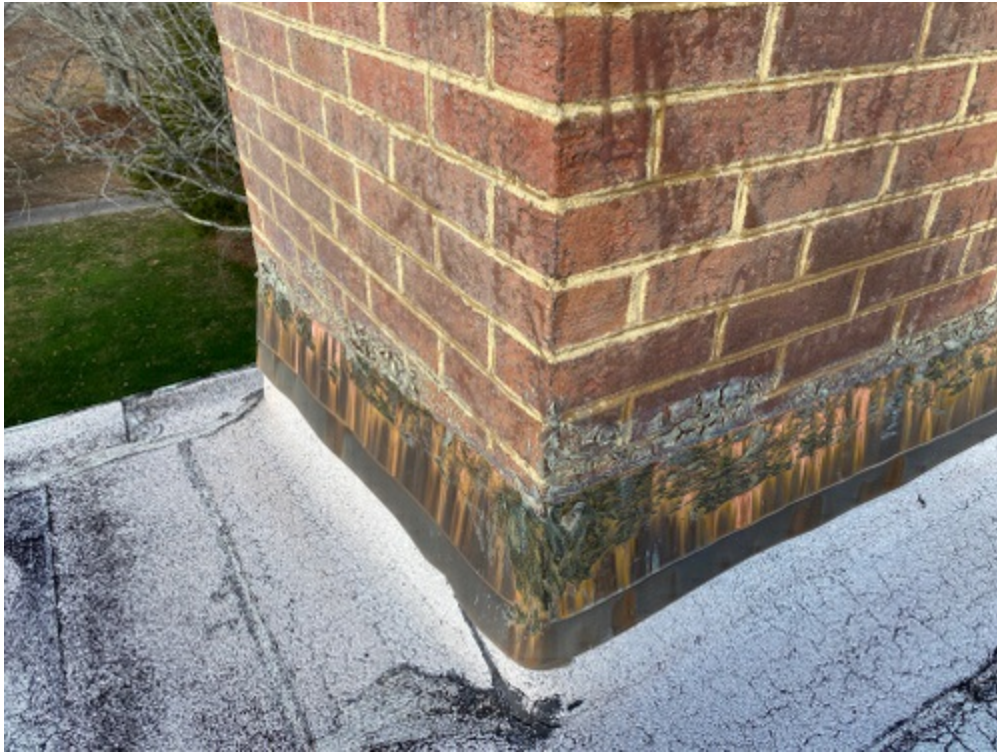
Photo 4

Caulking Deterioration: As caulking is exposed to UV rays and temperature fluctuations it loses its flexibility and develops cracks. Once this occurs splits develop allowing water to penetrate walls and buildings causing damage as well as leaks.

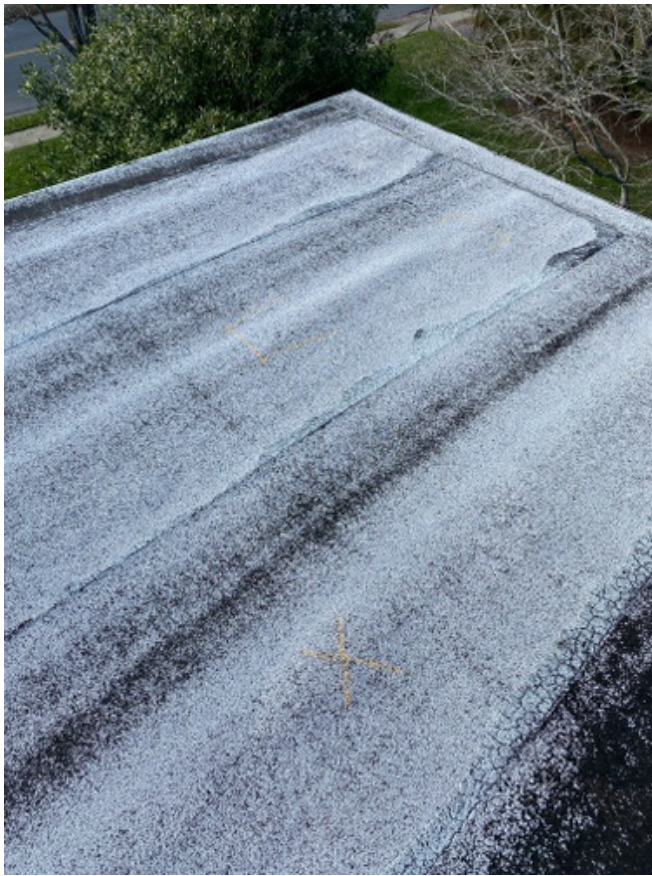
Photo 5

Blisters: Soft spongy pockets or swellings in the roofing material. They occur between layers of felt or between the roof membrane and substrate. Air or moisture vapor entrapped within a blister expands as the roof and outside air temperatures rise. This results in sufficient pressure to push the roofing felts upwards and apart. Blisters may be ruptured by roof traffic, expanding frozen water, or hail (especially during colder weather). Some blisters may become so large as to affect drainage, which may then cause ponding water. Laps could also be pulled apart, resulting in leakage. A ruptured blister will immediately allow water to penetrate and damage the roof system.

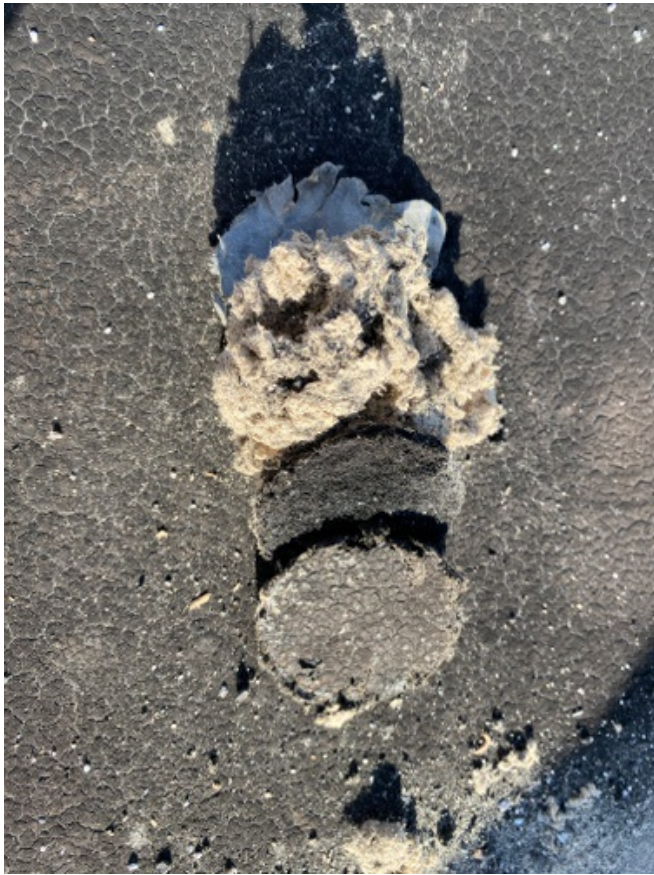
Photo 6

Roof's 2-ply composition.

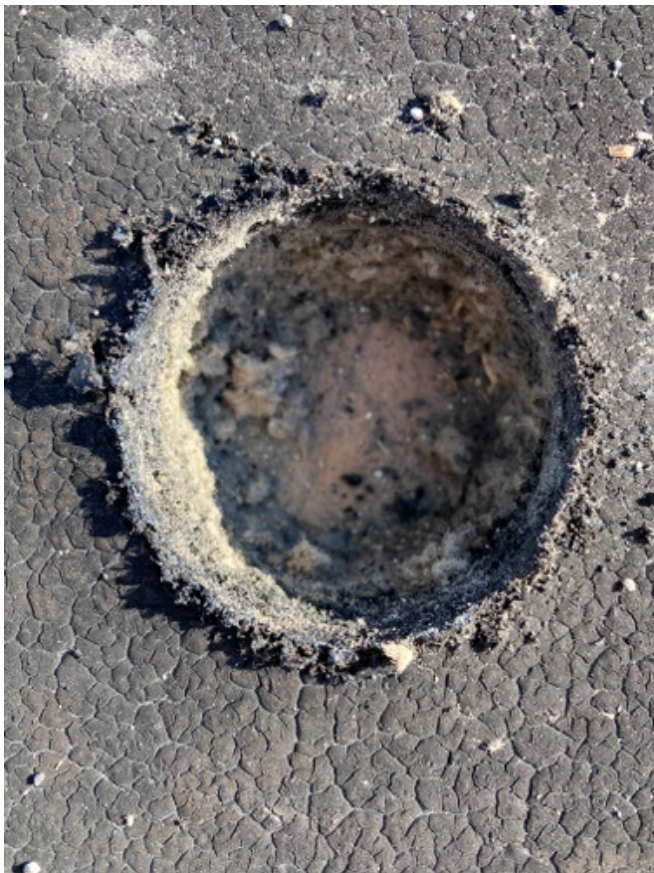
Photo 7

Exterior view of the wood deck.
