# FY27 CIP SUBMISSION

# CONDITION ASSESSMENT REPORT

GLOUCESTER COURT CIRCLE PROPERTIES &  
MUSEUM OF HISTORY  
GLOUCESTER COUNTY, VIRGINIA

*95% DRAFT SUBMISSION*

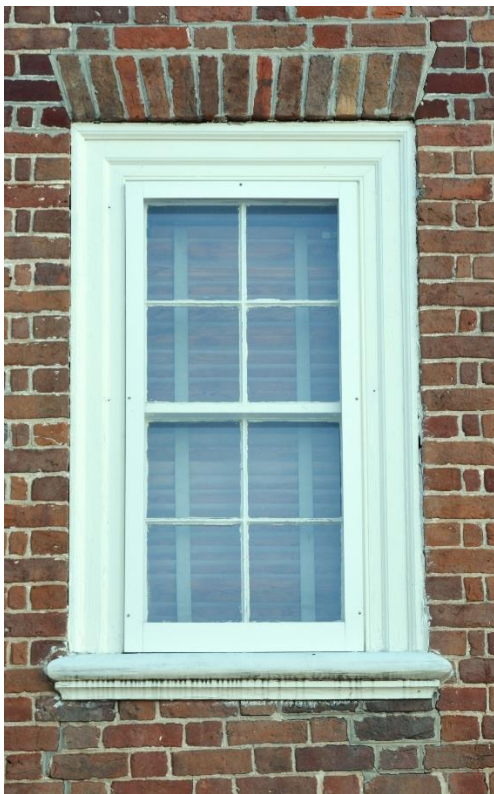
CODE	PHOTOGRAPH	CONDITION/REPAIR	QUANTITY
BB. W.1

<p>Existing wood windows display finish and substrate deterioration at various components.</p> <p>Restore 100% of wood windows. Remove window sashes and exterior storm windows. Remove glazing putty and glass. Label and store glass for future reinstallation. Strip paint. Remove rotted wood from sash and frames. Remove perimeter sealant. Provide epoxy patch for all surface repairs and wood dutchman for rotted sections. Reglaze sash. Paint all sides of frame, sill, and sash. Reinstall sash and provide new storm window where desired. Provide perimeter sealant.</p>	36 double-hung windows
BB. W.2

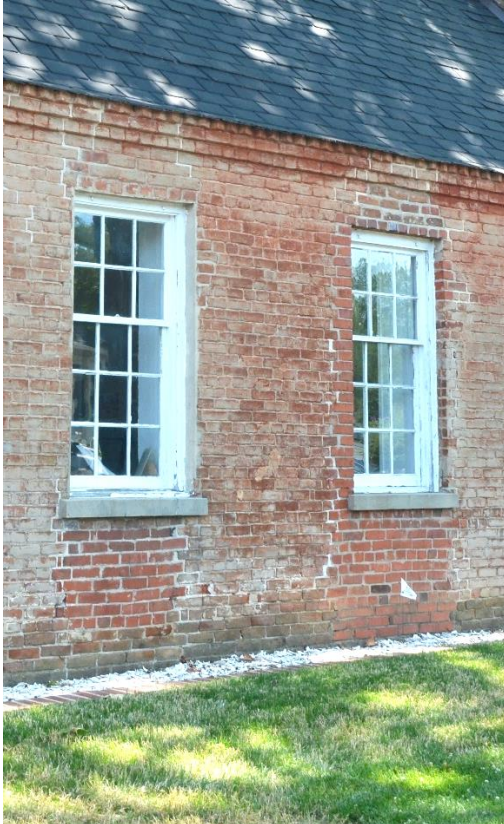
<p>Mismatched brick masonry is extant at two rear windows, suggesting potential former door location or deterioration at sill. These openings also have a nonstructural header course supported on a steel lintel. These repairs were made after the faded exterior treatment was applied, suggesting an early-to-mid-twentieth century alteration.</p> <p>Complete additional research and limited removals to confirm historic arrangement. Consider replacing mismatched masonry in concert with removing faded finish from adjacent walls. Provide jack arch if documentation confirms original design.</p>	25 SF of masonry replacement

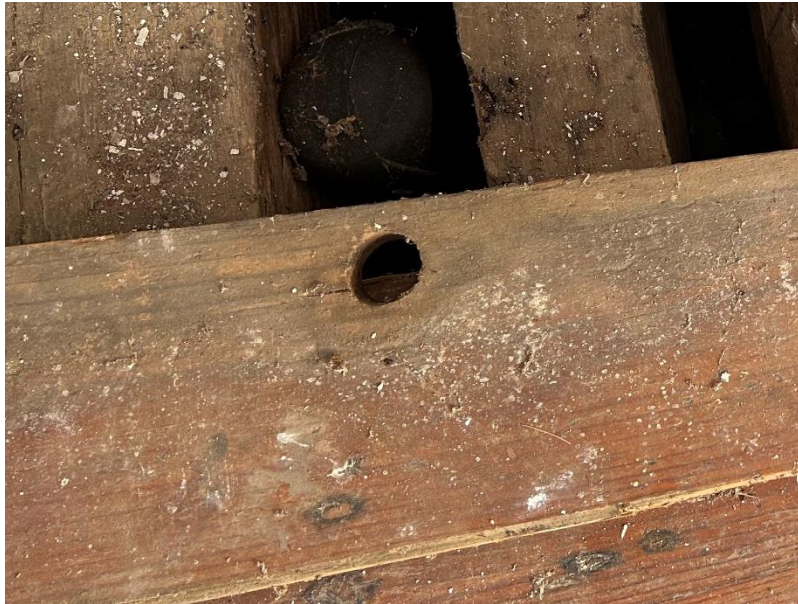
*Possible radiator piping hole at floor*

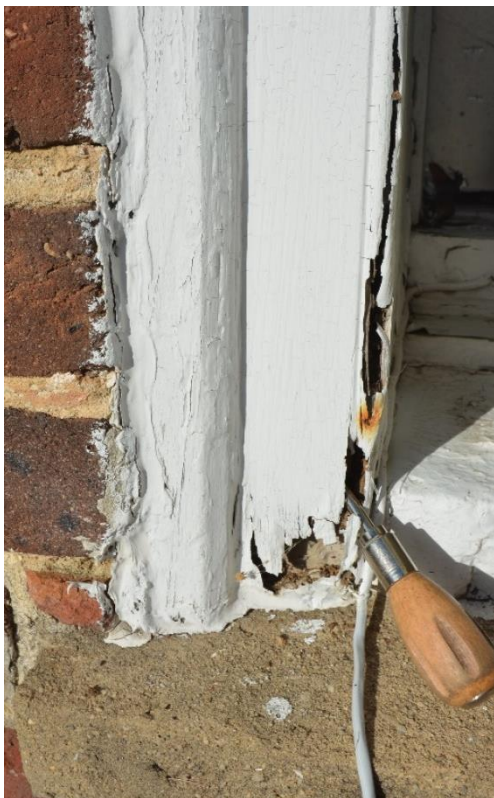
CODE	PHOTOGRAPH	CONDITION/REPAIR	QUANTITY
OJ. W.1

<p>Existing wood windows display finish and substrate deterioration at various components.</p> <p>Restore 100% of wood windows. Remove window sashes. Remove glazing putty and glass. Label and store glass for future reinstallation. Strip paint. Remove rotted wood from sash and frames. Remove remnants of iron bars if they will not be restored. Remove perimeter sealant. Provide epoxy patch for all surface repairs and wood dutchman for rotted sections. Reglaze sashes. Remove and replace locks. Paint all sides of frame, sill, and sash. Reinstall sash. Provide perimeter sealant.</p>	9 double-hung windows & 4 awning windows
OJ. W.2

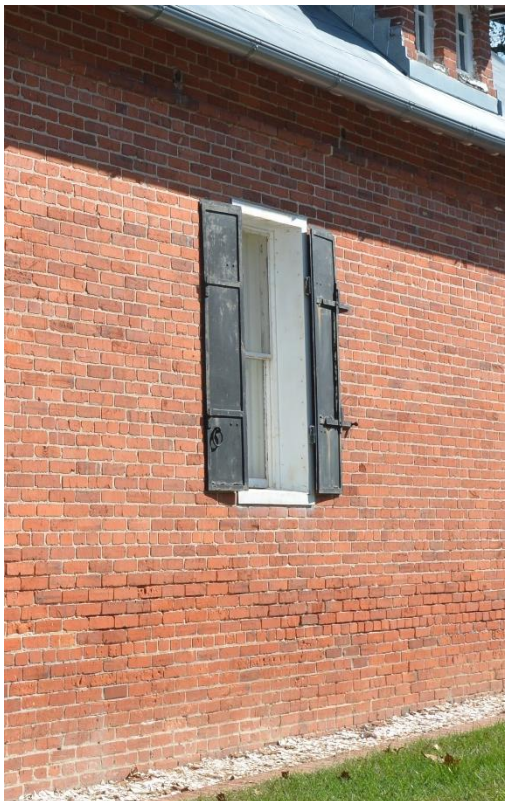
<p>The multi-wythe exterior walls have an internal air gap. The exterior wythe exhibits spalling and mortar loss at the evaporation line as a result of moisture driven vertically through the masonry. The inability of the walls to dry sufficiently has led to deterioration of the masonry.</p> <p>Perform additional analyses on the exterior walls to confirm extent of internal vents and micro-climate within the wall. Use borescope to perform visual analysis. Consider providing mechanical ventilation within cavity to support evaporation of moisture and insert dampproof course within masonry wall.</p>	Fees

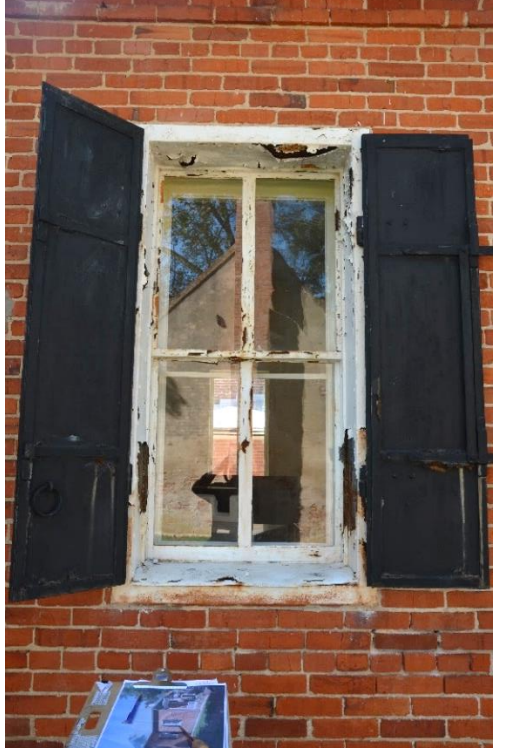
CODE	PHOTOGRAPH	CONDITION/REPAIR	QUANTITY
RB. W.1

<p>Existing steel windows and shutters display widespread finish and substrate deterioration at various components.</p> <p>Restore 100% of steel windows. Remove window sashes and shutters. Remove glazing putty and glass. Label and store glass for future reinstallation. Strip paint. Remove corroded areas from sash and frames. Remove perimeter sealant. Provide patch for all surface repairs and dutchman for heavily corroded sections. Reglaze sash. Paint all sides of frame, sill, sash, and shutter. Reinstall sashes and shutters. Provide perimeter sealant.</p>	8 double-hung windows @ 25 SF each / 10 casement windows @ 15 SF each / 4 transoms @ 10 SF each

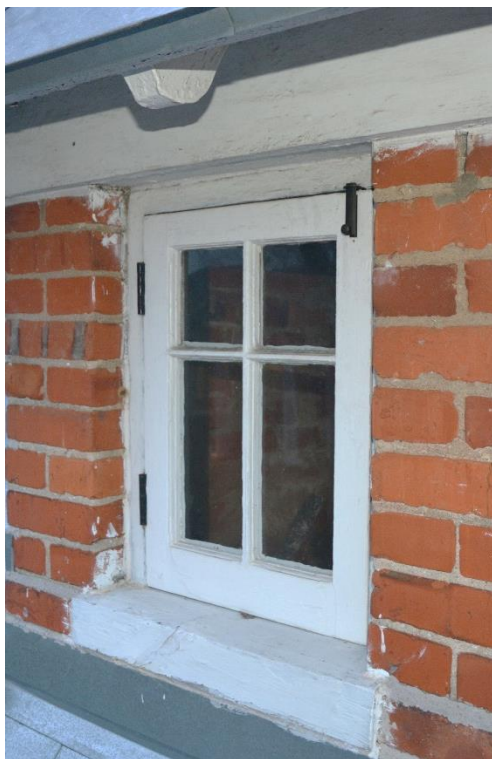
RB.  
W.2

Existing wood windows display minor finish and substrate deterioration at various components.

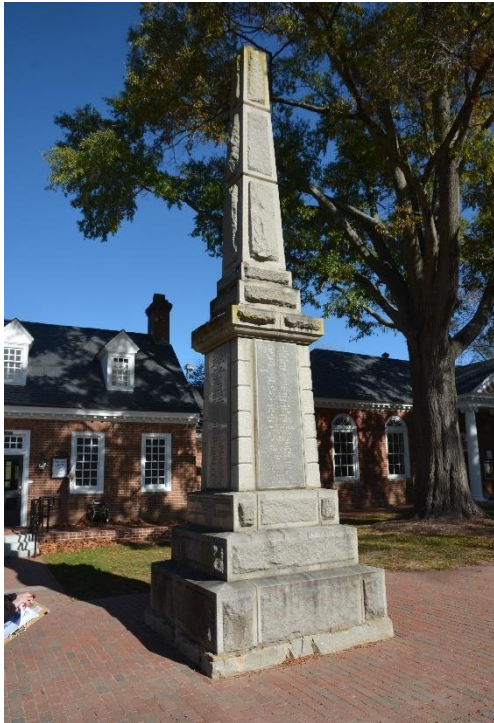
<p>Many localities across Virginia have reinterpreted or removed Confederate monuments so as to acknowledge those local citizens for whom the Confederacy's legacy of slavery is objectionable. Gloucester's monument avoids explicit celebratory or discriminatory language.</p> <p>Consider establishing a local citizens' communities to determine the long-term goals for the monument and its place in Court Circle. Recommend the minimum provision of an interpretive sign installed adjacent to the monument to contextualize its history.</p>	1 interpretive sign (3'x2')

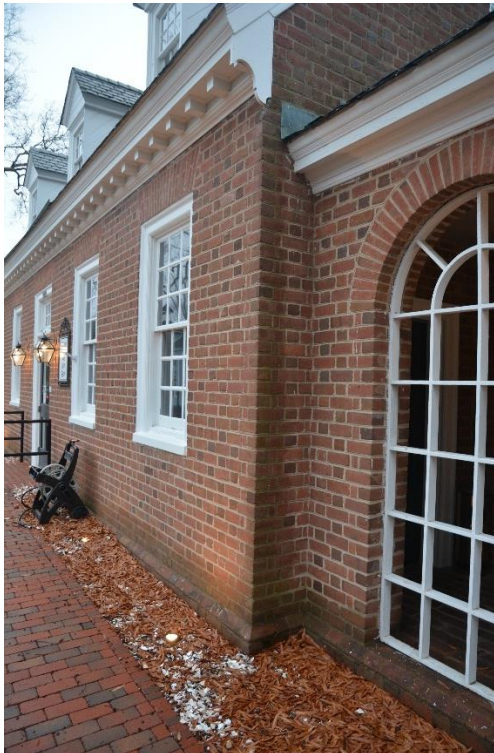
<p>There is no current analysis of the existing building for the presence of hazardous materials. No such analysis was performed as a part of this project. The original construction documents indicate the use of asbestos floor tile on the interior.</p> <p>Perform hazardous material survey to determine if lead-based paint, asbestos-containing materials, or other hazardous materials are present at the building. Survey should be completed before repairs are undertaken to allow for abatement of any hazardous materials in concert with associated work.</p>	Full building (interior and exterior)

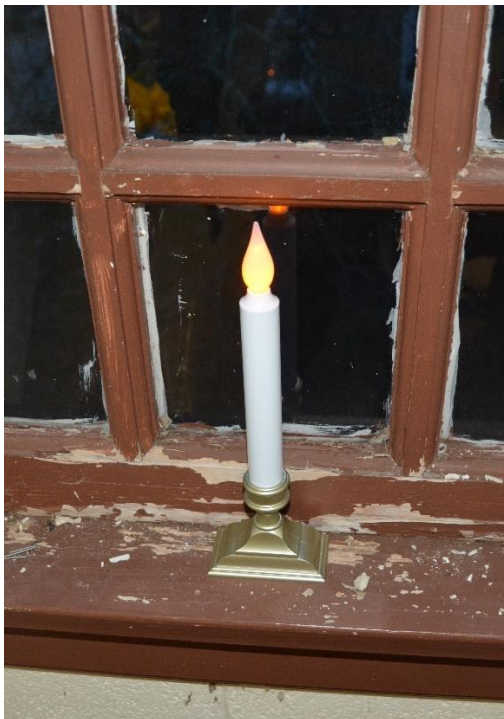
<p>Existing wood windows display finish and substrate deterioration at various components.</p> <p>Restore 100% of wood windows. Remove window sashes. Remove glazing putty and glass. Label and store glass for future reinstallation. Strip paint. Remove rotted wood from sash and frames. Remove metal flashing and perimeter sealant. Provide epoxy patch for all surface repairs and wood dutchman for rotted sections. Reglaze sash. Paint all sides of frame, sill, and sash. Reinstall sash. Provide perimeter sealant.</p>	21 double-hung windows
A. W.2
