# FY27 CIP SUBMISSION

# CONDITION ASSESSMENT REPORT

GLOUCESTER COURT CIRCLE PROPERTIES &  
MUSEUM OF HISTORY  
GLOUCESTER COUNTY, VIRGINIA

*95% DRAFT SUBMISSION*

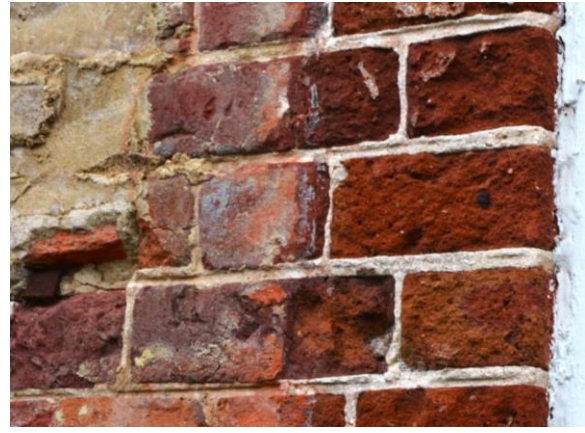
*North wall sandblasting damage.*

The masonry walls display a weathered appearance connected to the sandblasting of the exterior masonry which occurred as a part of the 1959 renovation project. The bricks, presumably made locally, range in color from red-orange to dark red and measure approximately 8 3/4" wide and 2 7/8" tall. A number of the headers retain some portion of their glazed face despite the sandblasting, but the overall effect has been lost. The mortar joints range from off-white to gray and exhibit at least four different campaigns of pointing. The apparently oldest joints exhibit staining from a red paint that was previously been applied to the masonry. The mortar is typically finished with a grapevine joint. In many cases the mortar extends onto the face of the brick. The undersides of the concrete window sills are lined with a modern brick header course. Scarring is visible at the front entrance where the former hipped roof porch attached to the masonry.

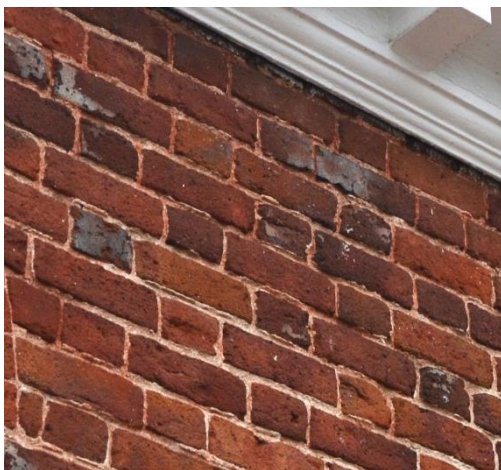
CODE	PHOTOGRAPH	CONDITION/REPAIR	QUANTITY
C. MB.1

<p>Open mortar joints and mortar deterioration occur on all elevations.</p> <p>Due to the number of cracked bricks and open joints paired with the moisture infiltration issues, 100% exterior repoint should be considered. Repoint open brick masonry joints with appropriate mortar mixture using techniques to match original mortar joints.</p>	100% exterior

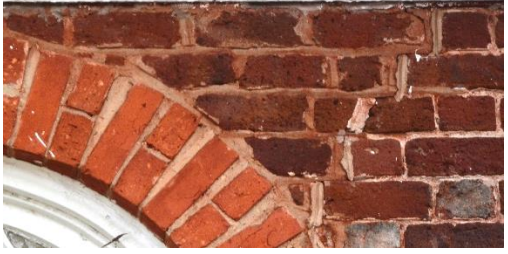
C. MB.2

<p>Stairstep cracks occur in the mortar joints extending from the heads of many windows and door openings.</p> <p>Repoint localized areas, refer to MB.1 for repair and quantity.</p>	See MB.1

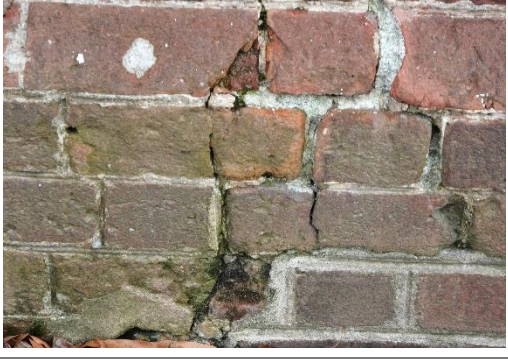
C. MB.3

<p>Brick masonry units are cracked in several locations. This issue occurs with greatest frequency near openings and wall corners.</p> <p>Remove cracked brick unit. Provide matching brick unit and install in concert with wall repointing.</p>	225 brick units

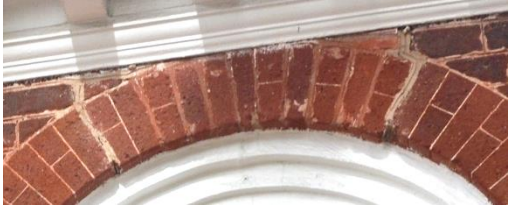
C. MB.4

<p>Existing brick unit is displaced from masonry assembly.</p> <p>Remove and reset displaced brick unit.</p>	4 brick units
C. MB.5

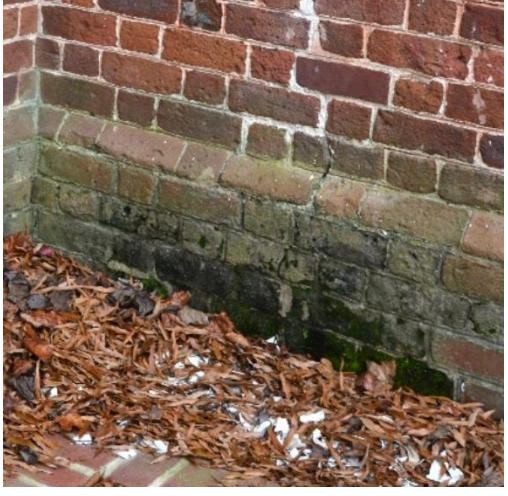
<p>Biological growth is occurring at localized areas of the exterior masonry, typically along the base of the building, and causing staining on the exterior facade.</p> <p>Remove biological growth and staining with architectural anti-microbial biocide. Use gentlest means possible. At northwest inside corner, regrade surface to inhibit moisture from collecting at face of building.</p>	400 SF of cleaning; 50 SF of regrading

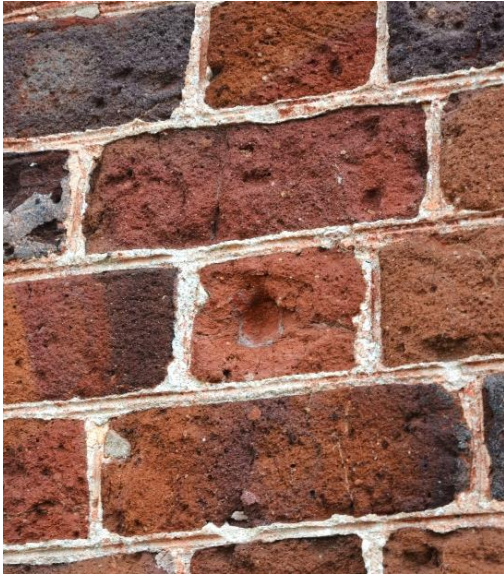
C. MB.6

<p>Surface of brick masonry displays extensive damage due to sandblasting. The process removed earlier coats of paint, but also destroyed the hard outer face of the brick.</p> <p>Perform petrographic analysis of 5 bricks to determine composition of brick to confirm desirability of applying penetrant coating, such as Siloxane, to mitigate water infiltration. If deemed appropriate per test findings, select and apply coating.</p>	Testing, application of coating to 100% of exterior
C MB.7

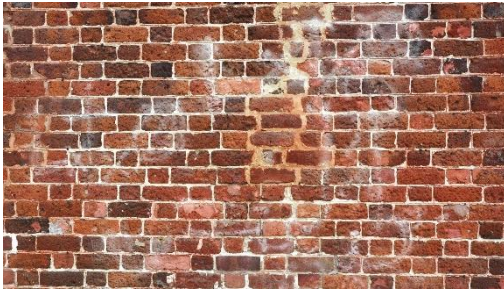
<p>Instances of graffiti are present on the brick masonry.</p> <p>Remove paint staining from surface of masonry walls. Perform tests on masonry and pursue the gentlest effective method.</p>	50 SF

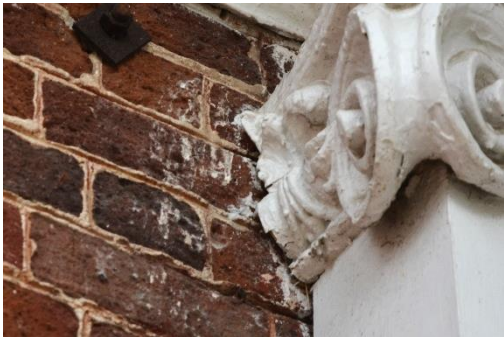
C. MB.8

<p>Overpaint is present on masonry surfaces directly adjacent to painted surfaces.</p> <p>Remove overpaint on brick surfaces using the gentlest effective method.</p>	Small spot locations across upper facade and below windows

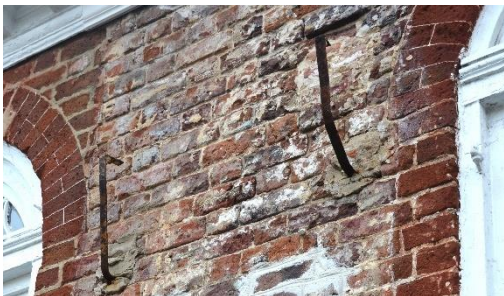
C. MB.9

<p>Abandoned metal brackets are mounted into brick walls and there is staining at location of former chimney.</p> <p>Remove metal brackets and replace any adjacent past repairs which do not match historic masonry.</p>	6 locations / 10 SF masonry / 100 SF of cleaning

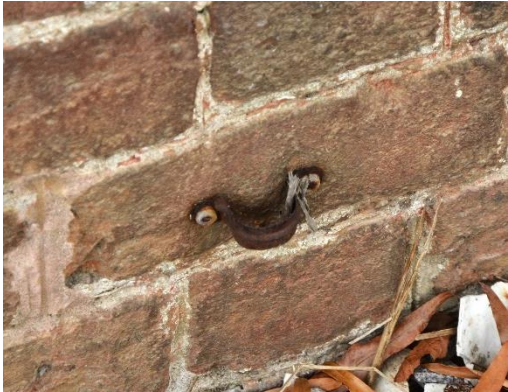
C. MB.10

Fasteners are installed into the face of brick for various purposes.  Remove all metal fasteners. Dispose of abandoned elements and remount all active items with appropriate fasteners into the mortar joint. Patch brick with color-matched grout of appropriate mix.	15 locations
C. MB.11

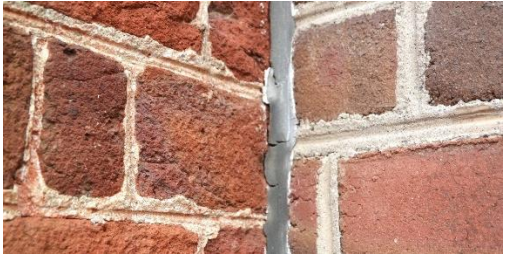
Sealant joint at intersection of Courthouse with Annex is aged and requires replacement.  Remove existing sealant. Prepare surface for installation of new sealant and backer rod.	40 LF

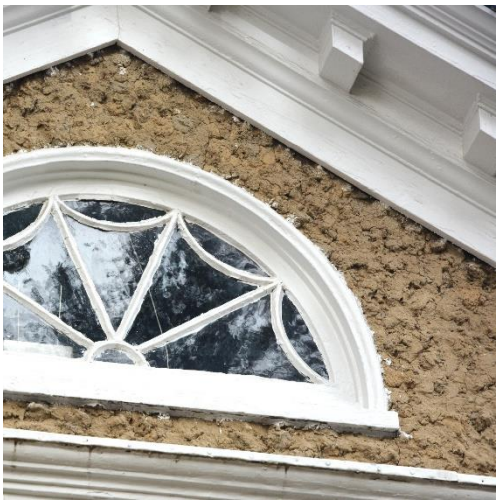
CODE	PHOTOGRAPH	CONDITION/REPAIR	QUANTITY
C. ST.1

Existing textured stucco tympanum displays cracking and surface deterioration.  Perform survey of pediment either via manlift or ladder. Tap all stucco to confirm areas of delamination. Remove delaminated areas and patch stucco to match utilizing mix design from petrographic analysis of existing stucco. Minimize extent of repairs to maintain intact historic stucco.	Assume 15 SF

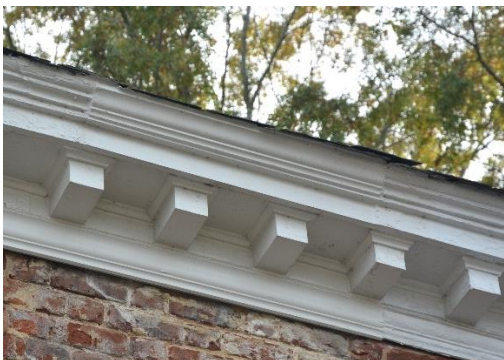
CODE	PHOTOGRAPH	CONDITION/REPAIR	QUANTITY
C. WD.1

Existing wood cornice board is damaged or has an inappropriate repair.  Strip finish from damaged portion of cornice board. Remove rotted or altered portions of wood and provide wood dutchman or epoxy repairs.	8 LF
C. WD.2

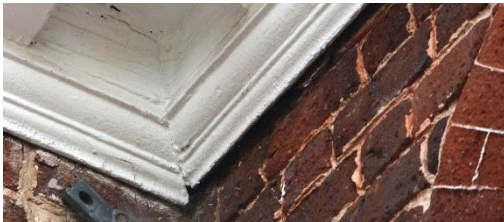
Gap has opened between wood cornice and brick wall.  Inspect gap, remove debris behind cornice. Insert painted wood shim to narrow gap.	2 locations
C. WD.3

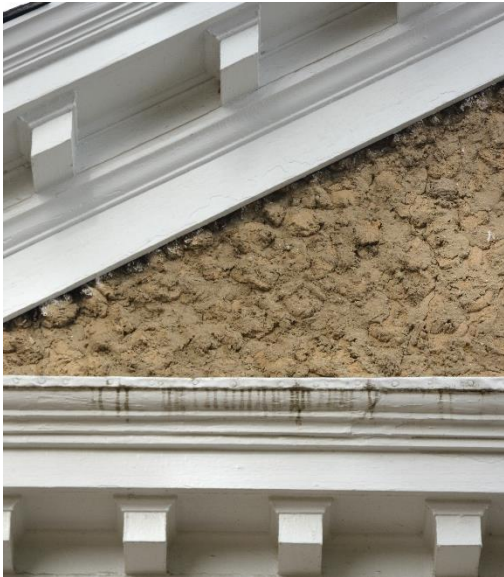
Existing wood cornice, pediment, and trim display minor degrees of paint failure.  Perform paint analysis of cornice at walls and at portico to confirm the treatment approach. Repair minor surface damage. Remove any rotted elements and provide wood dutchman. Do not strip surface until treatment is confirmed. Prepare existing surface for new paint finish per color recommendation in paint analysis report. Repaint.	275 LF of repainting / 25 LF of repairs

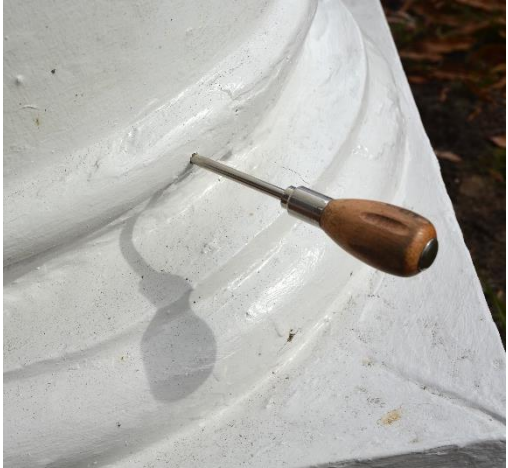
C. WD.4

Existing wood column exhibits rot at base of shaft and base.  Remove wood base and provide painted aluminum base. Provide wood repairs and/or dutchman as required to address deterioration. Consider replacement of concrete plinth with stone plinth shown in historic photographs. Keep columns in place during repairs if possible.	4 columns bases / 4 SF total of repairs
------------	---	---	--

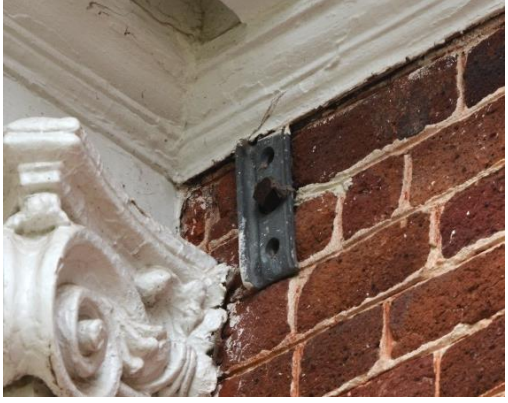
CODE	PHOTOGRAPH	CONDITION / REPAIR	QUANTITY
C. MT.1

Galvanized metal plate with bolt is mounted into the brick wall at the intersection of the portico.  Review plate in further detail to confirm attachment with structural members. If possible, remove and replace plate with durable option of complementary design.	3 locations
C. MT.2

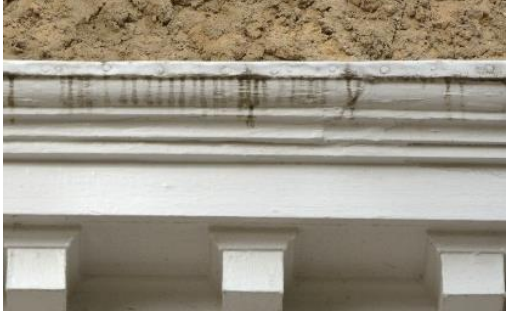
Sheet metal flashing at pediment cornice display signs of soiling.  During assessment of pediment stucco, review existing painted sheet metal flashing to confirm integrity. Clean soiling.	30 LF

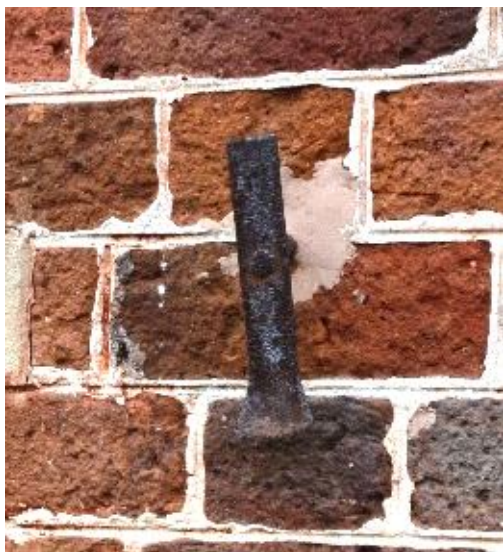
C.  
MT.3

Existing metal shutter dogs display paint failure and corrosion.

Confirm intent to restore shutters. If new shutters replicating historic shutters are provided, then restore existing shutter dogs and provide matching dogs where missing. If shutters are not intended to be provided in the future, remove shutter dogs and patch brick with color-matched grout of appropriate mix.

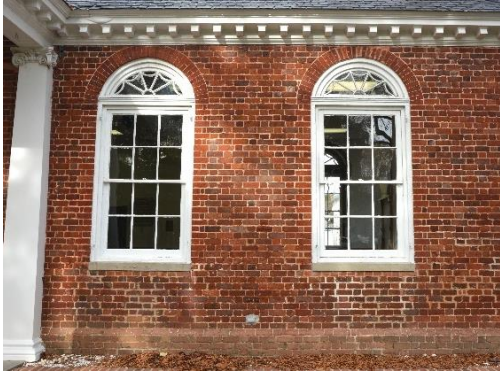
C. W.2

<p>Historic wood shutters are no longer extant.</p> <p>Consider providing new wood shutters to match the historic arrangement. Repair shutter hardware and secure any loose shutter dogs. Paint all sides of shutters and hardware. Install shutters.</p>	16 locations

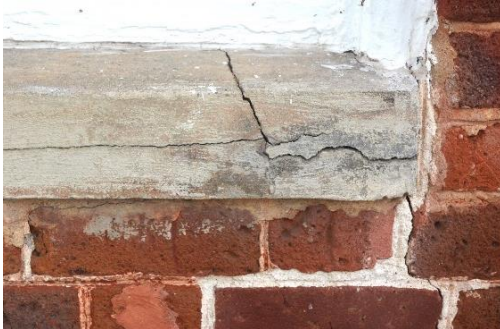
C. W.3

- Sills: The original sills have been replaced with concrete and they are cracking. There is no flashing under the sills to prevent water infiltration in to the wall system.

<p>Existing cast stone sills display cracking in many locations. Sills appear to date to ca.1907 remodeling.</p> <p>Remove existing sills. Inspect and prepare substrate. Provide new precast concrete sills to match existing sills.</p>	16 locations

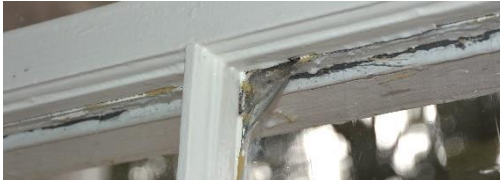
C. W.4

<p>Existing glass pane is broken.</p> <p>Remove cracked glass pane. Provide glass pane in existing window.</p>	10 locations
C. W.5

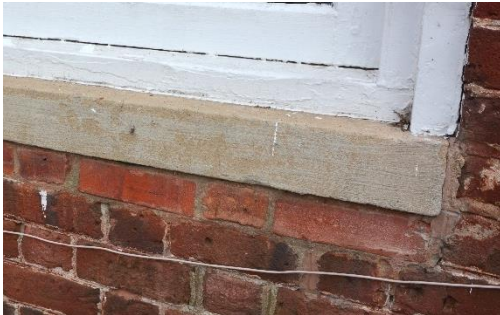
<p>Cast stone sill at north window does not project beyond face of masonry wall.</p> <p>Remove cast stone during window restoration effort. Determine ability to reset sill with sufficient projection. Replace in-kind as required.</p>	1 location

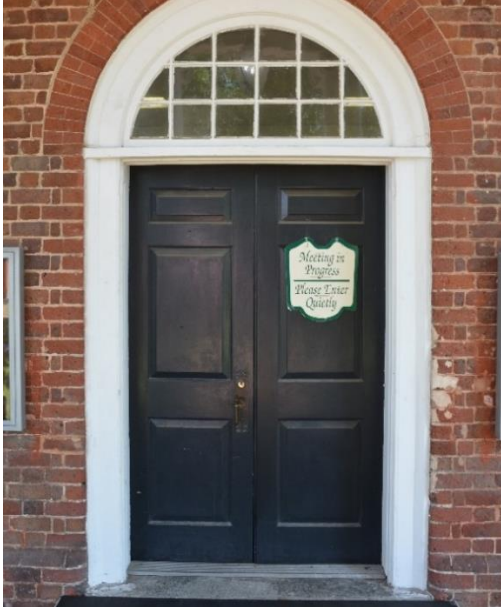
CODE	PHOTOGRAPH	CONDITION/REPAIR	QUANTITY
C. D.1

<p>Existing exterior doors do not comply with current building code requirements for an Assembly use with more than 50 occupants in swing direction, size, and arrangement.</p> <p>Complete code analysis for egress through existing doors and review with county building official to confirm existing arrangement is acceptable. Existing building code provides exceptions that may be applicable to current arrangement.</p>	N/A

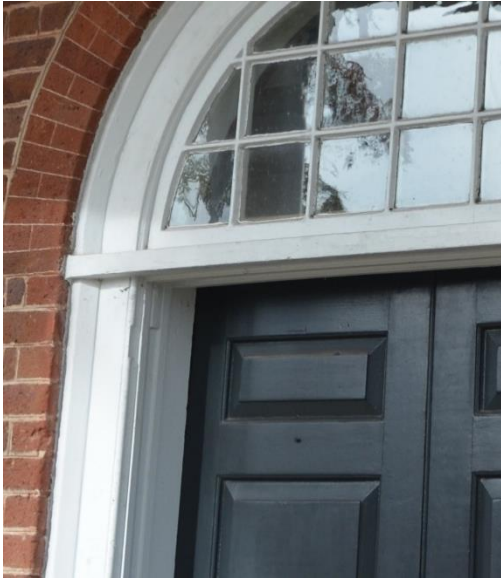
C. D.2

<p>Existing doors and frame display minor surface damage, scarring at former screen door locations, and perimeter sealant deterioration. Historic photographs suggest that the existing doors are a modern replacement with a different panel patterning.</p> <p>In concert with scheduled painting efforts and/or major repairs at building, refinish doors, including scrape and sand, fill/repair surface defects, and repaint.</p>	1 pair of doors

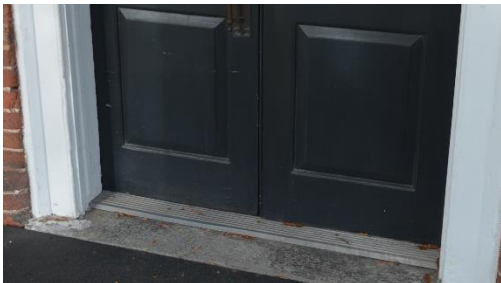
C. D.3

<p>Existing metal threshold is not a sympathetic material for the front entrance.</p> <p>Consider providing a wood threshold at front doors in concert with interior floor work.</p>	1 location

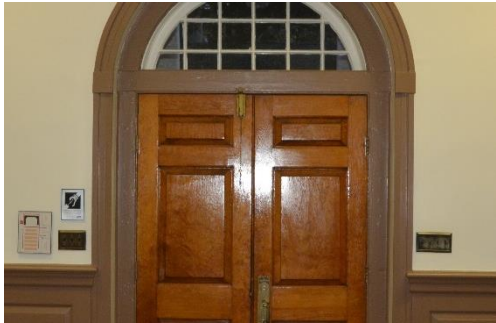
C. D.4

Existing doors do not have a closer to keep doors in closed position.  Consider impact to accessibility from interior to determine desirability of installing closer. Provide closer or spring hinges if desired.	1 location
-----------	---	---	------------

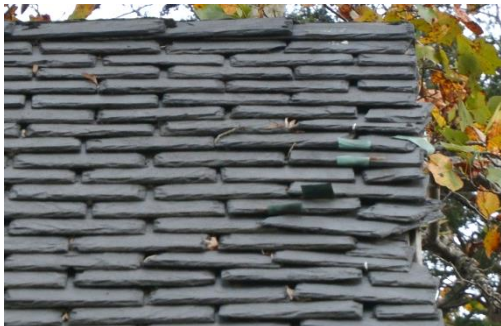
CODE	PHOTOGRAPH	CONDITION/REPAIR	QUANTITY
C. R.1

The slate roof has displaced, broken, and missing shingles.  Remove broken slate shingles. Inspect decking substrate to determine integrity. Repair decking. Provide in-kind slate shingle replacement, matching color, texture, and size.	30 shingles
C. R.2

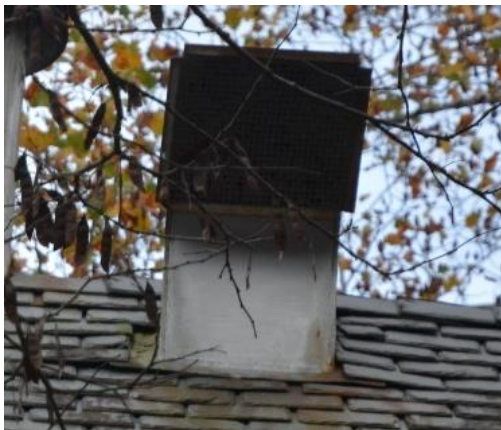
Existing roof flashings display staining from corrosion.  Review flashing using lift or via roof. Replace as required. Clean ferrous stains from surfaces. Review cleaning methods. Complete tests to determine impact on adjacent fabric, including downstream surfaces, before full cleaning. Use gentlest effective method.	2 locations / 30 SF of cleaning
C. R.3

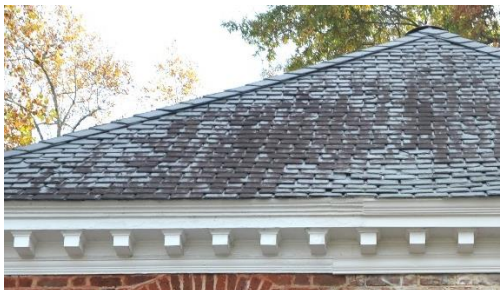
Roof surface is soiled with debris.  Remove debris from roof via lift. Gently clean to avoid damage to slate. Control runoff and gently clean any debris on cornice and walls.	50% of roof area

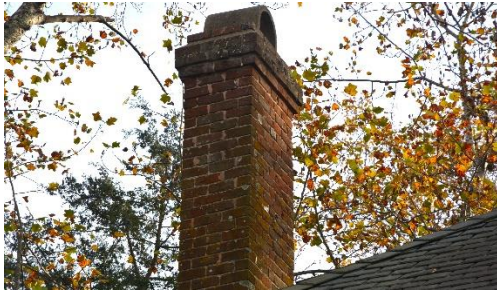
C. R.4

Concrete chimney caps could not be assessed from grade.  Use man lift to review chimney caps and chimney masonry in detail. Determine any deficiencies and develop treatment recommendations.	2 locations
-----------	---	---	-------------

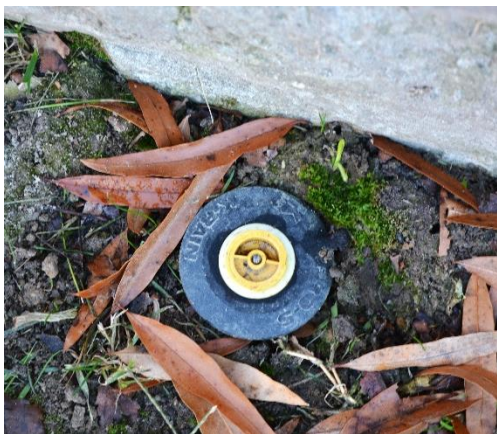
CODE	PHOTOGRAPH	CONDITION/REPAIR	QUANTITY
C. O.1

- Other: The irrigation lines are too close the building and could be a source of building moisture.

Sprinklers are located immediately adjacent to the base of the building, increasing the potential for moisture to affect the masonry walls.  Monitor operation of sprinklers to determine extent of water on and adjacent to the building. Relocate or rearrange sprinkler if water is saturating ground or face of building.	All locations at perimeter of building
C. O.2

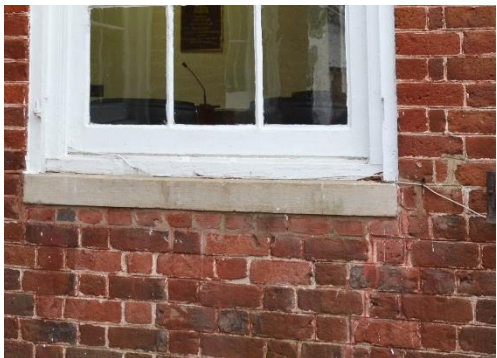
C. O.3

Wiring is mounted on the exterior face of the building and through a rear window.  Determine if wiring is in active service. Reroute surface wiring and remove mounting accessories. Repair surface as necessary. Provide concealed interior wiring.	1 instance

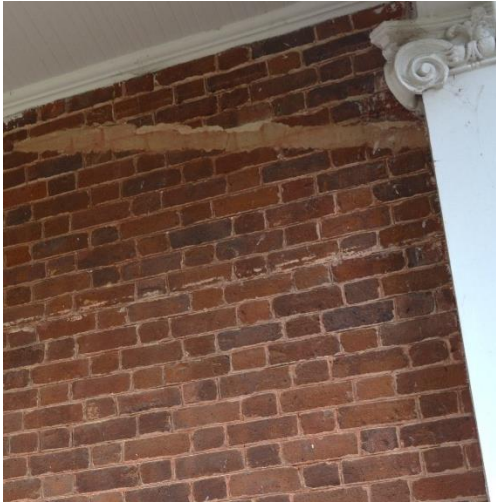
C. O.4

<p>Location of earlier porch roof structure is ghosted on the face of the building.</p> <p>Document and measure entire Courthouse prior to implementation of any exterior repairs. Prepare measured drawings for as-built Courthouse, original porch design, and earlier roof structure for potential future use in interpretation and restoration.</p>	Measured drawings

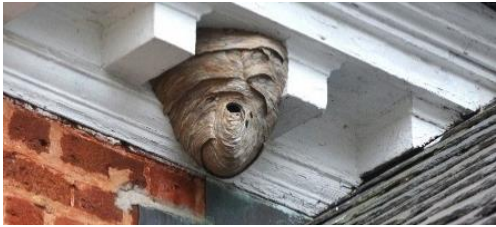
<p>There are instances of insect infestation at the cornice of the building.</p> <p>As a part of full exterior cleaning, remove insect nests.</p>	1 location

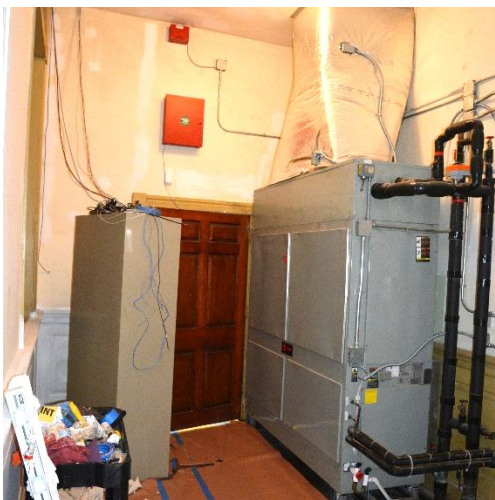
CODE	PHOTOGRAPH	CONDITION/REPAIR	QUANTITY
C. GI.1

Existing rooms at rear are used for A/V production and to hold HVAC equipment.  Prior to any building renovation, review program to determine if current use meets long-term goals.	N/A
C. GI.2

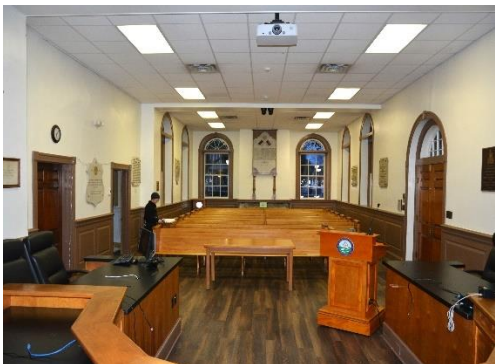
Historic paint interior schemes are not documented.  Perform paint analysis on historic interior wood and plaster surfaces to confirm the historic color scheme. It is expected that much of the extant historic finishes date to 1907 renovation.	All historic interior surfaces

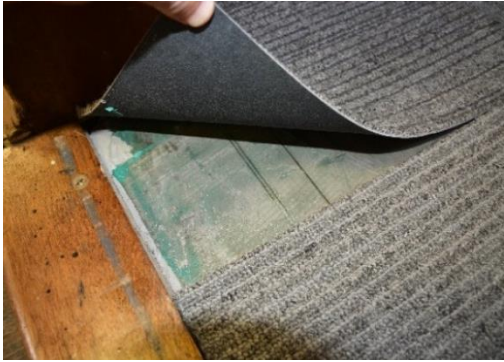
C. F.2

<p>Raised courtroom platform has carpet tile floor finish on a wood-framed structure.</p> <p>Develop long-term plan to restore historic interior finishes, including raised wood flooring at bar area. Replace carpet tile on schedule or as required.</p>	325 SF
C. F.3

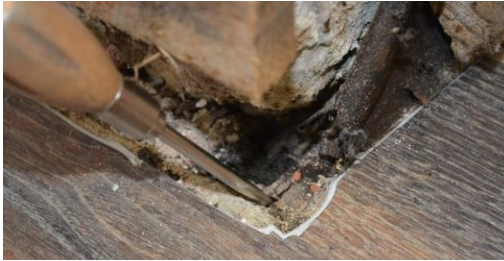
<p>Wood nailers at base of wood wainscoting at chimneys display rot.</p> <p>Remove wood wainscoting. Remove and replace rotted wood furring and nailers.</p>	2 locations @ 15 LF total
C. F.4

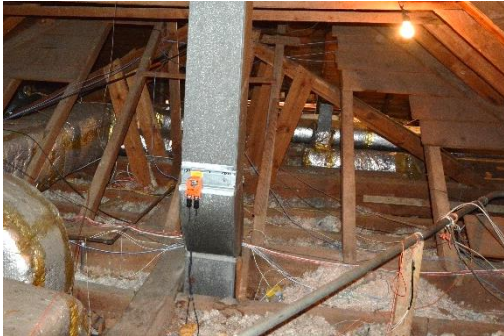
<p>Attic lacks a walking surface to permit maintenance access across length.</p> <p>Install 4'-0" wide by 3/4" thick plywood decking on existing ceiling joists to create maintenance access path to full length of attic.</p>	100 LF

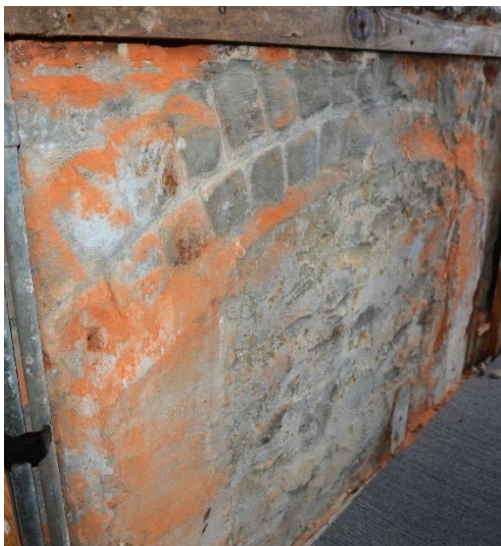
CODE	PHOTOGRAPH	CONDITION/REPAIR	QUANTITY
C. WA.1

<p>The waterproofing applied during the 1956 renovation to the base of the perimeter walls and fireplaces is deteriorating the brick masonry by trapping the moisture that entered the assembly via exterior or ground.</p> <p>Perform testing on waterproofing to confirm material. Prepare sample areas utilizing options for removal of coating. Determine treatment approach.</p>	TBD

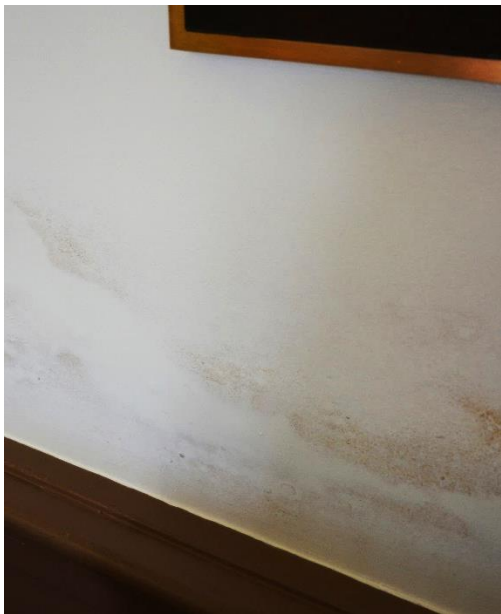
C. WA.2

<p>Plaster wall finish on existing perimeter walls exhibits elevated moisture readings above wainscoting and deterioration where repaired as a part of the 1956 renovation.</p> <p>Selectively remove 2'-0" x 5'-0" area at two locations of deteriorated wall finish. Assess condition of plaster and masonry substrate. Confirm presence of waterproofing coating. If present, implement removal plans noted elsewhere. Remove and replace deteriorated plaster finish.</p>	115 SF

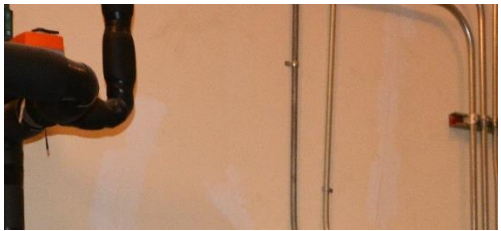
C. WA.3

<p>Existing plaster wall finish has cracks in various locations.</p> <p>Rout out cracks. Patch plaster with appropriate design. Paint 100% of affected wall.</p>	40 LF of crack repair

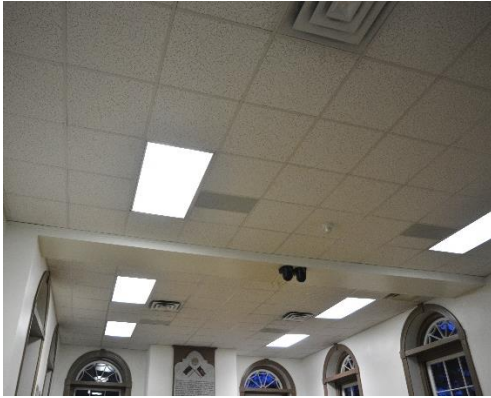
CODE	PHOTOGRAPH	CONDITION/REPAIR	QUANTITY
C. CL.1

<p>The courtroom ceiling is a modern suspended acoustical tile system with wallboard clad bulkheads at locations of tie rods.</p> <p>Develop long-term plan to restore historic interior finishes, including a wallboard ceiling finish with cornice and paneling trim and ornamental brackets.</p>	1,200 SF

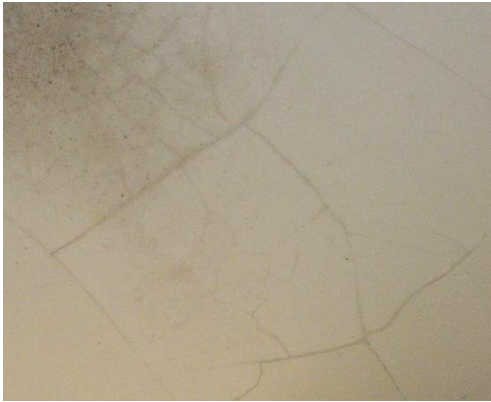
C. CL.2

<p>Plaster ceiling exhibits finish deterioration and cracking.</p> <p>Tap plaster to confirm lamination. Replace all delaminated plaster. Clean staining from surface of ceiling. Paint 100% of ceiling. Coordinate repairs with larger interior renovation and current paint schedule.</p>	30 SF plaster replacement / 350 SF painting

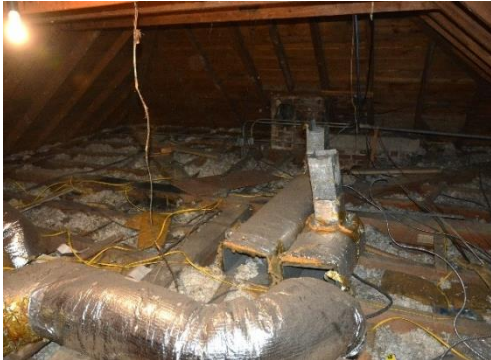
C. CL.3

<p>There is debris throughout attic. In addition, the blown-in insulation is soiled and deteriorated in localized areas.</p> <p>Remove debris. Salvage any artifacts for further examination. Remove cellulose and provide batt insulation between joists.</p>	1500 SF

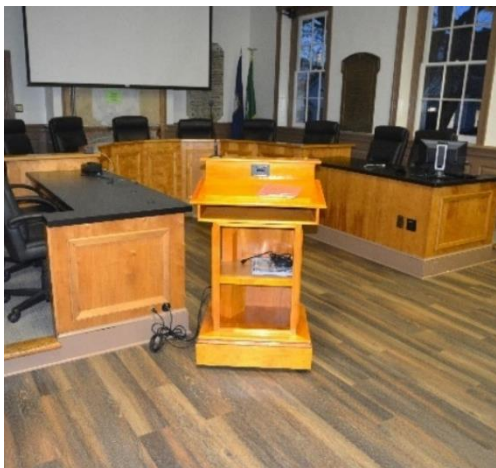
CODE	PHOTOGRAPH	CONDITION/REPAIR	QUANTITY
C. OI.1

Existing raised dais dates to 1956 renovation.  Develop long-term plan to restore historic interior design, including original magistrates' area. Consider reorienting courtroom to 1907 arrangement. develop floor plans for original and 1907 designs to facilitate interpretation. As a part of this restoration, consider installing stoves and pipes.	N/A

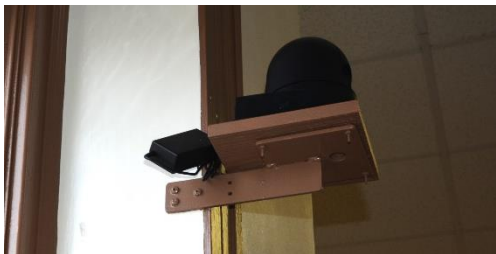
C. OI.2

A/V equipment is mounted on conspicuous shelving.  As a part of a larger renovation effort, review potential for providing low-profile mounting near ceiling.	2 locations

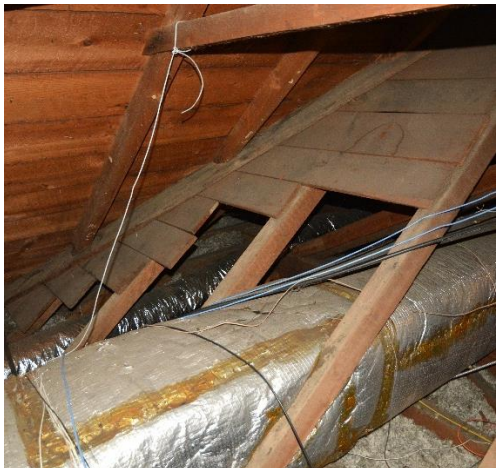
C. OI.3

Earlier roof structure is extant in the attic.  Document and measure entire Courthouse prior to implementation of any exterior repairs. Prepare measured drawings for as-built Courthouse, original porch design, and earlier roof structure for potential future use in interpretation and restoration.	N/A

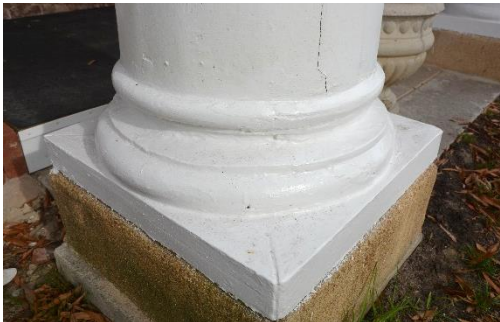
CODE	PHOTOGRAPH	CONDITION/REPAIR	QUANTITY
C. S.1

<p>Rot was evident at the base of the front left wood column at the entry portico.</p> <p>It is presumed that the cause of the water penetration into the column is the lack of separation between the column base and the concrete plinth, but this area should be investigated further to confirm the preferred treatment.</p>	TBD

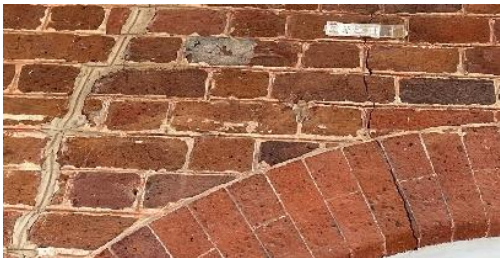
C. S.2

<p>There is a vertical present at the top of the brick entry arch. The crack is presently being monitored with a crack gauge.</p> <p>No additional movement is evident since the gauge was installed.</p>	None at present but this should continue to be monitored.

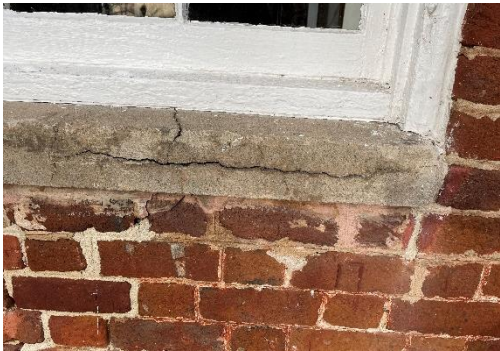
C. S.3

<p>The precast concrete sills at the base of the windows have cracked at multiple locations.</p> <p>The sills will need to be removed and replaced. There are (16) sills in total and each has some level of deterioration. Refer to Architectural for additional discussion on this matter.</p>	Remove and replace 16 sills. Ref Architectural for material for future sills.

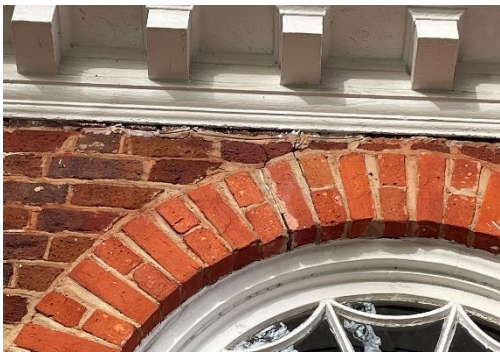
C. S.4

<p>A vertical crack extends through the arch into the brick wall above.</p> <p>To keep water from penetrating into the wall, the crack should be repointed and filled with a lime-based mortar. This occurs at approx. (4) arch locations.</p>	10 LF of repointing

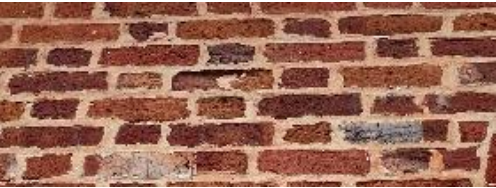
C. S.5

<p>Spalled brick at 5<sup>th</sup> course from the top of the wall on north elevation.</p> <p>Brick needs to be cut out and replaced with a brick of the same vintage.</p>	1 location

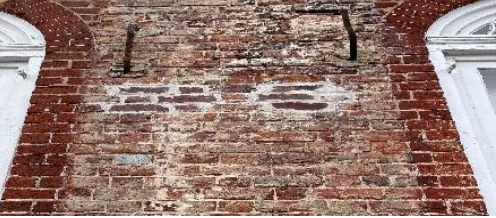
C. S.6

<p>Abandoned brick pockets are extant at the north wall.</p> <p>Cut out damaged areas of brick masonry. Install matching brick with appropriate mortar.</p>	5 SF of brick repair/replacement

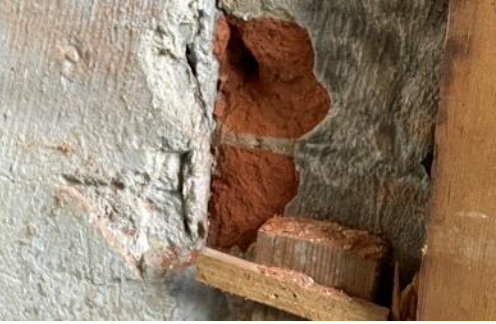
C. S.7

<p>The interior brick at the two chimney locations is in a very poor condition and crumbles easily when contracted. Brick dust is evident at the bottom of the chimney in several locations.</p> <p>Further study to confirm the cause of the deterioration is required. Refer to Architectural for additional information.</p>	TBD

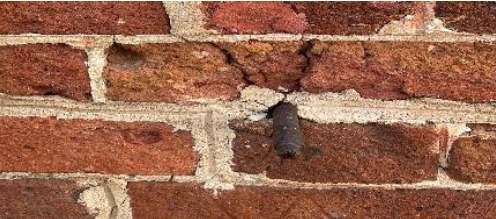
C. S.8

<p>Spalled and cracked brick at present at the embedded anchor location.</p> <p>Cut out one brick unit and replace in-kind. Repoint cracks with a lime-based mortar.</p>	1 brick replacement and 1 LF of crack repair.

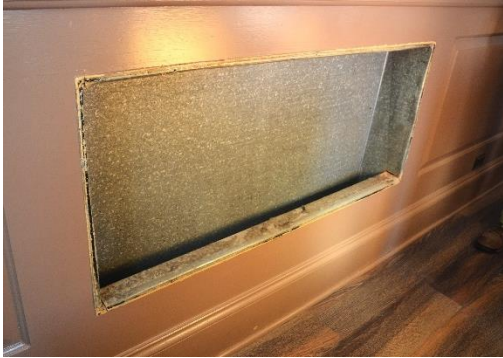
<p>The condition of the underslab ductwork could not be assessed.</p> <p>Depending on level of active maintenance, perform inspection of interior of ductwork with camera. Determine level of repairs required.</p>	Assessment
C. P.1	N/A	<p>The existing Courthouse lacks plumbing facilities and relies upon the Annex to provide these services.</p> <p>Review arrangement with long-term renovation plans to confirm current arrangement complies with goals and requirements.</p>	N/A
C. E.1

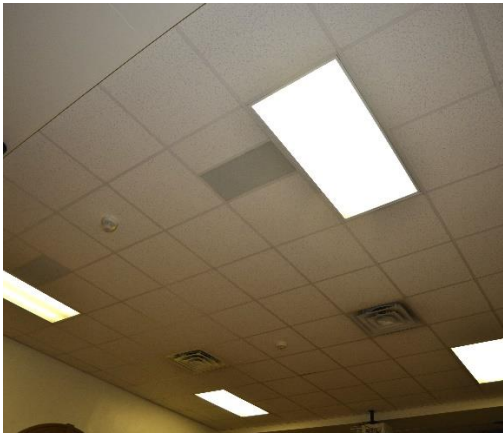
<p>Existing lighting fixtures and lamps are outdated or insufficient.</p> <p>During any planned renovation or modernization project, existing light fixtures should be replaced or relamped with LED fixtures and provided with code required lighting levels and controls.</p>	100%

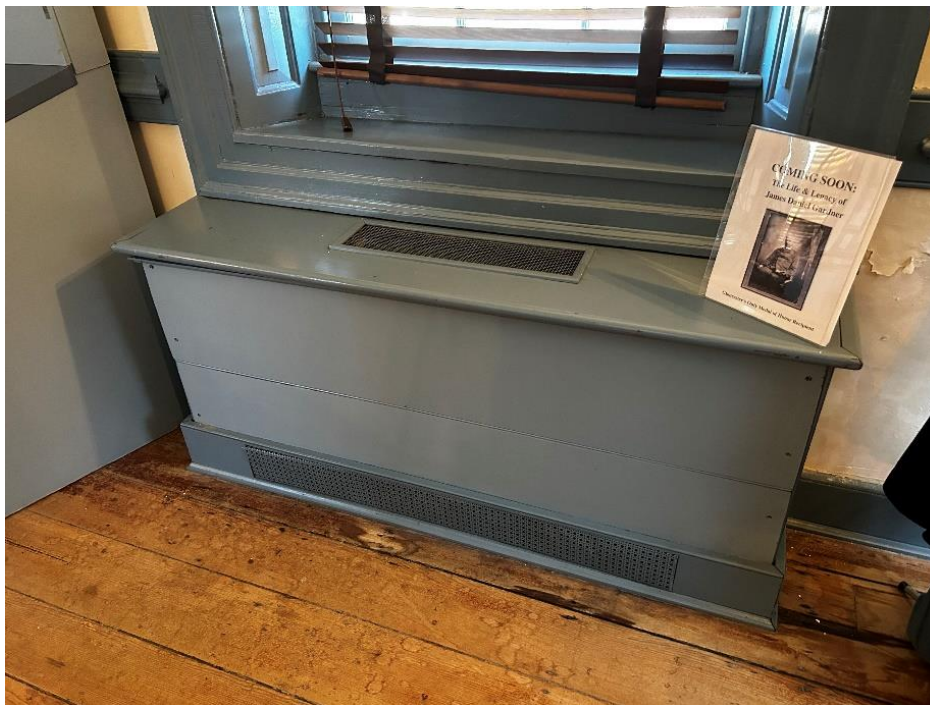
*Fan coil unit*

- The HVAC system is in functional condition and has been maintained, but due to the age of system distribution, equipment, and various components, future replacement and modernization should be planned. Water stains observed on the ceiling tiles of the first floor appear to be from degradation of the original system insulation details, leading to condensation. Replacement of the dual-temperature piping distribution, with separate hot water and chilled water distribution, would improve the HVAC system's ability to provide thermal comfort while maintaining humidity control and conditions for exhibit areas. Consideration should be given to provide the building with a mechanical ventilation system for any planned mechanical system modernization or building renovation. The central mechanical ventilation system will allow greater flexibility to meet current building code requirements and can assist in maintaining positive building pressurization and thermal conditions.

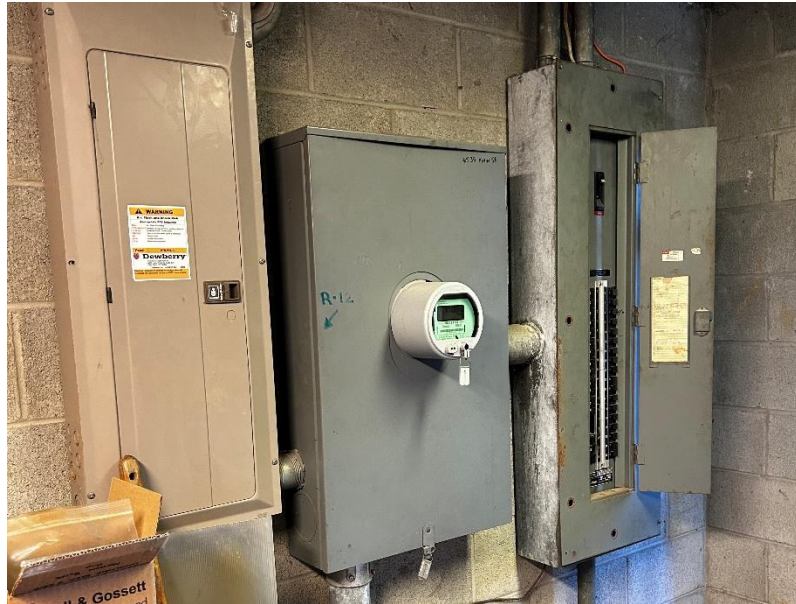
*120/208V, 3Ø, 4 Wire 320 Amp electrical service in rear building utility room*

- An obsolete Federal Pacific electrical panel is being utilized within the distribution system and must be replaced as the manufacturer is defunct and replacement breakers that are UL listed are difficult to source. Consideration should be given to remove any Romex wiring and replace it with EMT or MC wiring for any planned system modernization or building renovation. Conductors within conduit (EMT) or metal clad armored cable (MC) are the industry standards for the building type and use and are better at ensuring that wiring is not accidentally damaged by other building activities.

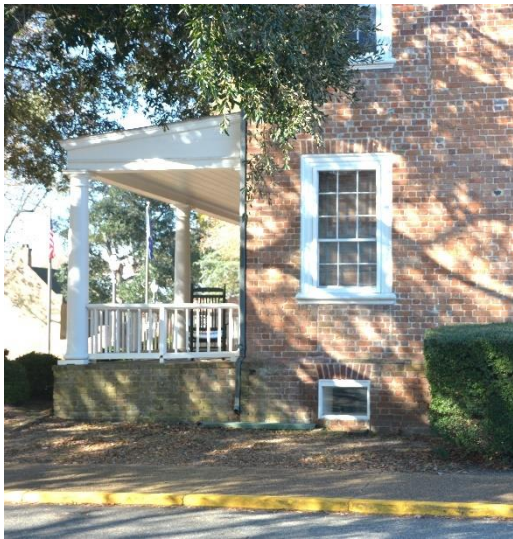
<p>The Botetourt Building does not have an accessible entrance to either the main south entrance into the museum or the rear basement entrance.</p> <p>As a part of a long-term plan, develop accessibility goals for museum. Determine if elevator is desired to make second floor and basement accessible. Provide removable wood framed accessible ramp at east end of south porch.</p>	1 accessible ramp approx. 30'-0" in length and 5'-0" in width

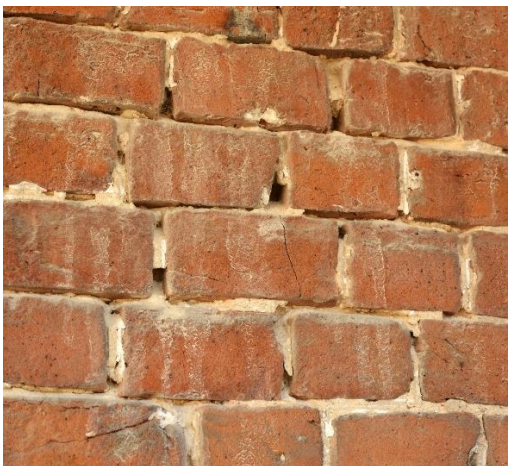
CODE	PHOTOGRAPH	CONDITION/REPAIR	QUANTITY
BB. MB.1

<p>Open mortar joints and mortar deterioration occur on all elevations.</p> <p>Due to the number of cracked bricks and open joints paired with the moisture infiltration issues, 100% repoint should be considered. Repoint open brick masonry joints with appropriate mortar mixture using techniques to match original mortar joints.</p>	100% exterior
BB. MB.2

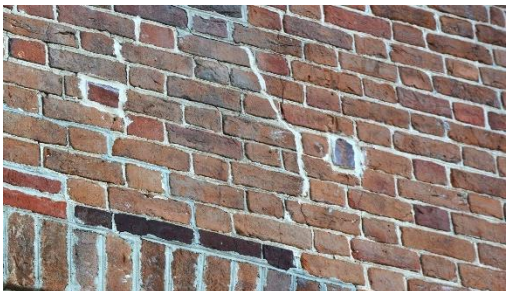
<p>Stairstep cracks occur in the mortar joints extending from the heads of many windows and door openings.</p> <p>Repoint localized areas identified on drawings, refer to MB.1 for repair and quantity.</p>	See MB.1
BB. MB.3

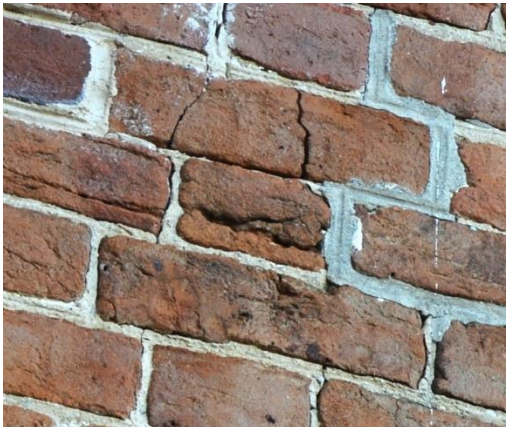
<p>Brick masonry units are cracked in numerous locations. This issue occurs with greatest frequency at the window lintel bearing points and near the south doors.</p> <p>Remove cracked brick unit. Provide matching brick unit and install in concert with wall repointing. Use salvaged bricks where possible.</p>	375 brick units

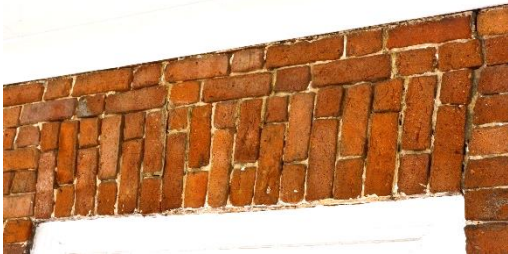
BB. MB.4

<p>Existing brick unit appears to be displaced from masonry assembly.</p> <p>Remove and reset displaced brick unit.</p>	1 brick unit

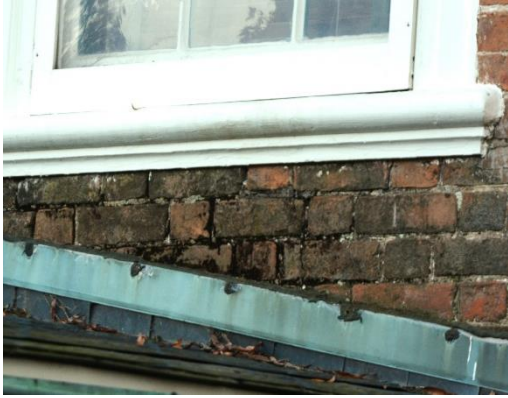
BB. MB.5

<p>Biological growth is occurring at localized areas of the exterior masonry, typically along the base and north side of the building, and causing staining on the exterior facade.</p> <p>Remove biological growth and staining with architectural anti-microbial biocide. Use gentlest means possible.</p>	400 SF
BB. MB.6

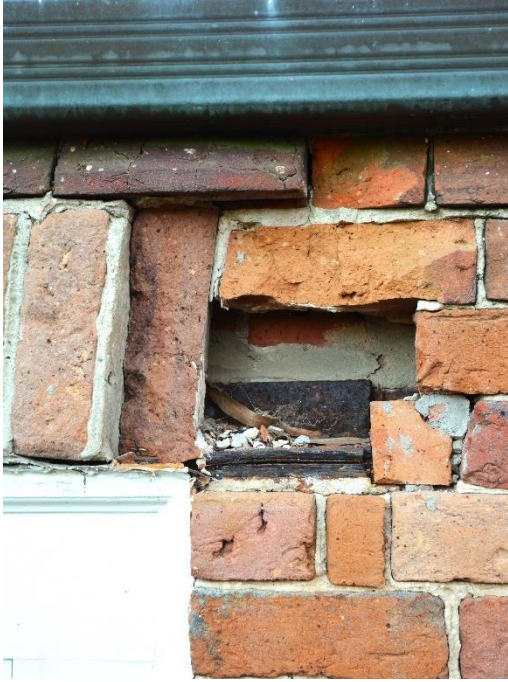
<p>Thin brick units are installed at the basement window head corners, many of which have displaced and failed due to corrosion at loose steel lintels. Masonry wall gradually steps out along height of windows to accommodate design.</p> <p>Investigate brick masonry further to confirm assembly using selective removals. Dismantle brick headers and remove corroded steel lintels. Determine ability to reconstruct masonry jack arch at all locations. Provide new painted galvanized lintel and install masonry header course.</p>	10 windows
BB. MB.7

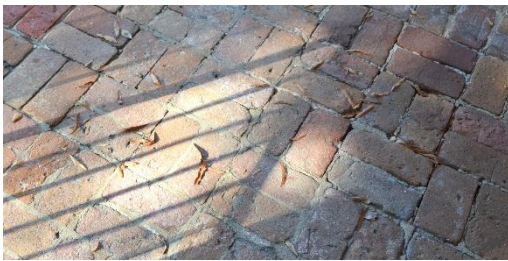
<p>Walking surface of brick porch and rear basement path exhibits mortar deterioration.</p> <p>RegROUT open brick masonry joints with appropriate mortar mixture using techniques to match original mortar joints.</p>	350 SF

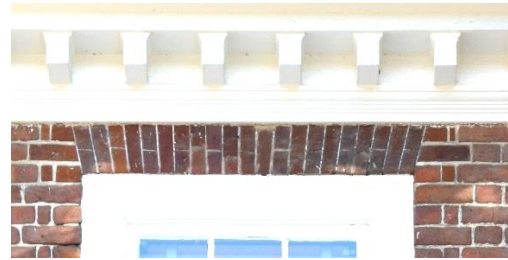
BB. MB.8

<p>Overpaint is present on masonry surfaces directly adjacent to painted surfaces.</p> <p>Remove overpaint on brick surfaces using the gentlest effective method.</p>	100%

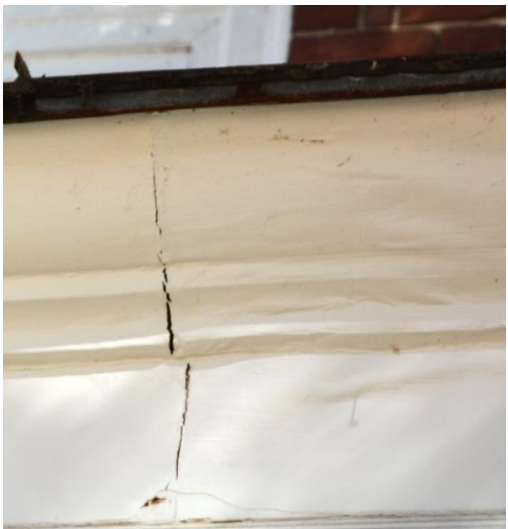
CODE	PHOTOGRAPH	CONDITION/REPAIR	QUANTITY
BB. WD.1

<p>Existing wood elements were painted in 2017. In general, correctly applied high-quality paint applications are rated to have a 10-year lifespan. Areas of paint deterioration were observed.</p> <p>Given current age and state of painted finish, prepare and repaint 100% of wood finishes. Repair/replace deteriorated wood elements. Develop maintenance schedule for painted finishes.</p>	325 LF of cornice and rake board / 1000 SF of siding painting / 40 LF of repairs
BB. WD.2

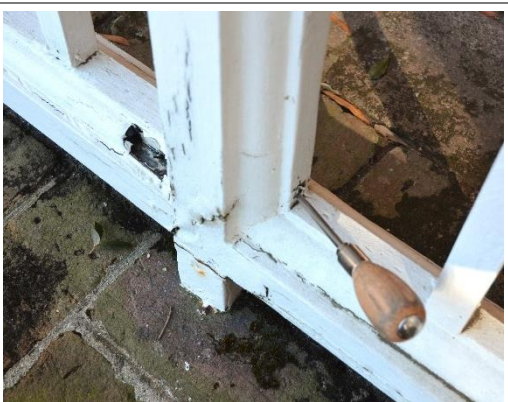
<p>Existing wood porch railing displays rot and finish deterioration.</p> <p>Remove bottom rail and rotted balusters at all sections of railing. Repair minor surface damage. Remove any rotted elements and provide wood dutchman. Prepare and repaint surfaces.</p>	75 LF of railing / 40 balusters

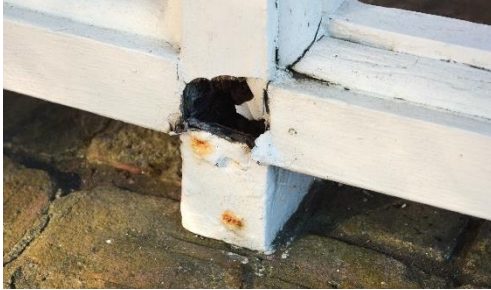
CODE	PHOTOGRAPH	CONDITION/REPAIR	QUANTITY
BB. MT.1

<p>Metal railing posts set into brick porch exhibit major corrosion.</p> <p>Remove support post. Provide new painted post. Set post into non-shrink grout bed. Complete repairs in concert with wood railing repairs.</p>	100%
BB. MT.2

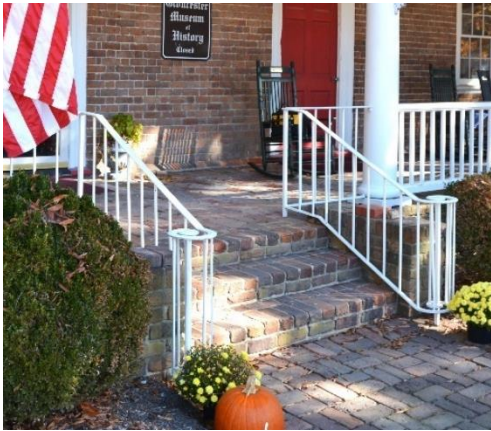
<p>Metal handrails at front and rear stairs exhibit corrosion and does not match design of porch railing.</p> <p>Depending on scope of repairs, consider a range of treatments – from finish repair to replacement. Remove paint and any corrosion. Prepare and finish existing railing. Patch and repair brick surface.</p>	40 LF
BB. MT.3

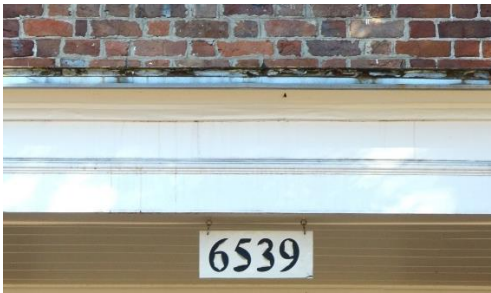
<p>Existing rain diverter is displaying evidence of corrosion.</p> <p>Remove metal diverter and replace with copper diverter to avoid galvanic reaction with extant roof flashing.</p>	5 LF

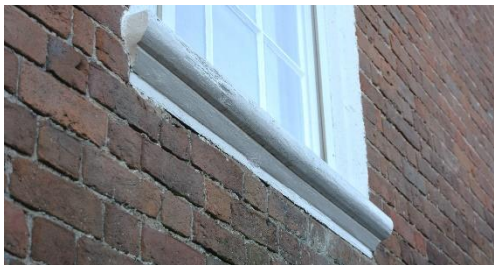
<p>Several windows have a mismatched wood sill, indicating a modern alteration.</p> <p>Remove existing sill. Provide painted wood molded sill to replicate historic profile.</p>	16 locations
BB. W.3

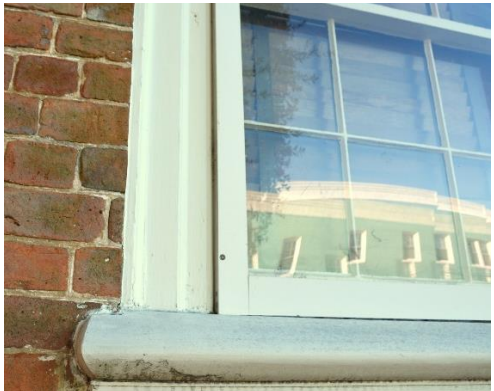
<p>Some existing windows, typically the east and north sides, have wooden exterior storms. Other windows do not have storm windows.</p> <p>Determine collections storage goals for building. Provide low profile metal exterior storm windows finished to match adjacent existing frames.</p>	36 locations
