# FY27 CIP SUBMISSION

# CONDITION ASSESSMENT REPORT

GLOUCESTER COURT CIRCLE PROPERTIES &  
MUSEUM OF HISTORY  
GLOUCESTER COUNTY, VIRGINIA

*95% DRAFT SUBMISSION*

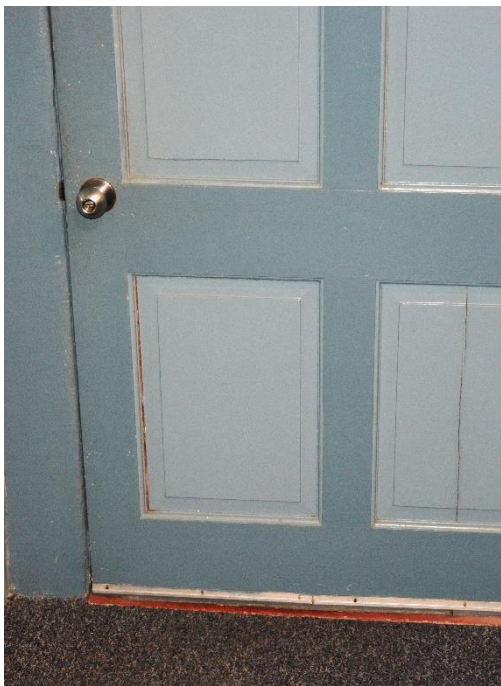
CODE	PHOTOGRAPH	CONDITION/REPAIR	QUANTITY
BB. D.1

<p>Existing wood doors display finish and substrate deterioration at various elements.</p> <p>Restore wood doors. Remove wood doors. Replace door hardware to improve operability and meet accessibility requirements. Remove deteriorated paint from door and frame. Remove rotted wood and broken panels. Provide epoxy patch for all surface repairs for rotted elements. Scrape and sand surface to prepare for new finish and paint all sides of door and frame. Reinstall door.</p>	4 doors / Assume minor surface damage and replacement of 2 panels
BB. D.2

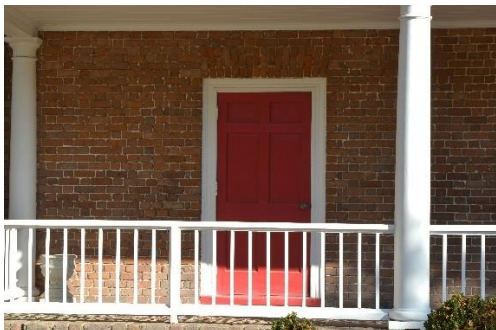
<p>Existing exterior doors do not have a closer to keep doors in closed position.</p> <p>Consider impact to accessibility from interior to determine desirability of installing closer. Provide closer or spring hinges if desired.</p>	4 doors
BB. D.3

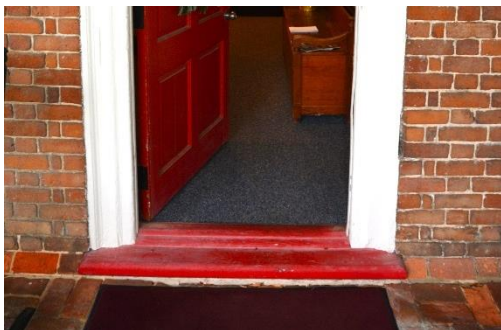
<p>The thresholds at the exterior doors are not accessible.</p> <p>In concert with addition of ramp on east end of porch, modify one door opening and door to meet accessibility requirements of no greater than 3/4" in elevation change.</p>	1 location

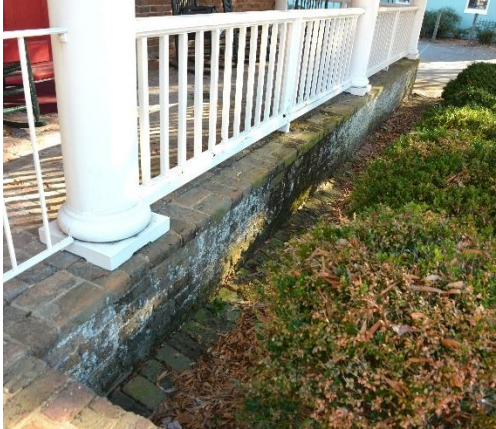
CODE	PHOTOGRAPH	CONDITION/REPAIR	QUANTITY
BB. O.1

<p>Shrubs are located immediately adjacent to the base of the building, increasing the potential to hold moisture directly against the masonry walls and propagating staining.</p> <p>As a part of long-term maintenance plan, consider removing shrubs and replacing with smaller plantings to reduce moisture at base of wall.</p>	South and east sides

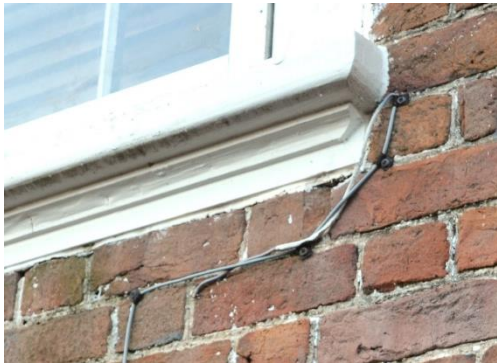
BB. O.2

<p>Various types of wiring are mounted to the exterior face of the building.</p> <p>Determine if wiring is in active service. Reroute surface wiring and remove mounting accessories. Repair surface as necessary. Provide concealed interior wiring.</p>	1 instance
BB. O.3

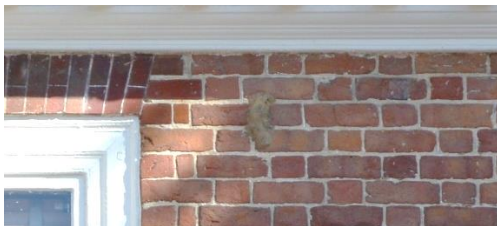
<p>There are instances of insect infestation at the building.</p> <p>As a part of full exterior cleaning, remove insect nests.</p>	1 location

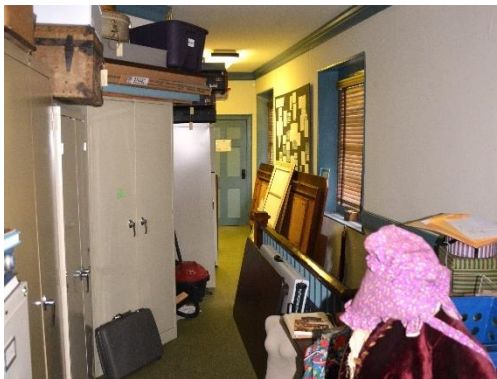
CODE	PHOTOGRAPH	CONDITION/REPAIR	QUANTITY
BB. GI.1

<p>First- and second-floor office areas are overcrowded with general and collections storage.</p> <p>Develop long-term plan for museum. Complete as-built measured drawings. Pursue full-building renovation, including updated office suite on first and second floors.</p>	N/A
BB. GI.2

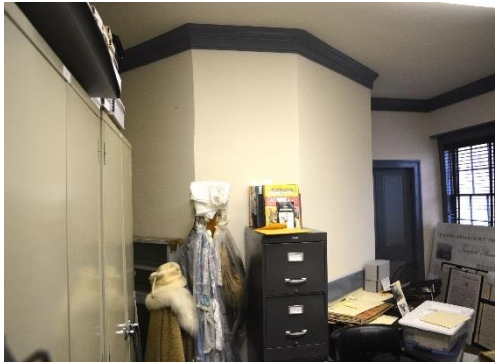
<p>The historic fireplace on the second floor the west end of the building has been obscured by modern changes.</p> <p>Consider expanding interpretive exhibit area to allow access to restored fireplace as a part of a full-building renovation.</p>	N/A

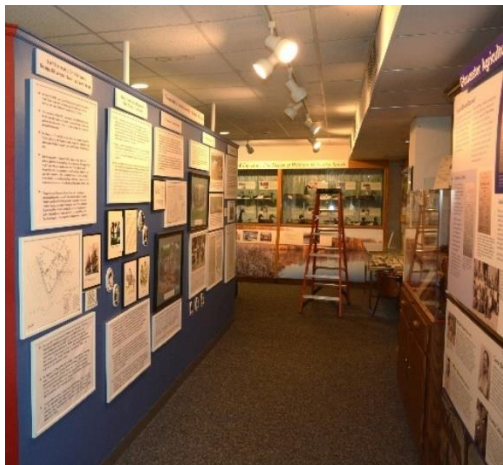
BB.  
GL.3

First floor of museum does not present a historic appearance to visitors upon arrival to the building.

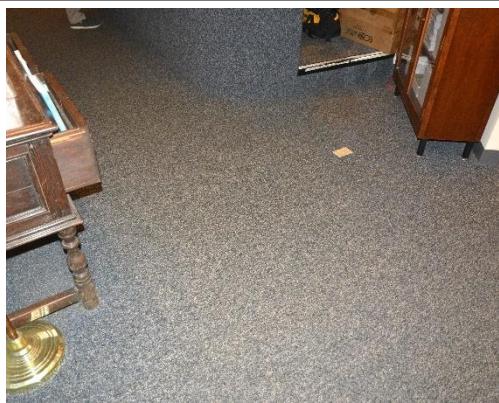
CODE	PHOTOGRAPH	CONDITION/REPAIR	QUANTITY
BB. F.1

Existing carpet floor finish installed over wood flooring is aged with minor areas of damage and does not suit the interior of the historic building.  In concert with long-term plans for museum, remove carpet floor finish. Restore wood flooring. Patch and repair where required.	270 LF
BB. F.2

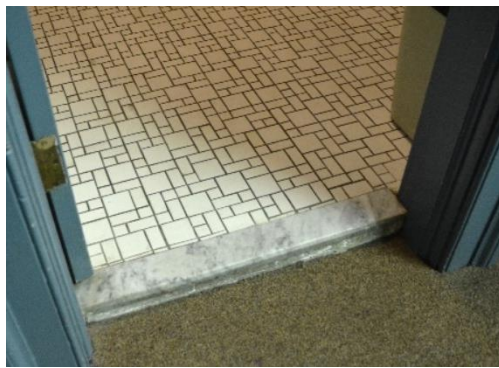
Existing first-floor bathrooms are not accessible due to step at the threshold and floor finishes have aged.  As a part of larger interior renovation effort, redesign area to provide larger restrooms available to visitors with updated finishes.	2 instances

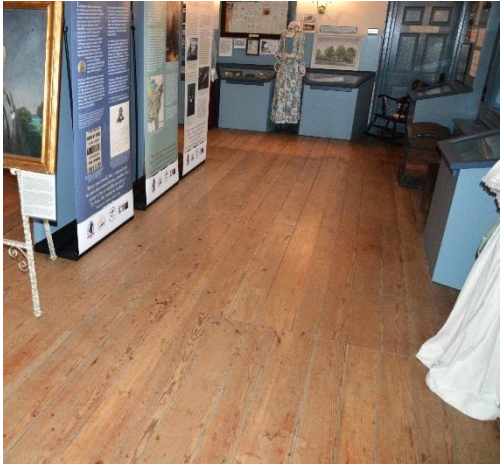
BB. F.3

<p>Wood flooring has localized surface damage and gaps between floorboards.</p> <p>Repair and sand area of floor damage. Prepare surface for new flooring finish. Fill gaps measuring <math>\frac{1}{4}</math>" or more with wood matching in species and graining. Provide new clear high-traffic coating on restored wood floor. Provide foot pads on all furniture and equipment.</p>	600 SF of refinishing / 10 LF of repairs
BB. F.4

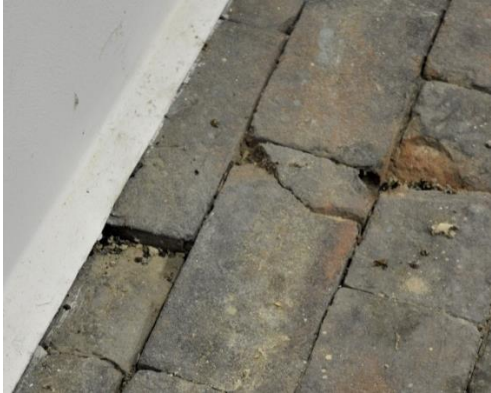
<p>The brick hearths in the jury rooms have several broken bricks.</p> <p>Remove broken bricks. Prepare substrate and reset salvageable units. Replace heavily damaged units with salvaged bricks. Consider removal of the infill panels in each room to restore fireplace.</p>	10 units / 2 infill panels
BB. F.5

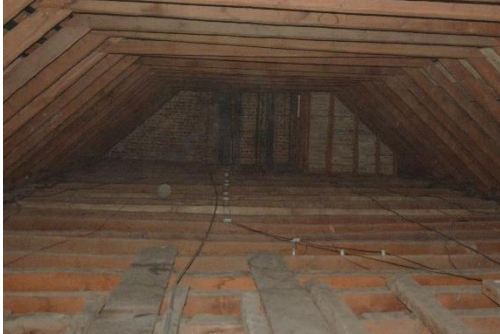
<p>Attic lacks a walking surface to permit maintenance access across length.</p> <p>Install 4'-0" wide by <math>\frac{3}{4}</math>" thick plywood decking on existing ceiling joists to create maintenance access path to full length of attic.</p>	300 SF

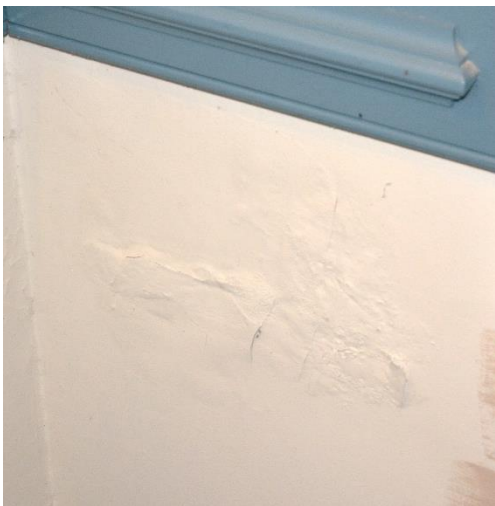
CODE	PHOTOGRAPH	CONDITION/REPAIR	QUANTITY
BB. WA.1

<p>Painted finish and plaster substrate display deterioration and localized areas of poor execution.</p> <p>Perform test cut into wall surface to confirm assembly and condition. Complete interior paint analysis if desired. Remove deteriorated plaster surfaces. Prepare surface and repaint 100% of wall surfaces and wood trim per findings of analysis.</p>	175 SF plaster repairs / 100% painting
BB. WA.2

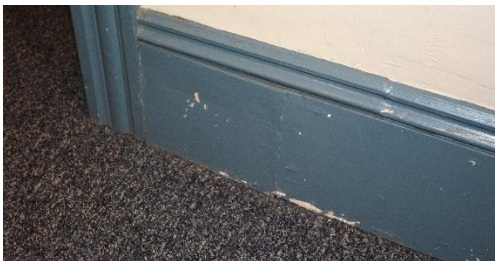
<p>Wood wall base has localized areas of deterioration.</p> <p>Remove paint from surface of wood trim. Repair areas of wood deterioration. Prepare and paint surface.</p>	4 LF
BB. WA.3

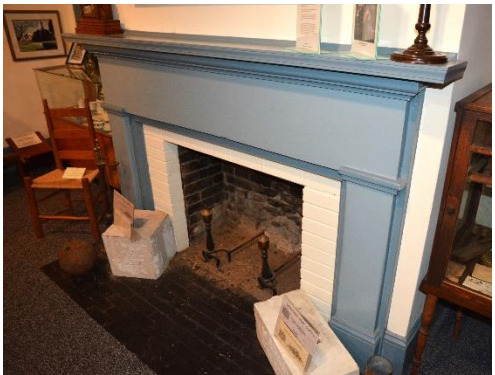
<p>There are cracked bricks at fireplace and paint has been applied to first-floor fireplace.</p> <p>Remove and replace broken bricks with salvaged bricks from attic. Remove paint from face of brick fireplace. Repoint fireplace and hearth as required.</p>	3 bricks / 50 SF of repointing / 25 SF of paint removal

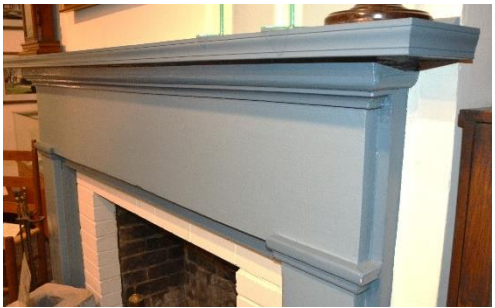
BB. WA.4

<p>First-floor mantelpiece is poorly detailed and does not properly reflect historical style.</p> <p>Remove and replace mantelpiece with design per historical precedents in the region.</p>	1 location

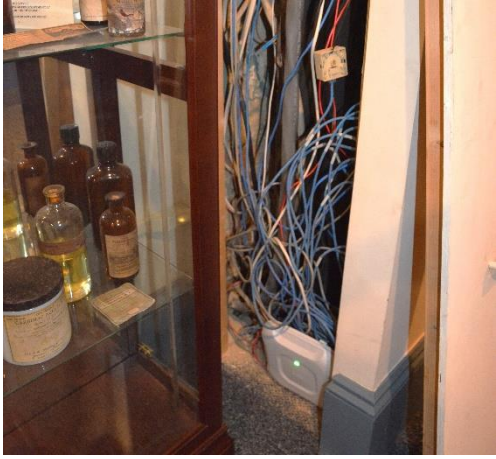
BB. WA.5

<p>Chase at north wall has a removable panel to allow access to utilities.</p> <p>As a part of a larger renovation, determine need for chase. If needed, remove finishes and provide access panel.</p>	1 location
BB. WA.6

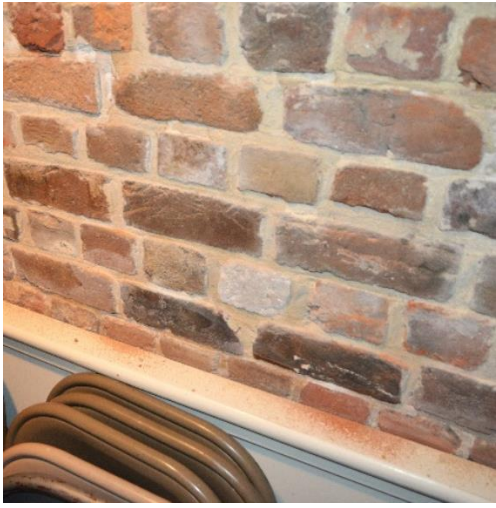
<p>Brick dust and efflorescence is present at several locations on the exposed north wall of the basement.</p> <p>Excavate at base of exterior wall at basement to confirm presence of exterior waterproofing. If not present, install liquid-applied waterproofing below grade and consider installing dampproof course in masonry wall. Dry brush efflorescence from face of wall.</p>	75 LF water proofing / 50 SF cleaning
BB. WA.7

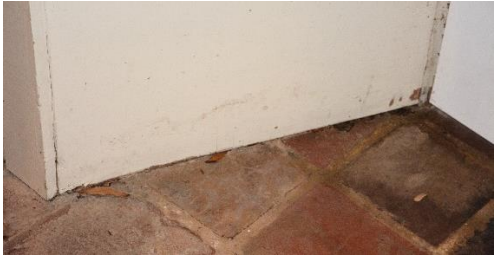
<p>Base of wood jamb at basement door displays deterioration.</p> <p>Remove rotted wood and provide dutchman. Repair surface deterioration. Prepare surface and paint.</p>	2 SF
BB. WA.8

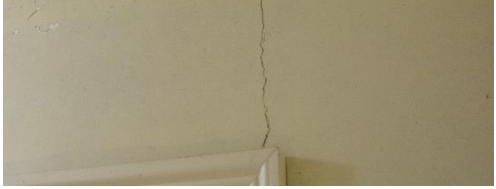
<p>Gypsum wallboard is cracked.</p> <p>Rout out crack for full length. Patch wall surface. Prepare and paint 100% of wall.</p>	5 LF

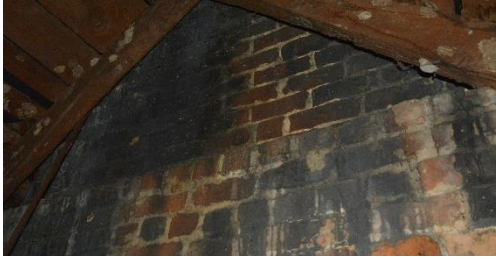
BB. WA.9

<p>Attic masonry end wall is stained with coating associated with roof installation.</p> <p>Remove coating from face of brick masonry. Use gentlest means possible.</p>	50 SF
-------------	---	---	-------

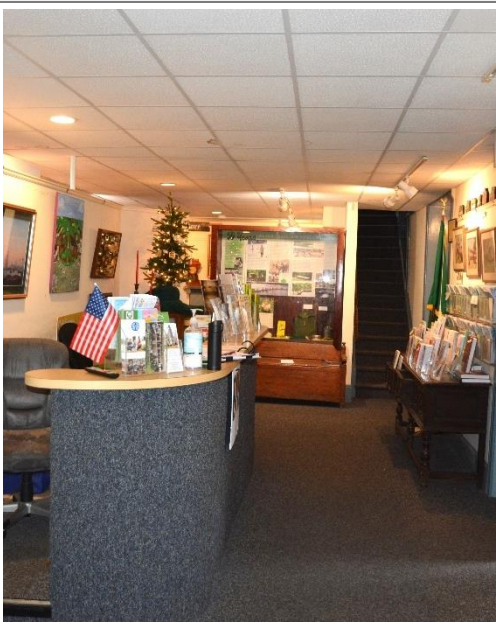
CODE	PHOTOGRAPH	CONDITION/REPAIR	QUANTITY
BB. CL.1

<p>Ceiling finish throughout first floor is suspended acoustical ceiling tile (ACT). The modern finish allows for easy above-ceiling access and improved acoustical conditions, but does not present a historic appearance.</p> <p>Remove ACT system in its entirety in concert with above ceiling equipment repairs and larger renovation effort. Document all conditions. Provide suspended drywall ceiling with access panels and painted wood crown molding.</p>	825 SF / 225 LF
BB. CL.2

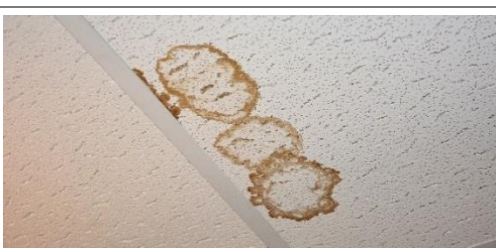
<p>Existing acoustical ceiling tiles are stained due to HVAC leaks.</p> <p>Replace stained ceiling tiles ahead of long-term interior renovation.</p>	75 SF

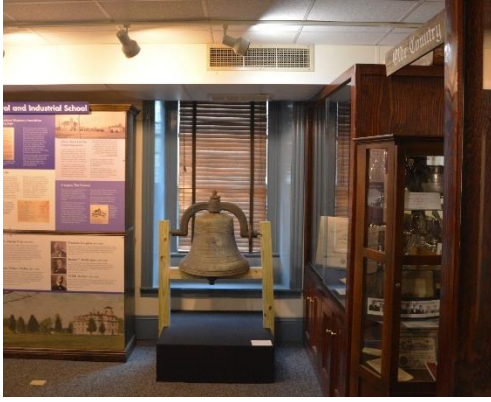
BB. CL.3

<p>Suspended bulkhead is provided at north side of first floor to accommodate mechanical systems. Current routing passes below head of adjacent windows.</p> <p>As a part of full building renovation, determine ability to reduce size or eliminate bulkhead entirely.</p>	See CL.1 for quantity
BB. CL.4

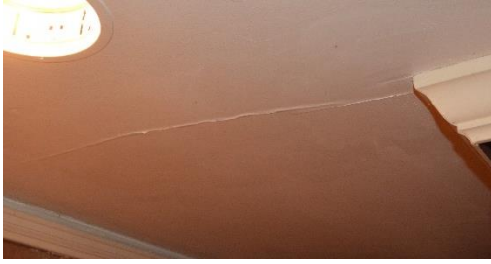
<p>Localized areas of gypsum wallboard ceiling displays cracking.</p> <p>Rout out crack along length. Patch wall surface. Prepare and paint.</p>	10 LF
BB. CL.5

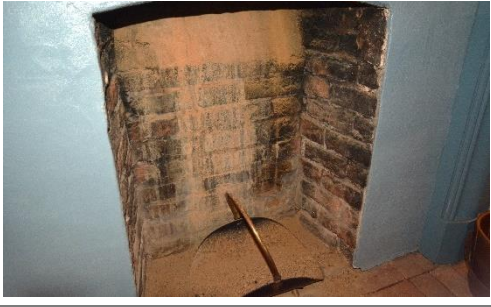
<p>Non-functioning fireplace flue is open to above. Extensive brick dust is present.</p> <p>Inspect flue with camera to determine source of brick dust. Provide operable flue door to seal opening.</p>	3 instances
BB. CL.6

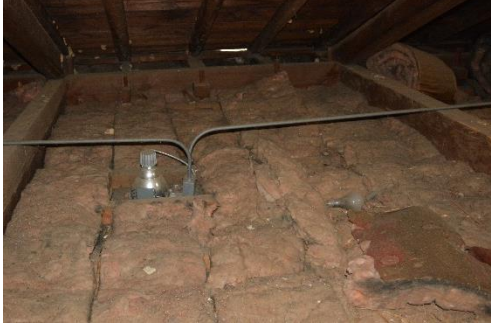
<p>Existing fiberglass attic insulation located in the joist bays above the upper floor ceiling appears to be soiled and deteriorated due to the presence of moisture infiltration.</p> <p>Remove and replace 100% of fiberglass insulation.</p>	1500 SF

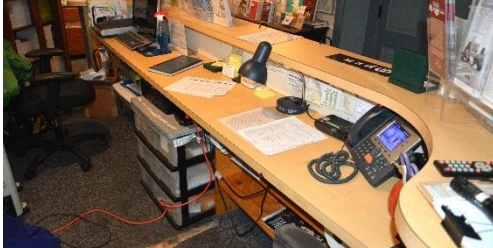
CODE	PHOTOGRAPH	CONDITION/REPAIR	QUANTITY
BB. OI.1

Reception desk is aged and displays areas of damage.  In concert with interior renovation, provide new built-in reception desk for museum.	8 LF desk
BB. OI.2

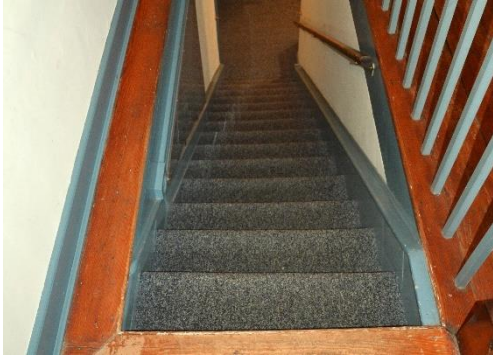
The east stair handrail does not meet code due to low mounting height and lack of connection to the upper landing.  Remove and replace existing basement stair handrail. Provide new handrail or extend existing handrail.	20 LF
BB. OI.3

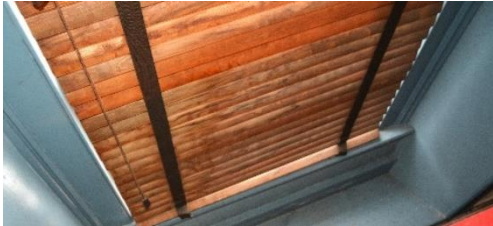
Windows have faux wood blinds that are aged and operate poorly.  Remove and replace blinds in-kind.	36 locations

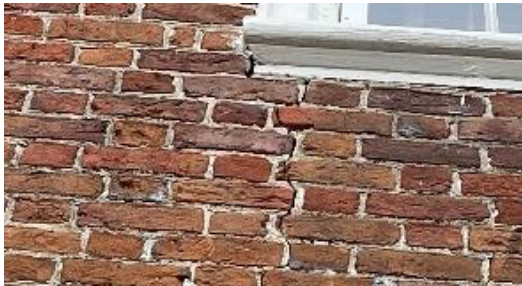
CODE	PHOTOGRAPH	CONDITION/REPAIR	QUANTITY
BB. S.1

<p>Vertical brick cracks appear to be related to seasonal thermal expansion of the brick façade.</p> <p>Remove and replace cracked bricks. Repoint open joints with appropriate mortar.</p>	20 LF of crack repair at approximately (4) different window locations.
BB. S.2

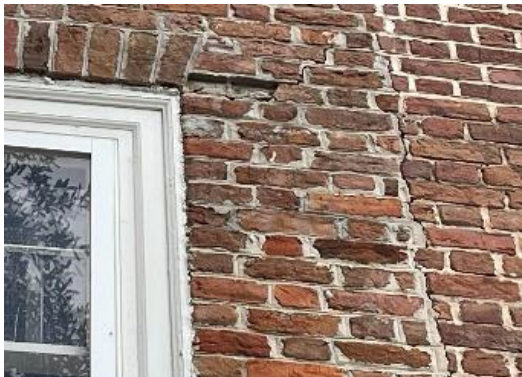
<p>Spalled brick at corner of windows with corroded steel angle lintel.</p> <p>Cut out spalled brick and replaced and with (2) existing steel angle lintels being removed and replaced with hot-dip galvanized steel brick lintels.</p>	10 LF galvanized steel angle lintels; 2 SF of brick repair; 2 locations
BB. S.3

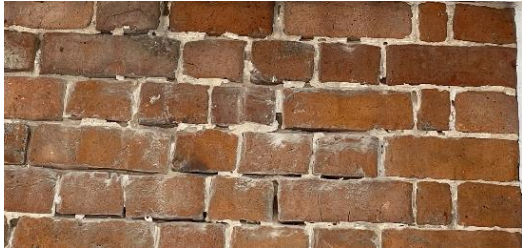
<p>Open mortar joints are present below the second-floor window on south elevation.</p> <p>Repoint open joints with an appropriate mortar.</p>	5 LF of mortar repointing
BB. S.4

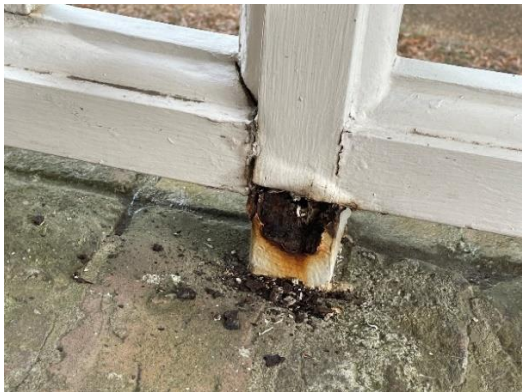
<p>Porch railing has corroded metal elements and rotted wood components.</p> <p>Disassemble post and railing. Cut out rotted wood post and ends of bottom railings. Splice in new wood post base and rails with a half-lap connection back to sound lumber.</p>	One post location at the right side of front porch

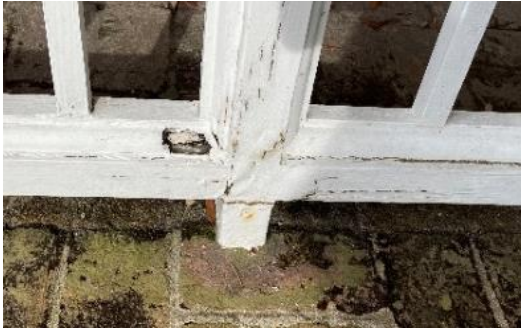
BB. S.5

<p>Rotted post base and bottom railing connection at front of porch.</p> <p>Since rot appears to be localized at the surface of the wood, rotted wood shall be cut out and repaired with a wood epoxy.</p>	1 post location at front entry porch
BB. S.6

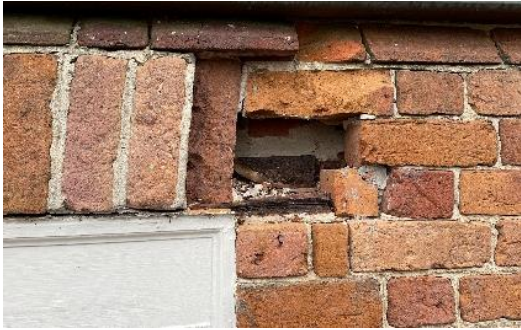
<p>Severely spalled brick at corners of window opening at rear left corner of building.</p> <p>Cut out spalled brick and replace. Remove and replace existing steel angle lintels at window head with hot-dip galvanized steel brick lintels.</p>	25 LF galvanized steel angle lintels; 10 SF of brick repair; 5 locations

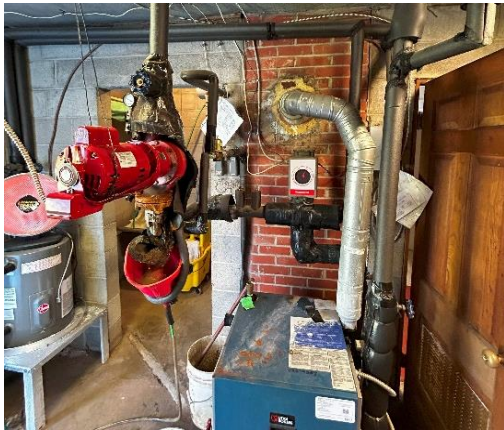
CODE	PHOTOGRAPH	CONDITION/REPAIR	QUANTITY
BB. M.1

<p>The existing gas-fired hot water boiler was replaced in 2000 and the hot water recirculation pump appears to have been replaced recently. Distribution piping and controls are from the 1990s renovations.</p> <p>Consider modernization and/or replacement of HVAC dual-temperature system distribution.</p>	1
BB. M.2

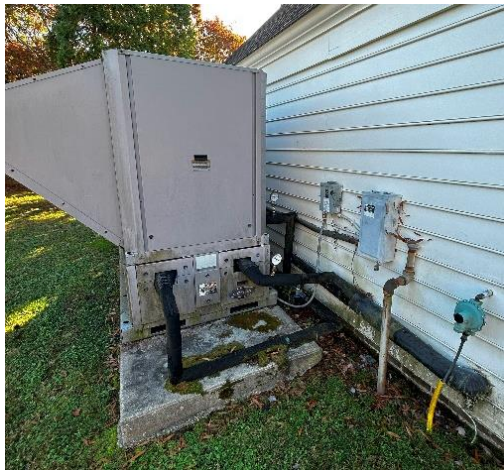
<p>The existing air-cooled chiller is operational and was installed in 2008. Distribution piping and controls are from the 1990s renovations.</p> <p>The ASHRAE life expectancy for exterior air-cooled equipment is 15-20 years. Consider modernization and/or replacement of HVAC dual-temperature system distribution.</p>	1
BB. M.3

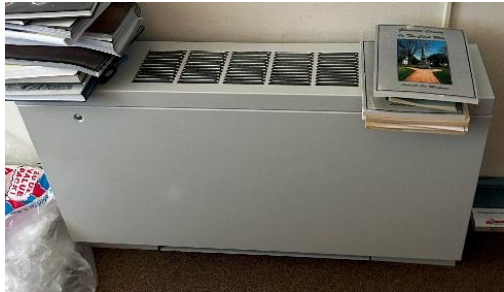
<p>Existing floor console fan coil with dual-temperature coil is aged.</p> <p>Consider modernization and/or replacement of HVAC dual-temperature system distribution.</p>	15 locations
BB. M.4	N/A	<p>Building does not currently have an active means of introducing fresh air.</p> <p>Consider installing a central mechanical ventilation system for any building modernization project.</p>	N/A

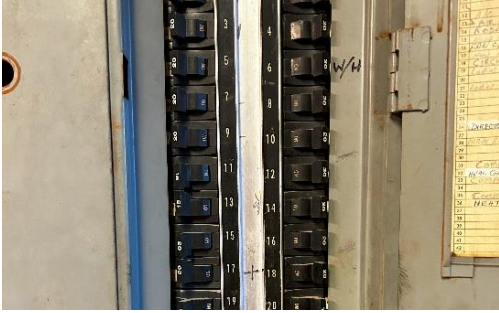
BB. E.1

Federal Pacific electrical distribution panel BTB-PNL-R is an obsolete model from a defunct manufacturer.  Remove and replace panel.	1
BB. E.2

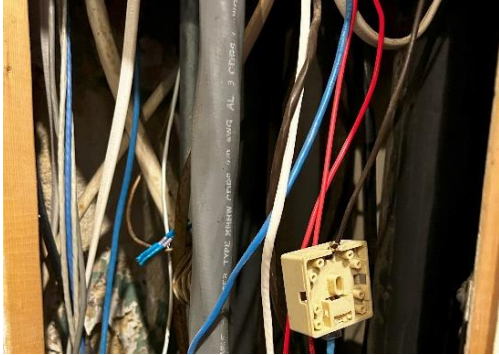
Insulated ROMEX wiring located within the utility chase at the rear of the first-floor Museum Exhibition area.  Replacement of ROMEX with metal clad armored cable (MC) or power wiring conductors in conduit (EMT) should be considered.	TBD
BB. E.3

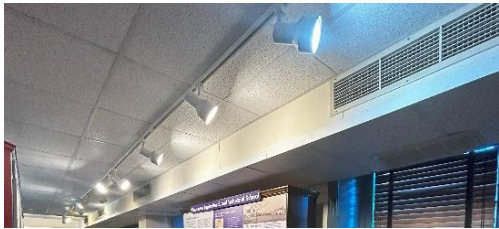
Existing track lighting system with incandescent PAR bulbs.  Consider replacement with LED fixtures.	TBD
BB. E.4

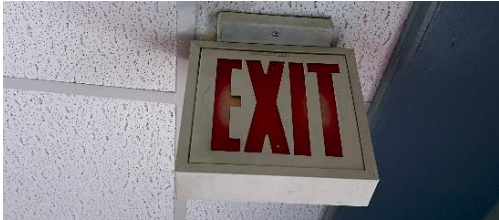
Backlit exit sign not illuminated.  Replace all exit signs and provide emergency lighting for the building.	100%
BB. P.1	N/A	The domestic water and sanitary distribution piping, insulation, and plumbing fixtures throughout building are outdated and require replacement.  Provide new plumbing system to basement kitchenette, first-floor restrooms, and rear addition.	100%

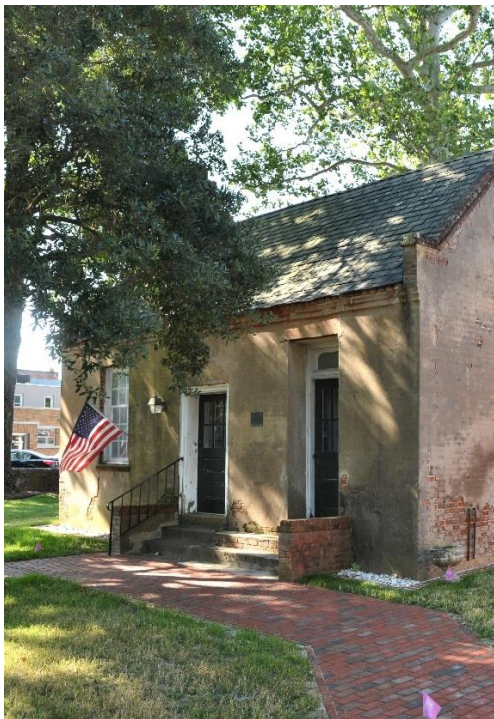
CODE	PHOTOGRAPH	CONDITION/REPAIR	QUANTITY
CB. G.1

<p>There is no current analysis of the existing building for the presence of hazardous materials, such as lead-based paint and asbestos-containing material. No such analysis was performed as a part of this project.</p> <p>Perform hazardous material survey to determine if lead-based paint, asbestos-containing materials, or other hazardous materials are present at the building. Survey should be completed before repairs are undertaken to allow for abatement of any hazardous materials in concert with associated work.</p>	Full building (interior and exterior)

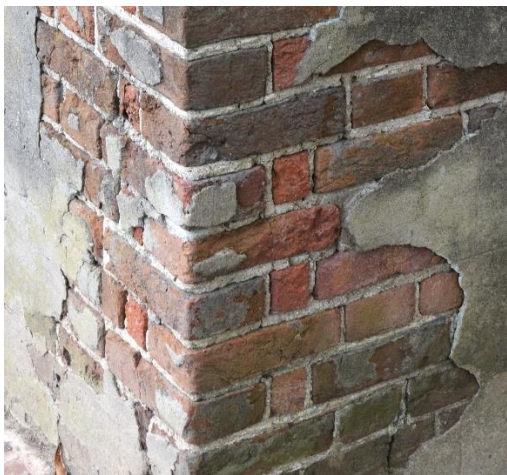
CODE	PHOTOGRAPH	CONDITION/REPAIR	QUANTITY
CB. MB.1

<p>Where exposed, open mortar joints and mortar deterioration occur on all elevations.</p> <p>Due to the number of cracked bricks and open joints paired with the moisture infiltration issues, 100% repoint should be considered. Repoint open brick masonry joints with appropriate mortar mixture using techniques to match original mortar joints.</p>	100% of exposed brick masonry
CB. MB.2

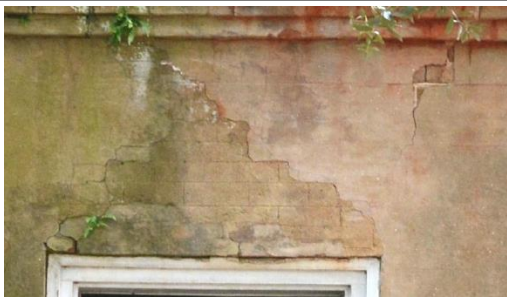
<p>Stairstep cracks occur in the mortar joints extending from the heads of many windows and door openings.</p> <p>Repoint localized areas identified on drawings, refer to MB.1 for repair and quantity.</p>	See MB.1
CB. MB.3

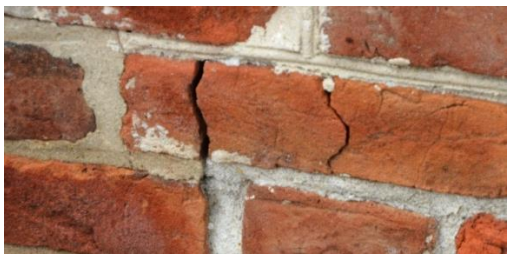
<p>Brick masonry units are cracked in several locations.</p> <p>Remove cracked brick unit. Provide matching brick unit salvaged from attic and install in concert with wall repointing.</p>	125 brick units
CB. MB.4

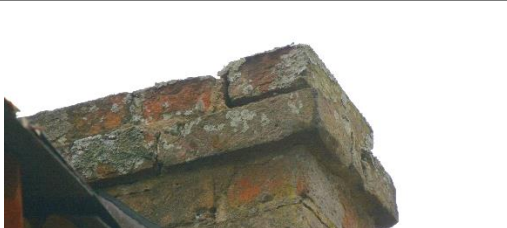
<p>Existing brick unit appears to be displaced from masonry assembly.</p> <p>Remove and reset displaced brick unit.</p>	2 locations

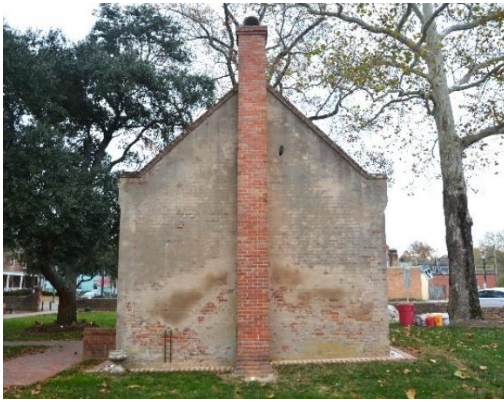
<p>Ca. 1900 brick chimney abuts historic west wall of building. No services are currently routed into chimney.</p> <p>Determine long-term restoration plans for building. Consider removing chimney in concert with other restoration efforts to return exterior to historic appearance.</p>	N/A
CB. MB.7

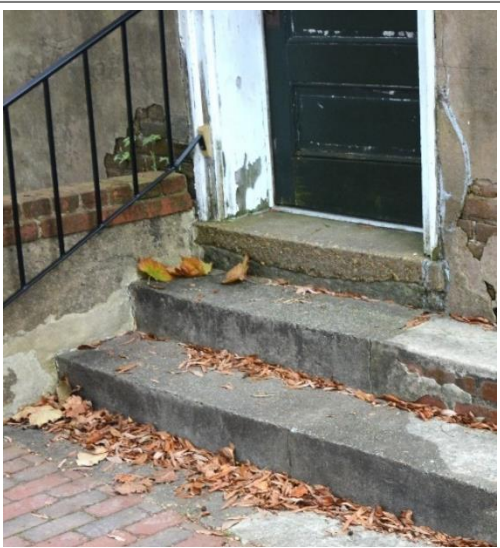
CODE	PHOTOGRAPH	CONDITION/REPAIR	QUANTITY
CB. C.1

<p>Existing concrete and brick masonry stair and concrete thresholds are designed to align with since-removed raised interior floor level.</p> <p>Determine goal to refinish interior flooring. If current level is to serve as finished floor elevation, remove and replace concrete and masonry stair. If west stair is returned to window, provide stair at central door only. Remove wing walls and provide handrails.</p>	10 LF stair width and 2 thresholds

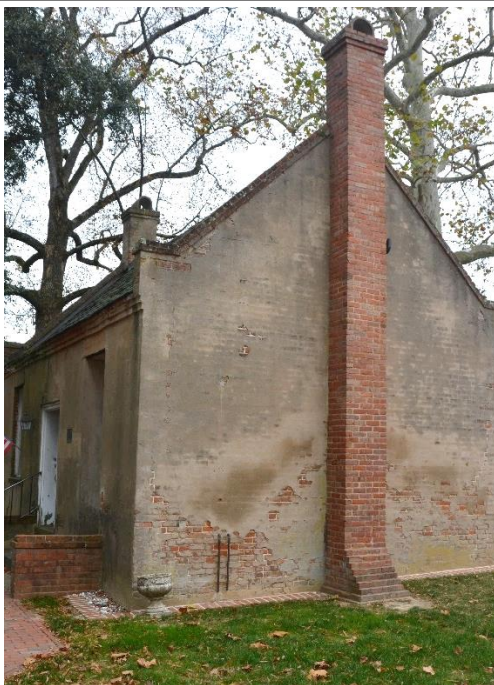
CODE	PHOTOGRAPH	CONDITION/REPAIR	QUANTITY
CB. ST.1

<p>Existing stucco on east, north, and west sides was installed ca.1900, and it is not original to the building. The stucco displays delamination, cracking, and other types of deterioration.</p> <p>Perform petrographic analysis of stucco to determine composition of stucco. Consider removal of stucco to restore original exterior appearance. If stucco is Portland cement-based, regularly inspect and remove delaminated areas of stucco to minimize damage to brick substrate while revealing historic brick finish.</p>	Testing, TBD on treatment
CB. ST.2

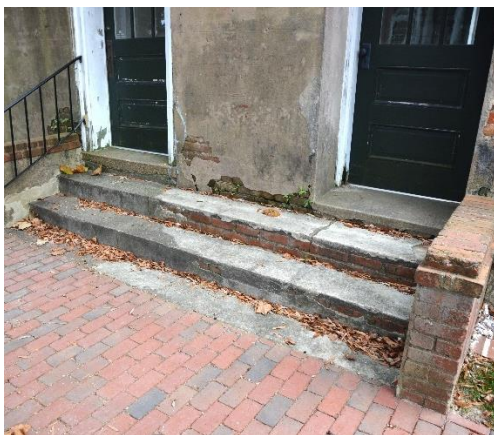
<p>Entry stair has areas of missing stucco on west side of risers.</p> <p>Develop long-term plan to restore exterior appearance, including removal of stucco finish and restoration of west door to a window. If pursued, remove west side of stair. If change is not made, prepare substrate and provide new stucco finish on risers.</p>	20 SF

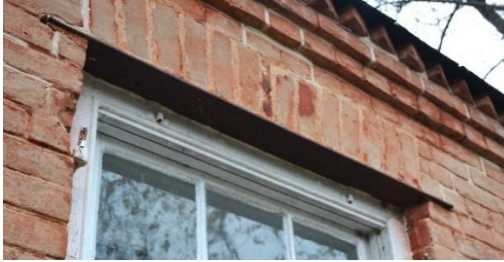
CODE	PHOTOGRAPH	CONDITION/REPAIR	QUANTITY
CB. MT.1

Galvanized steel lintels at all openings display corrosion.  Confirm integrity of steel. Remove corrosion from surface of metal element. Repair surface deterioration. Paint.	4 locations
CB. MT.2	 	Metal handrail exhibits deformation and has an ad hoc appearance.  As a part of repairs to stair, remove handrail and provide replacement of complimentary design on both sides of stair.	1 location (approx. 20 SF footprint)
CB. MT.3

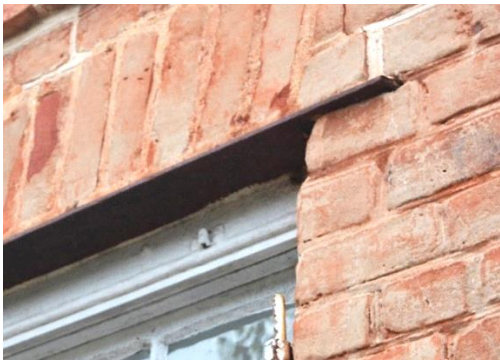
Steel lintel at rear window projects from face of masonry wall.  In concert with masonry and window repairs, determine ability to reset existing lintel to sit behind face of masonry. Replace lintel if additional deterioration is found.	1 location

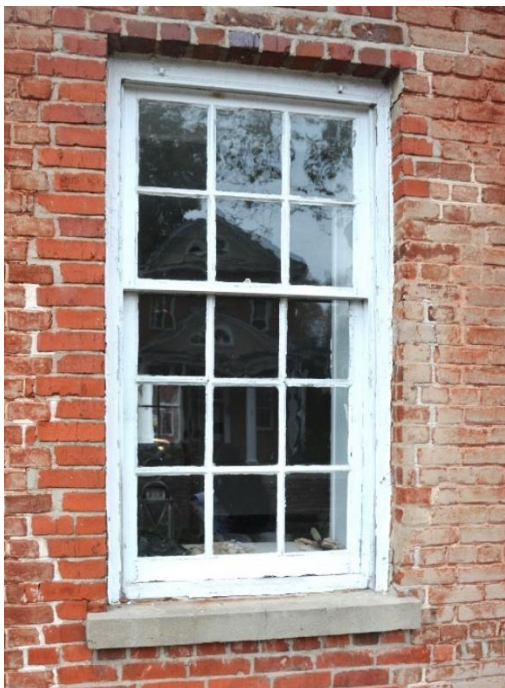
CODE	PHOTOGRAPH	CONDITION/REPAIR	QUANTITY
CB. W.1

<p>Existing wood windows display finish and substrate deterioration at various components.</p> <p>Restore 100% of wood windows. Remove window sashes. Remove glazing putty and glass. Label and store glass for future reinstallation. Strip paint. Remove rotted wood from sash and frames. Remove perimeter sealant. Provide epoxy patch for all surface repairs and wood dutchman for rotted sections. Reglaze sash. Paint all sides of frame, sill, and sash. Reinstall sash. Provide perimeter sealant.</p>	4 double-hung windows
CB. W.2

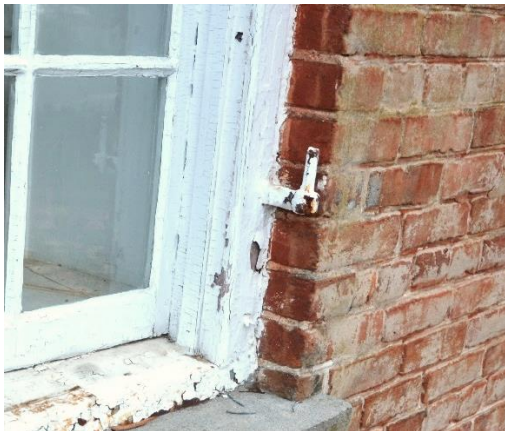
<p>Wood shutters which were once located at the building are no longer extant.</p> <p>Consider providing new wood shutters to match the historic arrangement in coordination with exterior restoration. Repair shutter hardware and secure any loose shutter dogs. Paint all sides of shutters and hardware. Install shutters.</p>	5 locations

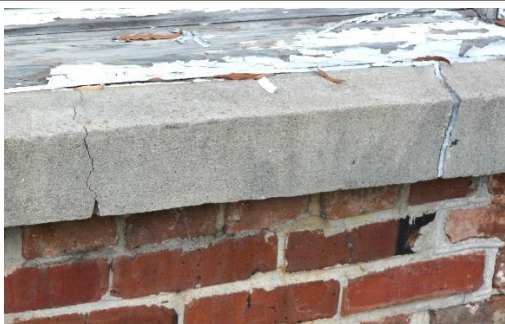
CB. W.3

<p>Existing sills display various deterioration, including cracking at stone sills and corrosion at metal flashing.</p> <p>Remove damaged sills. Inspect and prepare substrate. Provide new precast concrete sills to match existing sills.</p>	3 locations

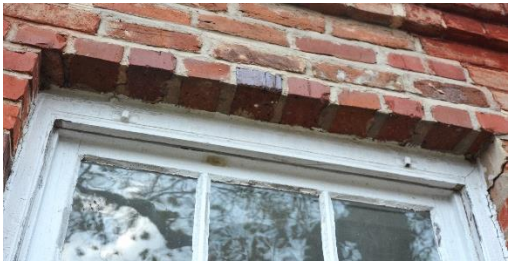
CB. W.4

<p>Abandoned elements from since-removed window screens are present at all windows.</p> <p>Remove storm window components and repair any damage at window frame.</p>	Spot repairs at 4 windows
CB. W.5

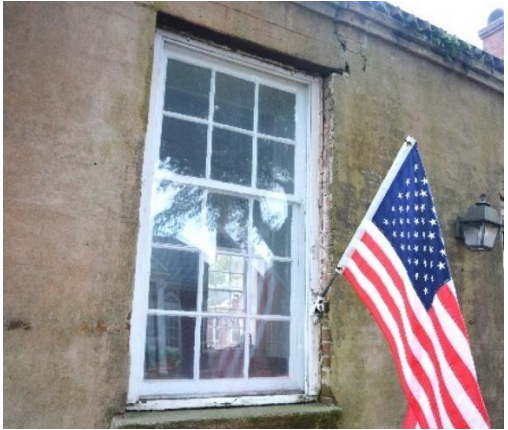
<p>North elevation window has exterior storm window which exhibits deterioration.</p> <p>In coordination with window restoration effort, remove extant storm window. Establish intended use for building and corresponding conditioning goals to determine if new storm windows are desired.</p>	N/A

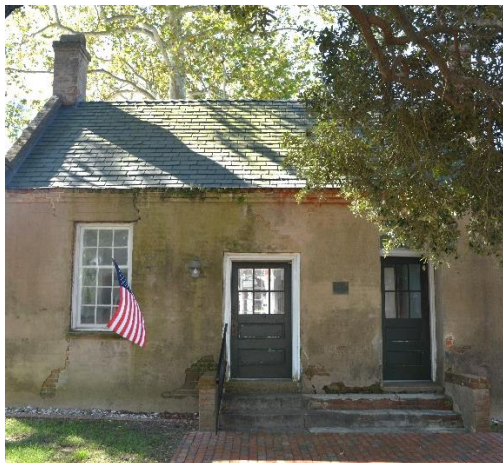
CB.  
D.2

Western door on north elevation dates to ca. 1900 and replaced a window that likely matched the eastern opening.

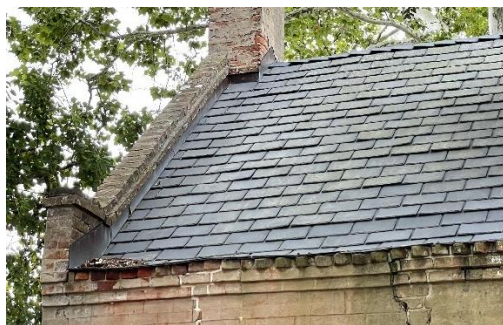
<p>Roof has synthetic rubber shingles which replaced an earlier slate roof in 2002.</p> <p>Replace synthetic shingles when material reaches its scheduled end of lifespan (~40 years). Provide slate shingle roof.</p>	400 SF
CB. R.2

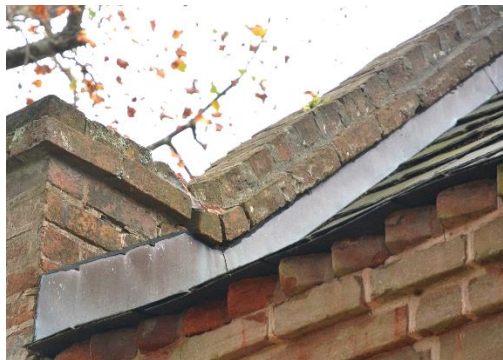
<p>Top of parapet walls consists of exposed brick masonry and lacks metal coping to prevent moisture infiltration into wall.</p> <p>Review parapet walls. Repoint and repair as required. Provide metal coping on top course finished to minimize visual appearance.</p>	60 LF
CB. R.3

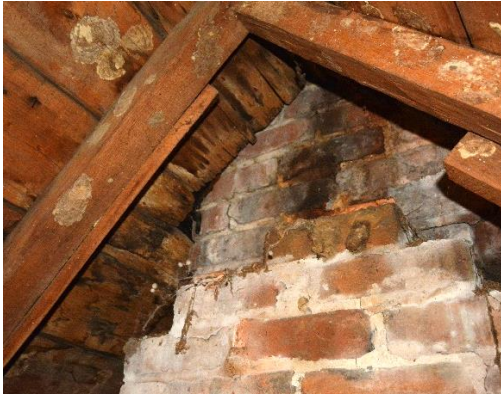
CB.  
R.4

Roof decking at gable end walls 20 SF displays deterioration and rot.

Remove deteriorated and rotted wood to the extent possible while minimizing disturbance to the roof. Monitor for moisture infiltration. Repair all deteriorated decking as a part of future reroofing.

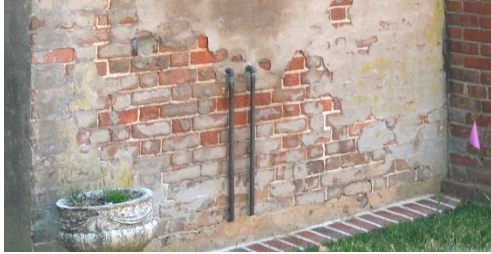
<p>Metal piping extends from face of west exterior wall.</p> <p>Determine if piping is in active service. Reroute and remove existing piping. Repair surface as necessary.</p>	2 locations
CB. O.2

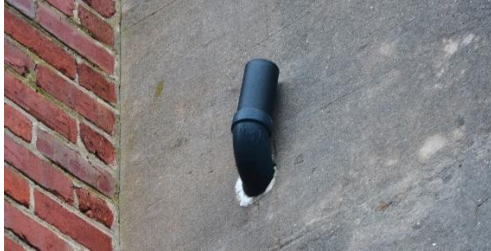
<p>Exhaust pipe extends from face of west exterior wall.</p> <p>Determine if piping is in active service. Redesign to minimize visual appearance. Repair surface as necessary.</p>	1 location

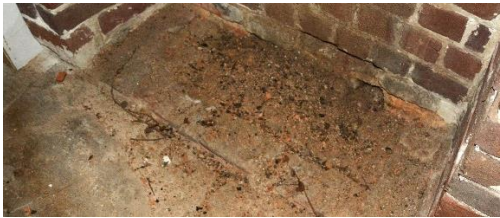
<p>The interior of the building has of debris and soiling throughout.</p> <p>Clean all interior spaces to remove debris and soiling.</p>	350 SF
CB. GL.2	 	<p>Building is currently closed to the public and it is not actively used by county.</p> <p>Prior to any building renovation, review program to determine use which meets long-term goals.</p>	N/A

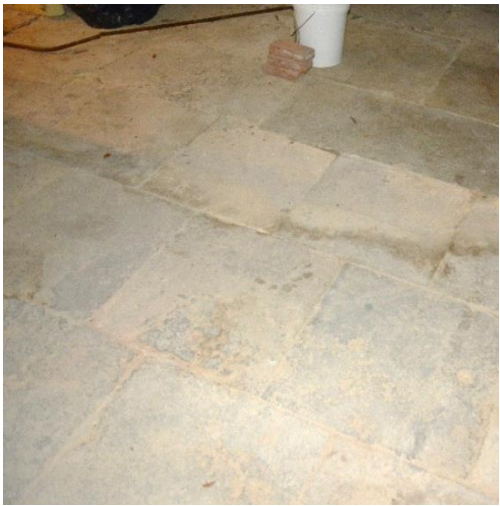
<p>Existing stone floor displays deterioration at mortar joints and surface of stone.</p> <p>Selectively remove deteriorated stones to complete full inspection of paver and substrate. Determine if material can be salvaged or requires replacement. For replacement, provide matching English limestone with Type O lime cement mortar joints tooled with scored rule joints.</p>	250 SF stone finish / 15 SF stone replacement

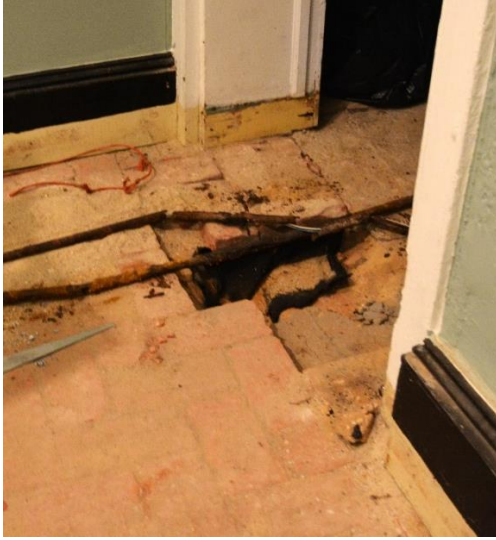
CB. F.2

<p>The two main rooms have different types of pavers – stone and brick – installed at the same elevation, suggesting a design distinction or difference in period of execution.</p> <p>Complete selective removals of brick in concert with stone repairs to confirm substrate dates to same period and complete any additional research to determine if materials were installed at the same time.</p>	TBD
CB. F.3

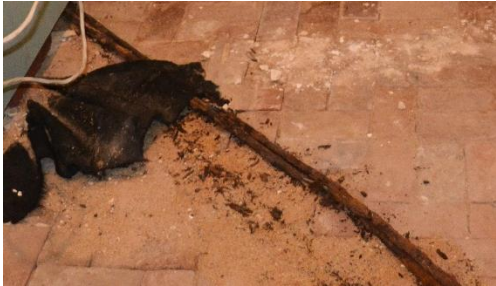
<p>Metal conduit, some of which is heavily corroded, is installed on the masonry flooring.</p> <p>Determine if services are active. Reroute and remove existing piping. Repair surface as necessary.</p>	West and east rooms
CB. F.4

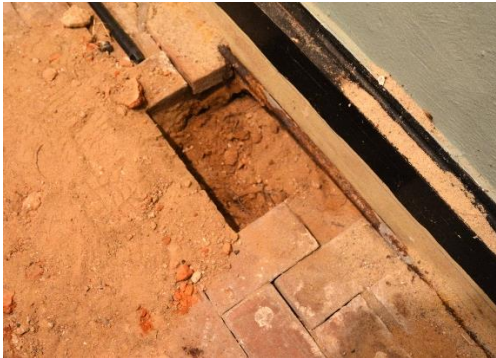
<p>Brick floor in west room has several holes.</p> <p>In concert with larger restoration goals, remove adjacent brick pavers to facilitate repairs to substate. Reinstall brick pavers with fine dryswept sand joints to create level floor finish.</p>	4 locations at 2 SF each

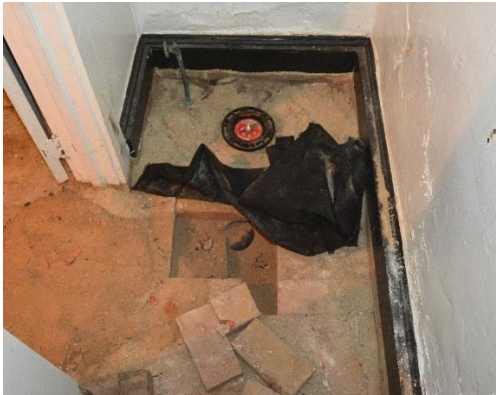
CB. F.5

<p>Defunct restroom has multiple floor levels and extant capped plumbing lines.</p> <p>Consider future use for this restroom. It is recommended that room remain as a storage or utility closet in lieu of full removal. Remove plumbing line and repair floor to create level surface.</p>	15 SF

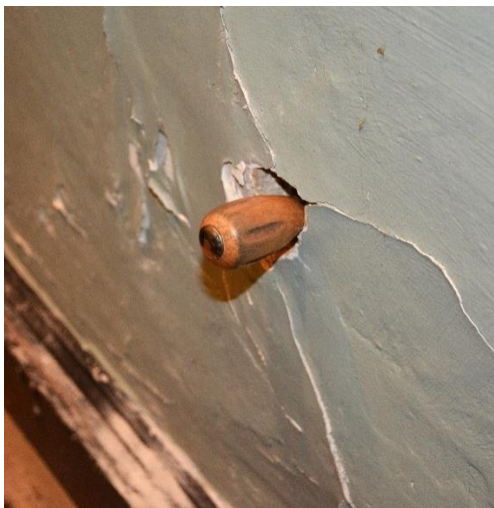
<p>Painted finish and plaster substrate display deterioration and localized areas of poor execution.</p> <p>Perform test cut into wall surface to confirm assembly and condition. Complete interior paint analysis if desired. Remove deteriorated plaster surfaces. Prepare surface and repaint 100% of wall surfaces and wood trim per findings of analysis.</p>	Paint 100% of interior / 125 SF of plaster repair / Paint analysis
CB. WA.2

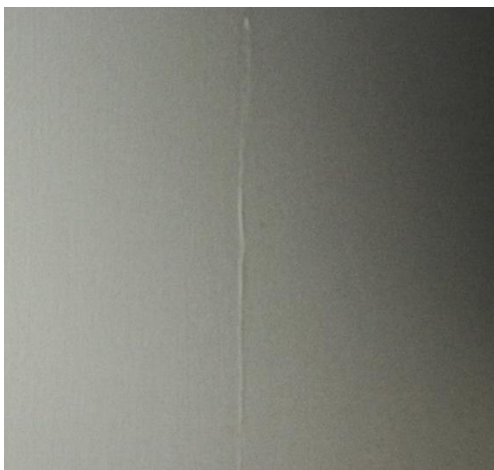
<p>Existing east room walls have a layer of painted wallboard, and various joints are visible in wall surface</p> <p>Following maintenance schedule, perform test cut into wall surface to confirm assembly. Determine if desirable to remove drywall surface or to remain. Repair visible joints. Paint 100% of walls.</p>	Paint 100% of east room / 5 SF of repairs at test cuts
CB. WA.3

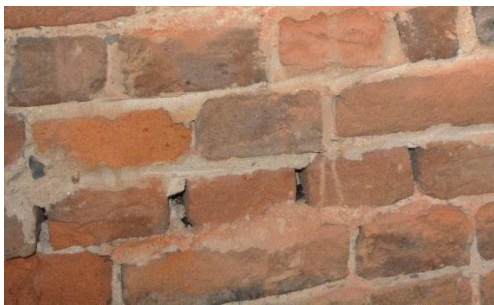
<p>Brick masonry gable end walls in the attic display mortar erosion and numerous open joints.</p> <p>Spot repoint open joints in masonry with appropriate mortar.</p>	50 SF

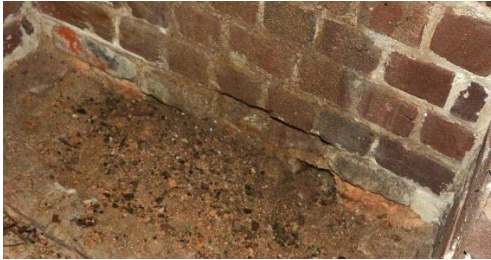
CB. WA.4

<p>There are spalled and displaced brick units at base of east room fireplace.</p> <p>Remove damaged masonry. Replace with salvaged matching units from attic.</p>	4 locations
CB. WA.5

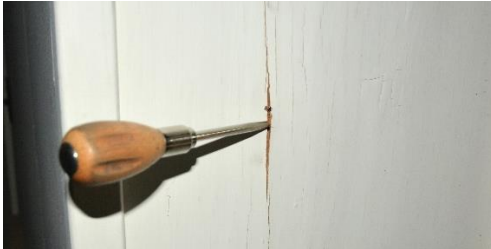
<p>Modern plywood returns at window jambs display splitting and finish deterioration.</p> <p>Strip paint and determine extent of damage. Repair deteriorated panels. Paint.</p>	8 SF
CB. WA.6

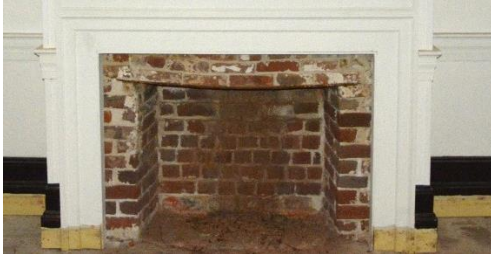
<p>The lintel at the fireplace has deflected.</p> <p>Refer to structural for scope of work at lintel. Salvage affected masonry and rebuild with new lintel.</p>	1 location with 10 SF of brick repairs
CB. WA.7

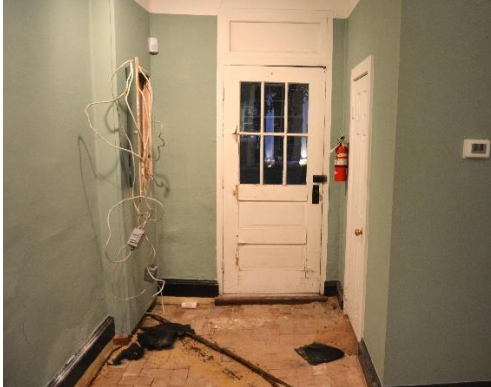
<p>A furred wall enclosure used to house utilities is located in the west room adjacent to the door.</p> <p>If room is intended to be used by public, consider relocating electrical panel into wall of former restroom and removing furred wall assembly in its entirety. Patch and repair plaster wall surface.</p>	1 location

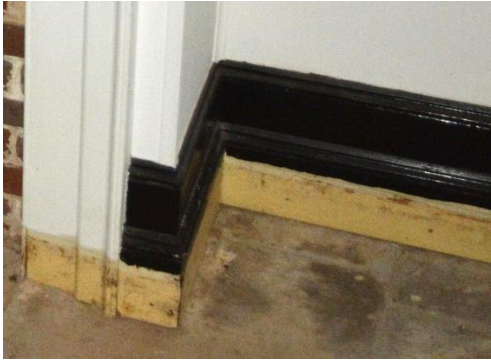
CB. WA.8

<p>Wood wall base is installed and painted per the since-removed raised floor elevation.</p> <p>Remove and salvage layered base trim in east room. Base trim in west room to remain in place. Strip paint and repair wood surface. Provide trim where missing. Paint.</p>	Refinish 100% of base trim / 5 LF of repairs

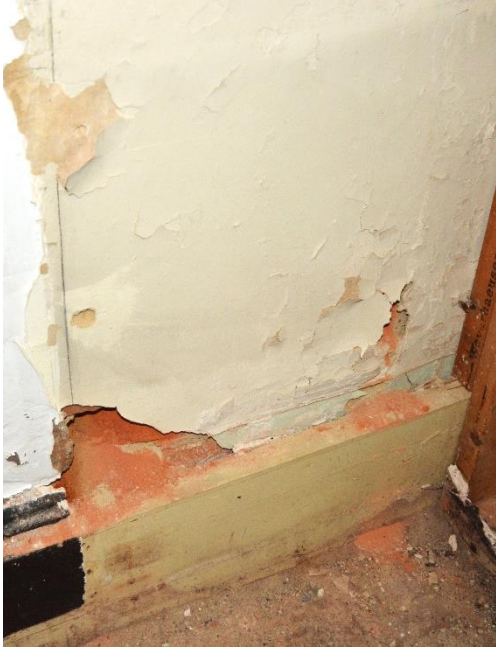
CB. WA.9

<p>Brick dust is present on the floor of the restroom where the plaster wall finish has failed, typically indicates the long-term presence of moisture within the wall assembly, which can cause the bricks to become soft and lose strength.</p> <p>Additional removals and testing is warranted to better assess the state of the masonry walls prior to action. Remove areas of wall plaster to confirm whether the condition is connected with rising damp. Perform testing at areas where finish is damaged.</p>	Removal of 2'x2' area of plaster at a minimum of three locations.
-------------	---	---	---

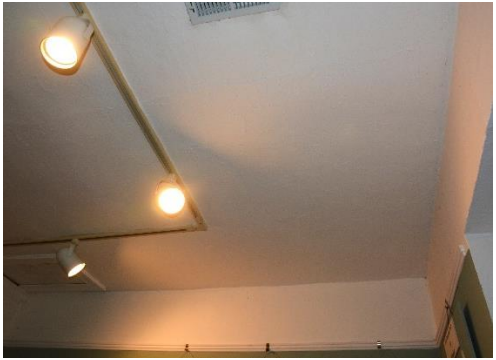
<p>Plaster ceiling in west room has areas of surface and finish deterioration.</p> <p>Tap plaster to confirm lamination to substrate. Remove delaminated areas of plaster. Remove damaged areas of paint finish. Repair plaster surface and paint.</p>	175 SF paint / 40 SF of repair
CB. CL.2	 	<p>Drywall ceiling in east room has visible joints in several locations.</p> <p>In concert with larger renovation effort, repair visible joints in ceiling. Paint.</p>	300 SF
