# FY27 CIP SUBMISSION

# CONDITION ASSESSMENT REPORT

GLOUCESTER COURT CIRCLE PROPERTIES &  
MUSEUM OF HISTORY  
GLOUCESTER COUNTY, VIRGINIA

*95% DRAFT SUBMISSION*

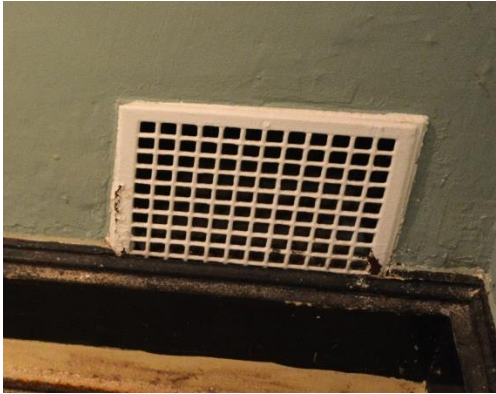
<p>Existing transfer grille is located on the south end of the masonry interior wall.</p> <p>Remove paint and refinish grille on both sides of wall. Determine if sound or conditioning goals would be supported by inserting removeable closure panel behind grille on one side.</p>	1 location
CB. OI.2

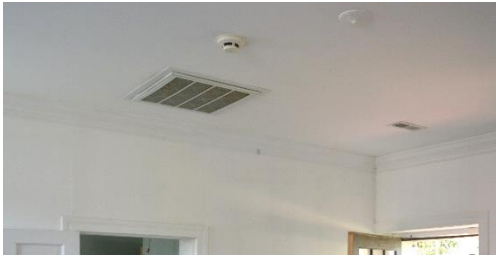
<p>The east room lacks an active ceiling-mounted lighting fixture.</p> <p>Determine long-term goals for use of room and provide appropriate lighting fixture.</p>	1 location
CB. OI.3

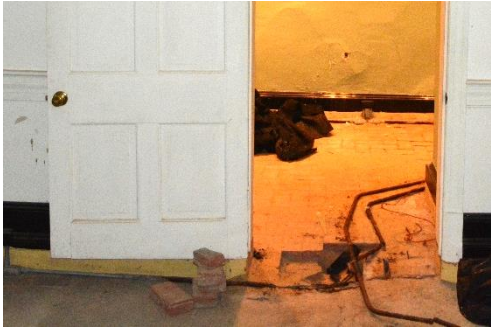
<p>The existing interior doors no longer meet the floor level due to the removed raised floor.</p> <p>Upon determination of an approach to the finished flooring for the Clayton Building, remove and replace modern doors with new doors.</p>	2 doors

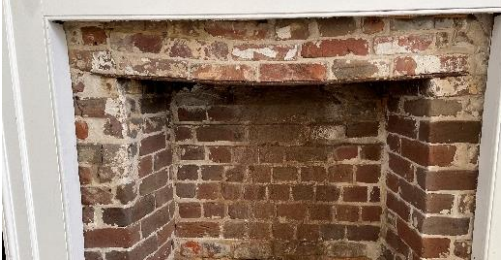
<p>The steel lintel at the interior fireplace is undersized and has deflected to a significant degree.</p> <p>Removed and replace existing lintel. Provide galvanized steel lintels painted to match existing.</p>	(2) galvanized steel angle lintels x 5 LF each.
S.2

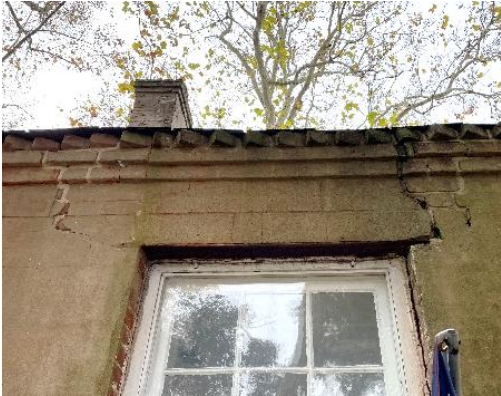
<p>A large vertical crack has occurred at the corner of the window and door openings at the front façade. It appears that this has been caused by corrosion and subsequent deflection of the steel lintel above the opening.</p> <p>Remove and replace existing lintel with a hot-dip galvanized steel lintel or possibly a precast CMU lintel. Repair crack with a helical stick rod.</p>	(2) lintels x 10LF total. (3) helical stick rods and 10SF of masonry reconstruction at each wall location.
S.3

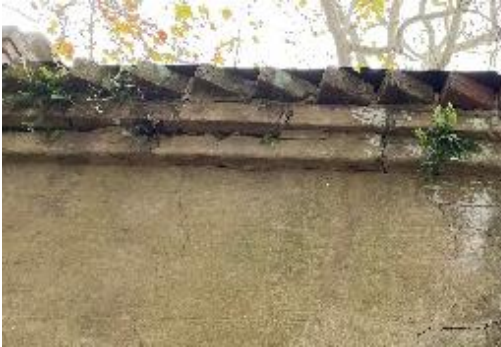
<p>Water penetration and vegetation are present at the top rowlock course.</p> <p>Inspect roof for a leak, remove vegetation. Remove loose bricks and reset in place with appropriate mortar.</p>	10LF of brick rowlock repairs.

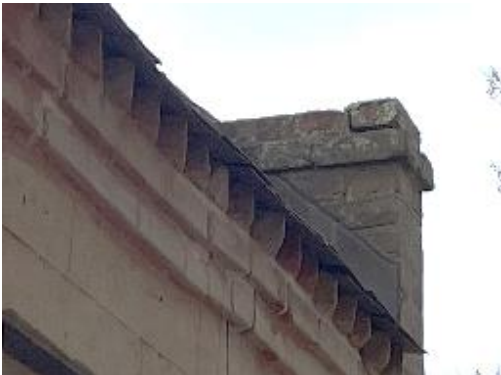
S.4

<p>Loose bricks were observed at the top of the brick parapet wall.</p> <p>Remove and reset cap bricks with appropriate mortar.</p>	5 LF of brick repair

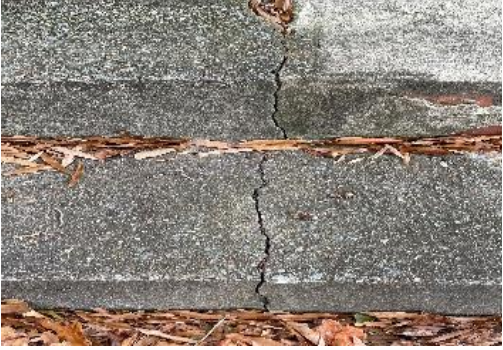
S.5

Concrete stairs are cracked.  Seal joint with a penetrating concrete sealer and injection grout.	5 LF
S.6

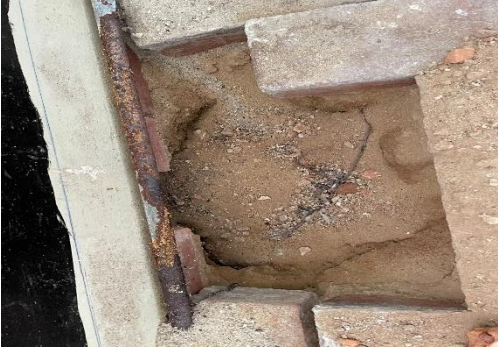
Existing brick pavers are uneven or missing at multiple locations.  Determine interior floor finish per Architectural. Remove and reset displaced pavers to provide a level floor.	20 SF

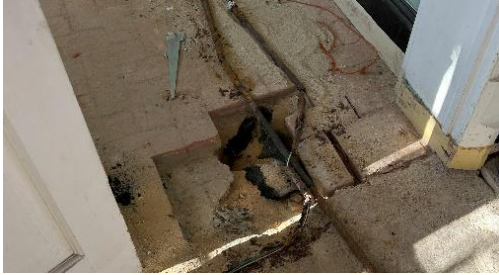
<p>The electrical EMT raceway at the floor level appears to have been damaged</p> <p>Replace and reroute conduit as a part of any floor repairs.</p>	100%
E.2	N/A	<p>The west room does not currently have a lighting fixture.</p> <p>Provide ceiling-mounted lighting fixture in west room.</p>	1 location
FA.1	N/A	<p>Building does not currently have a central fire alarm system to protect the historic building.</p> <p>As a part of future restoration, provide a central fire alarm as a part of any future renovation.</p>	100%

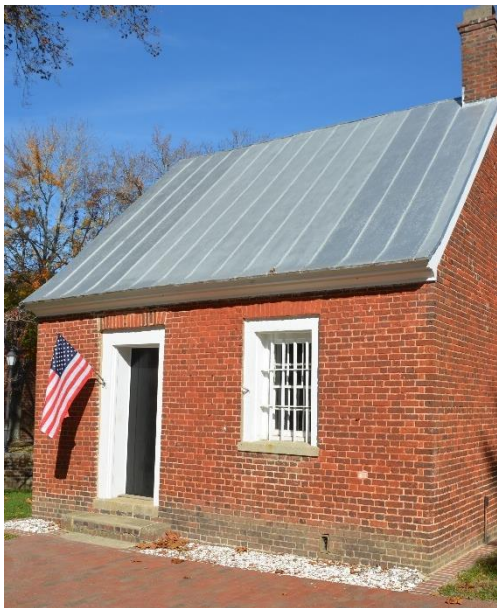
CODE	PHOTOGRAPH	CONDITION/REPAIR	QUANTITY
DP. G.1

<p>No hazardous materials testing appears to have been completed, such as for lead-based paint. No such analysis was performed as a part of this project.</p> <p>Perform hazardous material survey to determine if lead-based paint or other hazardous materials are present at the building. Survey should be completed before repairs are undertaken to allow for abatement of any hazardous materials in concert with associated work.</p>	Full building (interior and exterior)

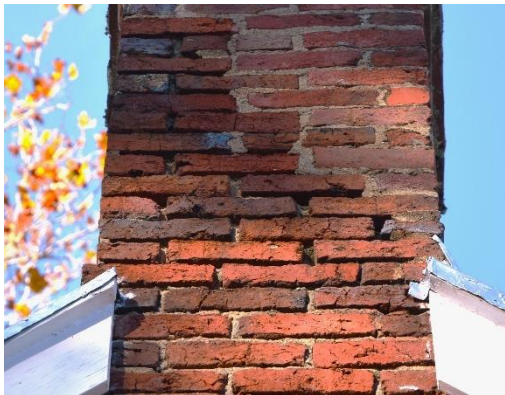
CODE	PHOTOGRAPH	CONDITION/REPAIR	QUANTITY
DP. MB.1

<p>Open mortar joints and mortar deterioration occur on all elevations.</p> <p>100% repoint should be pursued in concert with other repairs. Repoint open brick masonry joints with appropriate mortar mixture, using techniques to match original mortar joints.</p>	100% of joints

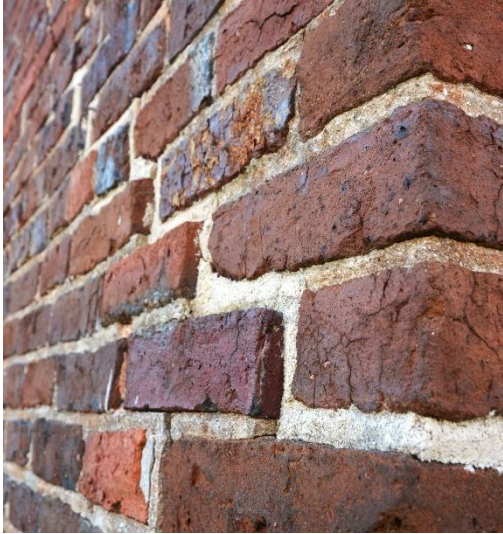
DP. MB.2

- A vertical separated brick crack occurs at the rear left corner of the building. The wall corner is no longer vertical. This appears to be related to foundation settlement.

<p>Displacement is active at the northwest corner of the building. The wall has failed and will exacerbate over time if not repaired.</p> <p>Refer to Structural for additional information, including investigation at foundation. For worst-case planning purposes, assume partial dismantling, salvaging, and reconstruction of northwest corner and underpinning of corner.</p>	200 SF of reconstruction, 10 LF of concrete underpinning
DP. MB.3

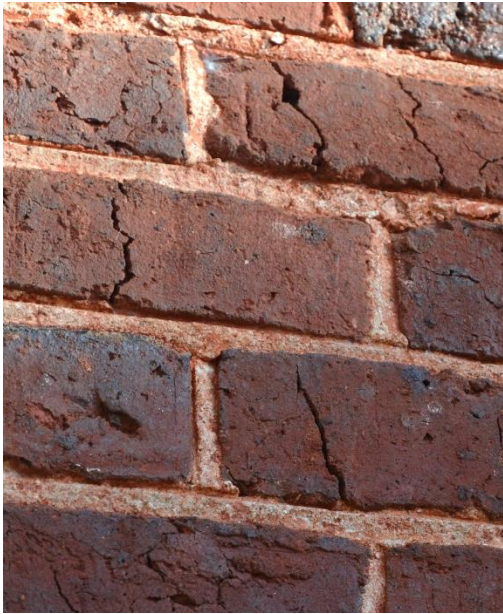
<p>Brick masonry units are cracked in several locations. The majority of the cracking likely stems from their firing during the production of the bricks.</p> <p>Remove bricks which have through cracks. Provide replacement brick units that match existing units in concert with repointing. Perform RILEM testing on several bricks with firing cracks as well as several repointed mortar joints to confirm extent of issue.</p>	Replace 50 brick units / RILEM testing on 10 locations

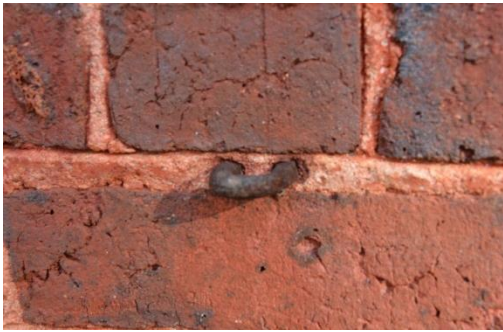
DP. MB.4

<p>Fasteners are installed into the face of brick for various purposes.</p> <p>Remove all fasteners. Patch brick with color-matched grout of appropriate mix and repoint mortar joint with compatible mixture.</p>	25 locations

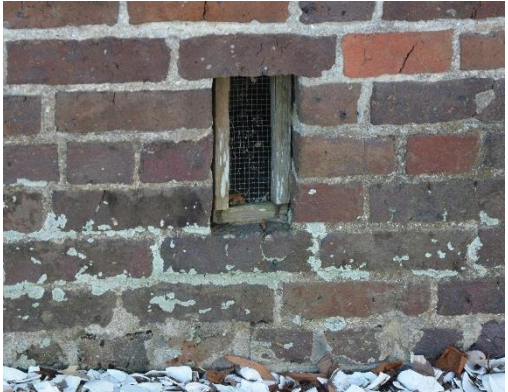
DP. MB.5

<p>Biological growth is occurring at localized areas of the exterior masonry, typically along the base of the building, and causing staining on the exterior facade.</p> <p>Remove biological growth and staining with architectural anti-microbial biocide. Use gentlest means possible.</p>	100 SF
DP. MB.6

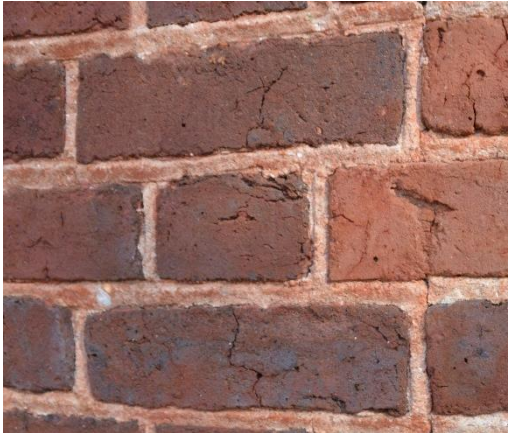
<p>The brick displays evidence of a red wash over the masonry walls. Historic photographs show this coating intact. This layer may have helped to mitigate water infiltration.</p> <p>In concert with masonry repairs, prepare surface and provide red wash of linseed oil tinted to match extant remnants.</p>	900 SF
DP. MB.7

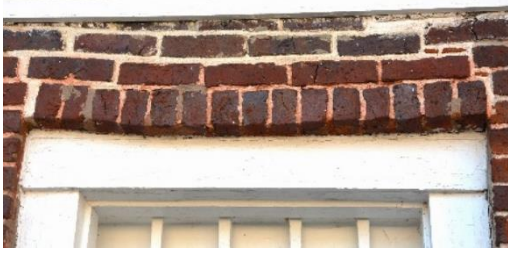
<p>Brick arches at front windows exhibit failure and poor repairs.</p> <p>Provide intact and fully supported arch. Refer to Structural.</p>	2 locations
DP. MB.8

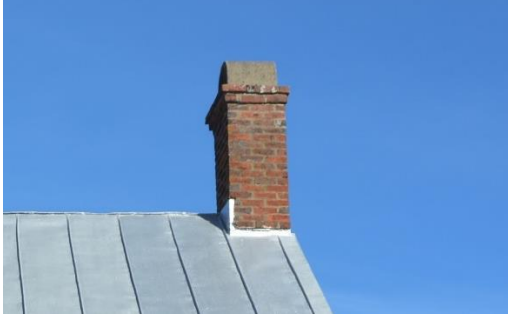
- There are open mortar joints at the chimney. A vertical brick crack has occurred in the chimney wall that had been repaired but has since reopened. The wall corner is out of plumb approximately 1/4-inch over 3-feet.

<p>Brick chimney leans to the west and exhibits a significant number of open joints.</p> <p>Perform assessment via lift of chimney. Assume dismantling, salvaging, and reconstruction of chimney for planning purposes.</p>	5 LF in height

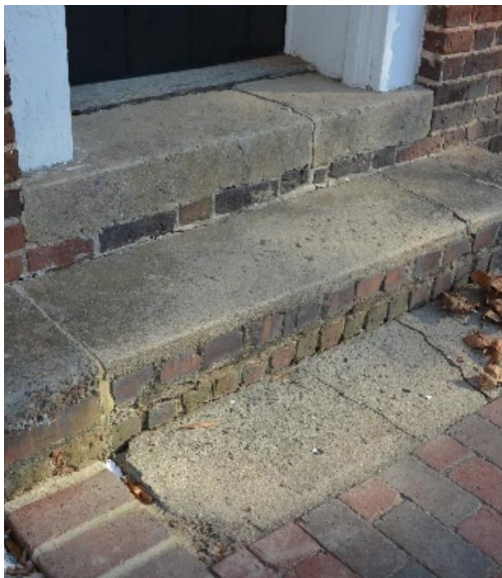
CODE	PHOTOGRAPH	CONDITION/REPAIR	QUANTITY
DP. C.1

<p>Existing concrete and brick masonry step and concrete door threshold display cracking and the former does not match the arrangement shown in historic photographs, in which corbelled wing walls were present.</p> <p>Replace single riser with new brick step and wing walls with a corbelled course. Provide compatible and color-matched cementitious grout injection at threshold. Provide handrail on single side for improved access.</p>	5 LF stair width and 1 door threshold

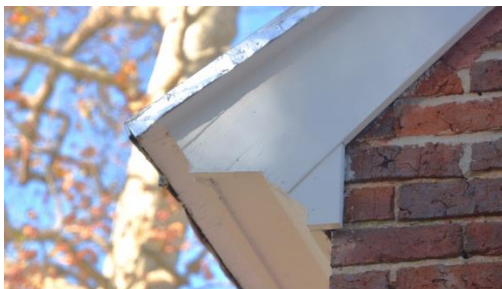
CODE	PHOTOGRAPH	CONDITION/REPAIR	QUANTITY
DP. WD.1

<p>Existing wood cornice and eaves display paint deterioration and localized rot.</p> <p>Strip existing paint. Prepare surface and repaint 100% of wood finishes. Repair/replace deteriorated wood elements.</p>	5 LF of repairs / 80 LF of painting

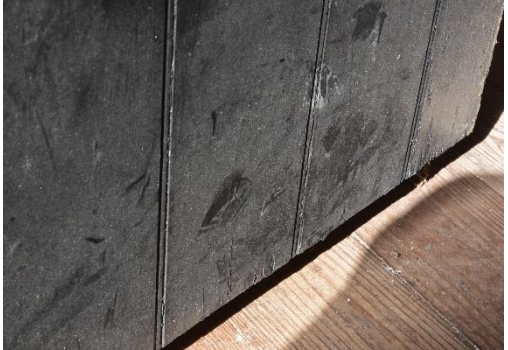
CODE	PHOTOGRAPH	CONDITION/REPAIR	QUANTITY
DP. D.1

<p>Existing modern front door displays minor deterioration along base and has areas of minor surface damage.</p> <p>Remove fasteners. Strip paint. Repair damaged areas. Improve operability of hardware. Prepare surface and paint.</p>	1 door

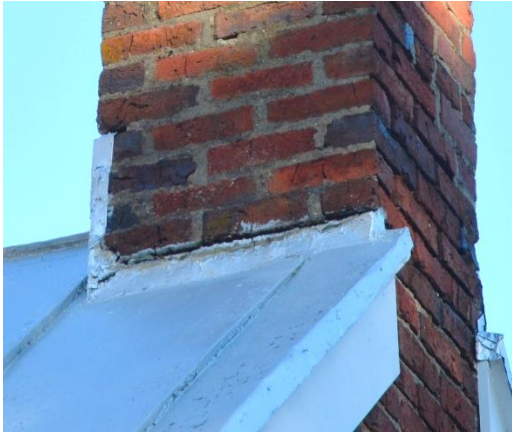
DP. R.2

<p>Chimney has active water infiltration and open mortar joints at intersection with roofline.</p> <p>Assess integrity of painted flashing. Repair or replace as required. Remove and reset flashing in repaired mortar joint. Provide sealant. Perform work in concert with masonry repairs.</p>	1 location
------------	---	---	------------

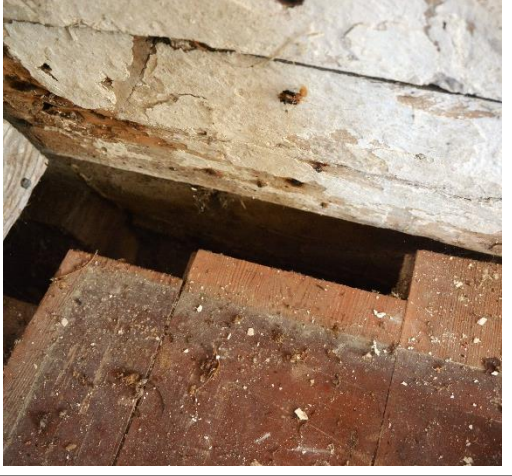
CODE	PHOTOGRAPH	CONDITION/REPAIR	QUANTITY
DP. F.1

<p>Tongue-and-groove wood flooring has uneven finish and does not meet face of wall along perimeter. Flooring may date to post-jail use.</p> <p>Provide low profile perimeter wood base and small tongue-and-groove wood floor boards to fill gaps. Remove applied finish on surface of wood and apply linseed oil finish to protect flooring.</p>	75 LF of base / 30 location of floor infill / 250 SF of floor finishing
DP. F.2

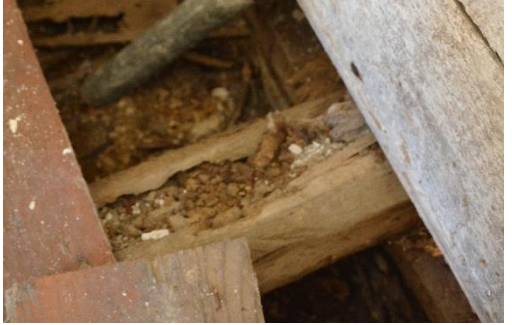
- There are cracks in the concrete sill and steps at the entrance to the building.
- Several severely rotted floor joists were observed adjacent to the existing wall at numerous locations. Several of the original joists have been replaced by more modern joists at the front left side of the building.

<p>Wood floor joists exhibit deterioration and rot in several locations.</p> <p>Remove areas of wood flooring where areas of rot are suspected at joists. Repair rotted areas. Refer to Structural.</p>	50 SF of floor removal and reinstallation

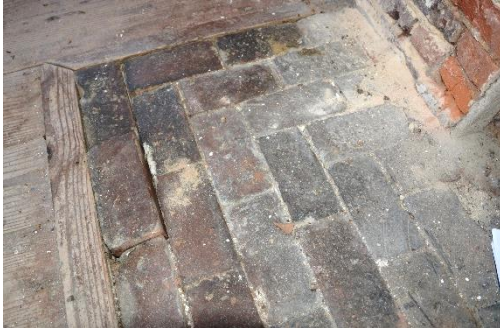
DP. F.3

Dry-laid brick hearth has uneven substrate and soiled surface.	5 SF
		Remove loose bricks in hearth. Assess substrate. Provide compacted sand fill to level base for brick hearth. Reinstall salvaged brick units.	
DP. F.4

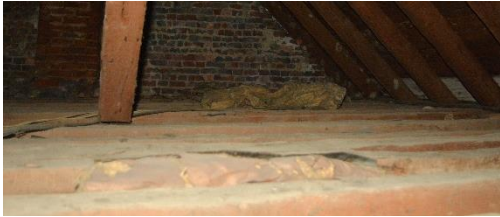
Existing attic floor lacks access walkway.	16 LF
		Provide wood boards fastened to ceiling to provide ease of maintenance access inside attic.

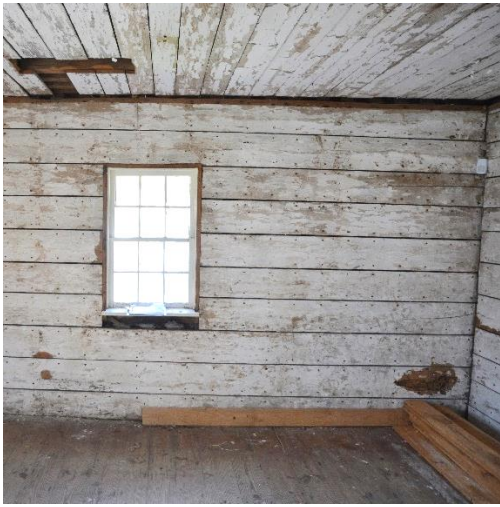
CODE	PHOTOGRAPH	CONDITION/REPAIR	QUANTITY
DP. WA.1

<p>Painted finish is missing from wood plank wall surfaces where previously covered by modern trim and it is also deteriorated throughout the space.</p> <p>Scrape loose finish from surface of wood planks. Repair damaged areas and modern alterations. Apply whitewash on surface of wood planks to achieve a more consistent finish on all planks.</p>	600 SF of prep and painting / 10 SF of repairs
DP. WA.2

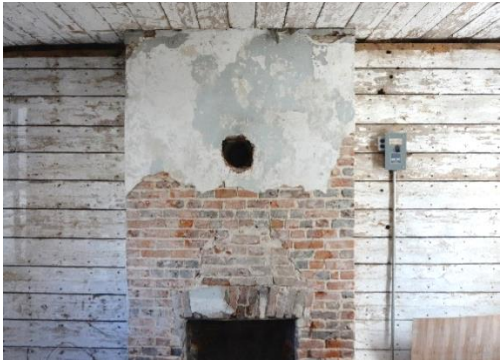
<p>Circular flue opening in brick chimney dates to building's use as an office.</p> <p>As the county stated its goal to use the building's original use as a Debtors Prison for future interpretation, provide masonry infill at flue opening to match adjacent existing.</p>	2 SF

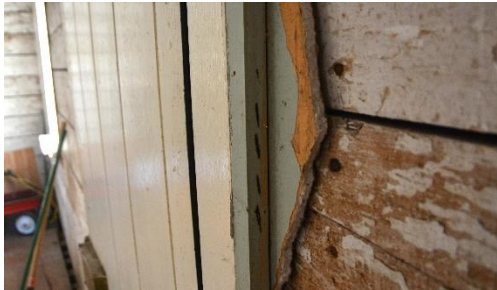
DP. WA.3

<p>Remnants of applied modern drywall finish are extant in several locations.</p> <p>Remove drywall and surface applied trims. Install new painted flat board wood trim to cover joints.</p>	1 door and 3 windows
DP. WA.4

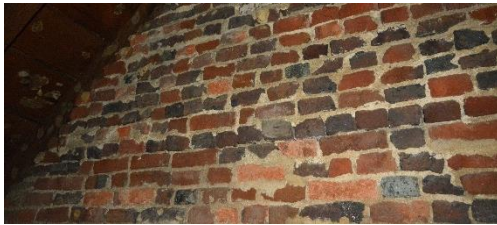
<p>Brick masonry gable end walls exhibit mortar deterioration and open joints in attic.</p> <p>Repoint 100% of interior joints to stabilize end walls.</p>	125 SF
DP. WA.5

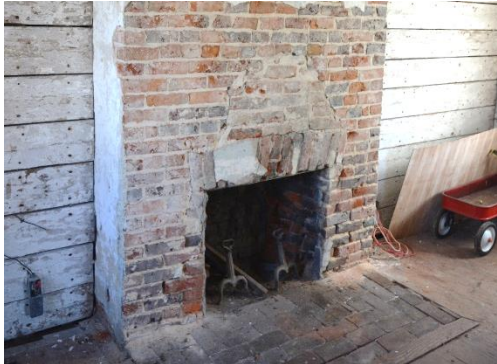
<p>Painted plaster finish on brick chimney is partially intact. It is unknown when chimney was first plastered.</p> <p>Sound existing plaster to confirm stability. Patch and repair damaged areas in concert with masonry work. Paint with breathable paint.</p>	60 SF of painting / 40 SF of repairs

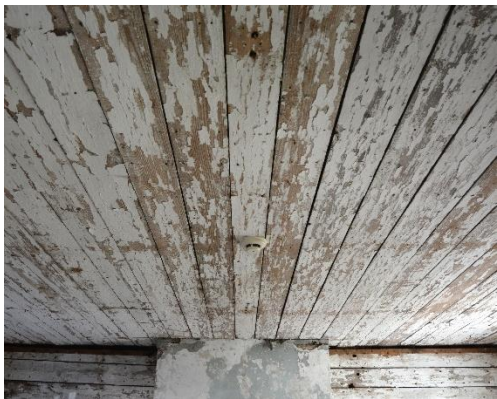
CODE	PHOTOGRAPH	CONDITION/REPAIR	QUANTITY
DP. CL.1

<p>Painted finish on ceiling is deteriorated throughout the space.</p> <p>Scrape loose finish from surface of wood planks. Repair damaged areas and modern alterations. Apply whitewash on surface of wood planks to achieve a consistent surface on all planks.</p>	250 SF of painting / 3 SF of repairs

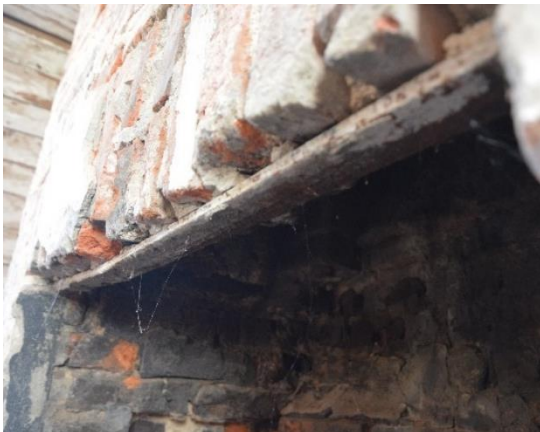
CODE	PHOTOGRAPH	CONDITION/REPAIR	QUANTITY
DP. OI.1

<p>Lintel at fireplace opening exhibits corrosion and adjacent chimney masonry has open mortar joints and a failed arch.</p> <p>Remove paint and corrosion. Dismantle and rebuild brick arch. Repoint 100% of chimney mortar joints. Protect existing plaster. Paint lintel.</p>	3 LF of lintel / 10 SF of reconstruction / 60 SF of repointing

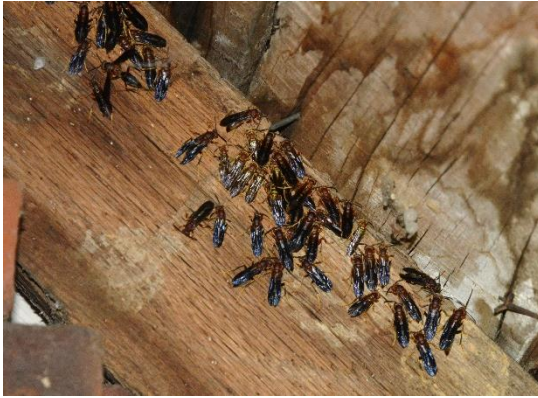
DP.  
OI.2

Insect infestation is present in the attic. The infestation appears to consist of winged carpenter ants.

Hire exterminator to confirm insect type and remove infestation. Seal any openings in concert with roofing and masonry repairs.

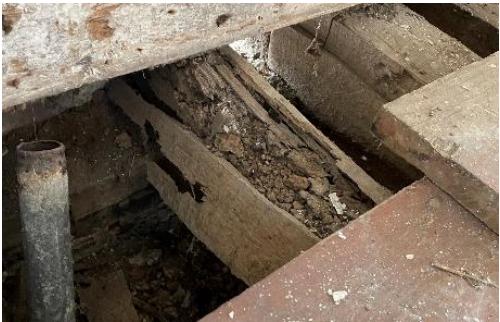
CODE	PHOTOGRAPH	CONDITION/REPAIR	QUANTITY
DP. S.1

<p>Floor joist at front entry wall is rotted and termite damaged.</p> <p>Additional joist sistering is likely needed. Remove and replace floor sheathing boards as needed. Provide waterproofing to prevent additional future damage.</p>	Provide (4) additional joists.
DP. S.2

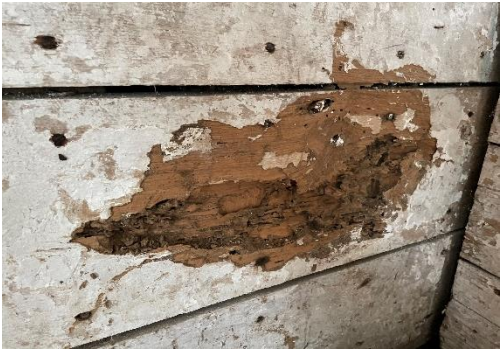
- Severe termite damage was observed at the left rear interior wall panel of the building.

<p>Wall sheathing board displays termite damage.</p> <p>Inspect building routinely for termites and carpenter ants. Remove and replace damaged board.</p>	5 LF
DP. S.3

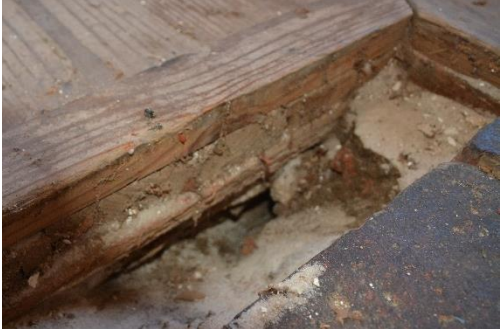
- A rotted floor joist was observed at the edge of the brick fireplace hearth. It appears that water has penetrated down through the chimney and seeped into the slope via the sloped brick hearth.

<p>Wood floor joist at front edge of fireplace hearth is rotted.</p> <p>Provide new full-length joist to supplement rotted joist.</p>	1 location
DP. S.4

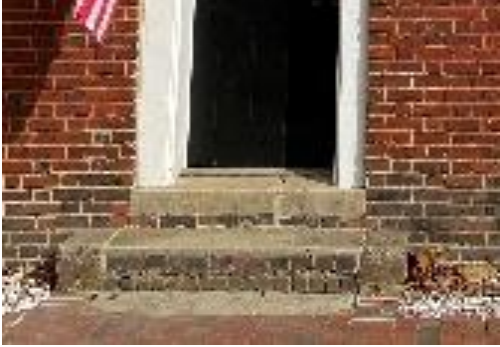
<p>Concrete and brick sill and stair at entry are cracked.</p> <p>The sill and stair non-original and should be removed. Provide new sill and stair that are appropriate in design and materials.</p>	1 sill and stair

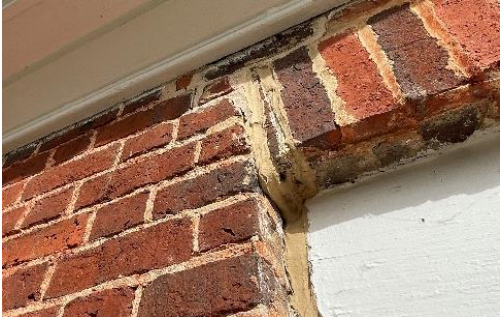
DP. S.5

<p>Flat brick arch at south elevation window does not appear to have adequate bearing at its left edge.</p> <p>Provide additional header brick. Tooth new brick into the wall to form an appropriate arch.</p>	Add (1) new header brick
DP. S.6

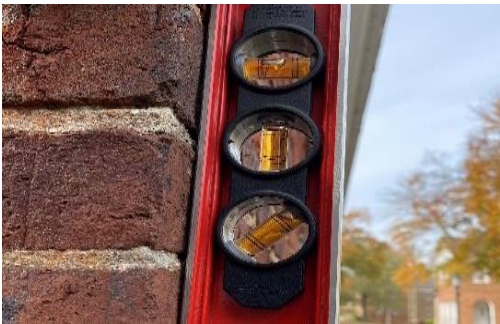
<p>The left rear corner of the wall is out of plumb in other directions.</p> <p>Additional study is needed to confirm if any remedial foundation work is needed. Extent of brick repairs to be determined.</p>	TBD
DP. S.7

An additional soil investigation study is needed in order to determine the possible cause of the soil settlement that was observed at the left rear corner of the building. It is possible that some regrading of the soil at this corner of the building may be necessary to ensure that surface water is directed away from the base of the building.

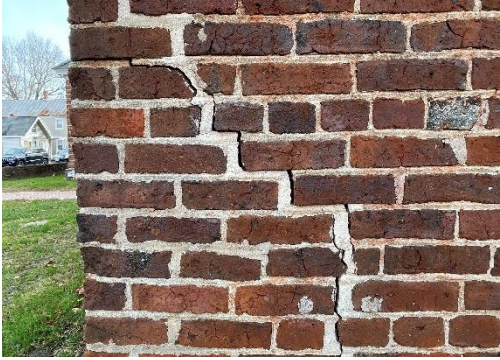
<p>A large stepped diagonal crack has been repaired and has subsequently reopened at the rear left corner. This condition is possibly related to foundation settlement.</p> <p>Additional study is needed. Extent of brick repairs to be determined.</p>	TBD
DP. S.8

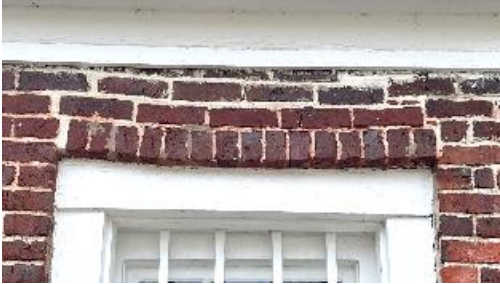
- Sagging was observed in the flat brick arch above the window in the rear wall. No bearing of the arch is present at this location and the mortar joint at the left side of the opening is excessively wide.

<p>The flat arch at the rear of the building appears to have inadequate bending at its ends and has sagged.</p> <p>Rebuild the arch in-kind with an additional header course at each end.</p>	4 LF

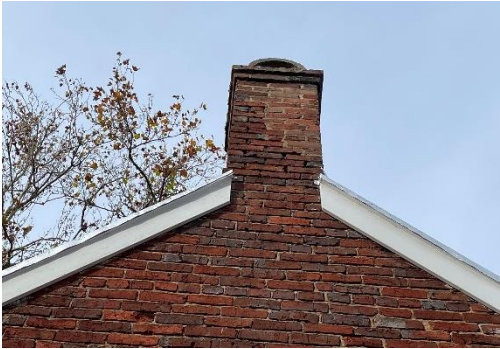
DP. S.9

Open mortar joints at top of chimney are appearing to allow surface water to penetrate down to the hearth below.	10SF of brick repointing
DP. S.10

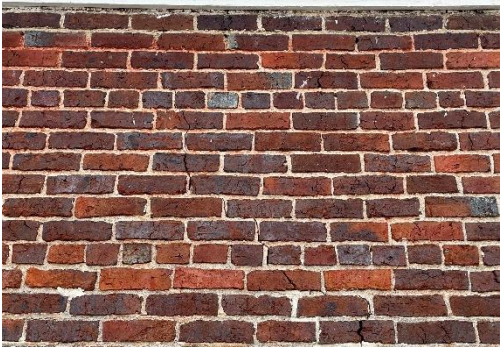
Brick cracks and open mortar joints are prevalent at each façade of the building. A general repointing using a lime-based repair mortar is needed. Additional repointing is needed at the entire fireplace above the opening.	110SF

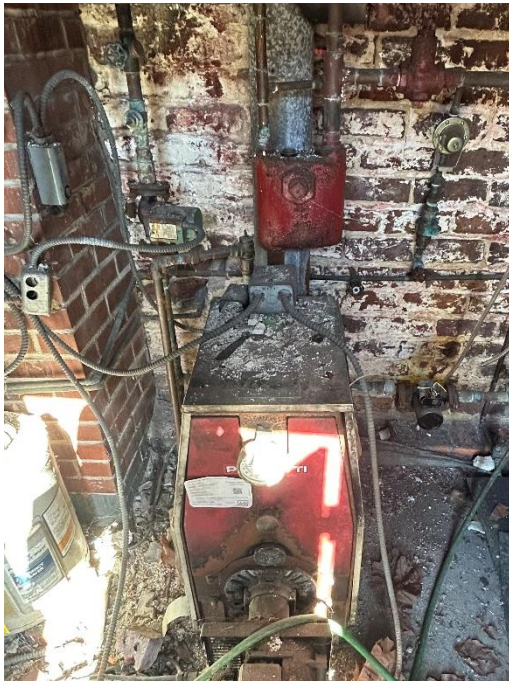
The Old Jail has an oil-fired heating boiler system that did not appear active at the time of the site survey. The boiler is connected to a single supply/return piping distribution to circulate hot water to floor pedestal radiators located in each room. The two rooms located on the first floor have window-packaged terminal air conditioning units.

*Inactive boiler system.*

- The HVAC systems appear to not be operational. For any renovation project, the hot water boiler should be replaced and a new central HVAC system should be considered.

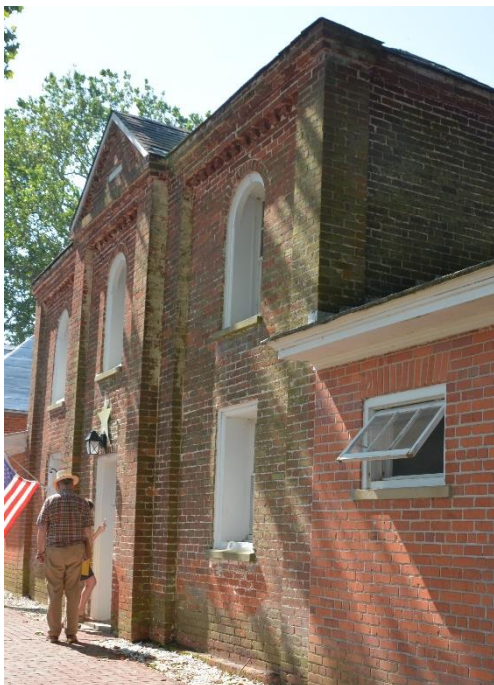
CODE	PHOTOGRAPH	CONDITION/REPAIR	QUANTITY
OJ. G.1

<p>Asbestos-containing materials in the floor were removed in 2021. No other hazardous materials testing appears to have been completed, such as for lead-based paint. No such analysis was performed as a part of this project.</p> <p>Perform hazardous material survey to determine if lead-based paint or other hazardous materials are present at the building. Survey should be completed before repairs are undertaken to allow for abatement of any hazardous materials in concert with associated work.</p>	Full building (interior and exterior)

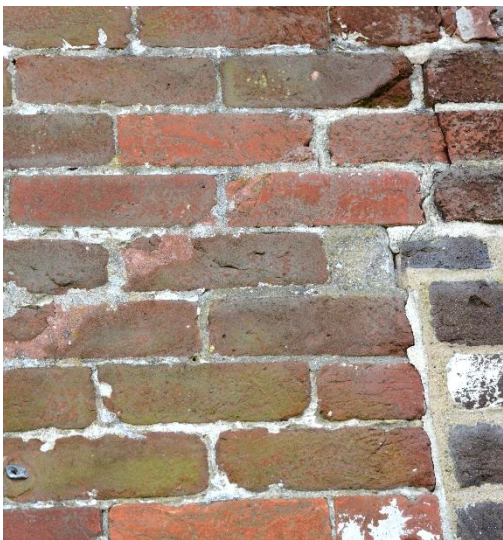
CODE	PHOTOGRAPH	CONDITION/REPAIR	QUANTITY
OJ. MB.1

<p>Open mortar joints and mortar deterioration occur on all elevations, primarily along the base of the walls and extending from the upper corners of openings.</p> <p>Due to the number of cracked bricks and open joints, 100% repoint should be pursued in concert with other repairs. Repoint open brick masonry joints with appropriate mortar mixture. using techniques to match original mortar joints.</p>	2,000 SF
OJ. MB.2

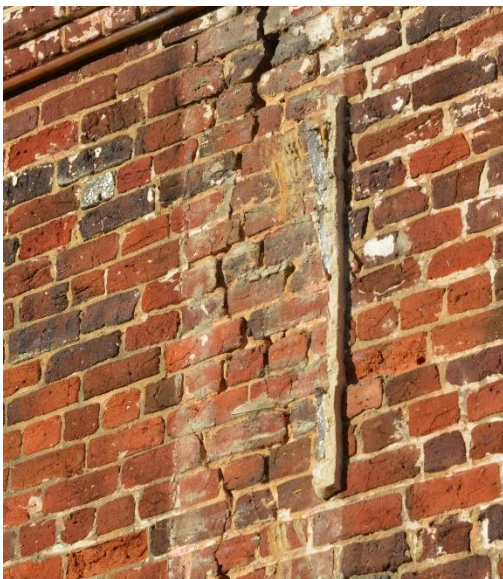
- There are vertical cracks evident in the rear wall of the building where the rear chimney was removed in order to accommodate the rear single-story addition.

<p>A vertical crack of significant size has developed on the rear elevation at the location of the removed chimney. This location will allow significant water infiltration.</p> <p>Determine potential for completing work in concert with other identified masonry repairs. If other masonry work will happen in the mid- or long-term, provide temporary and reversible masonry repair to cover or fill existing location. Refer to structural.</p>	12 LF

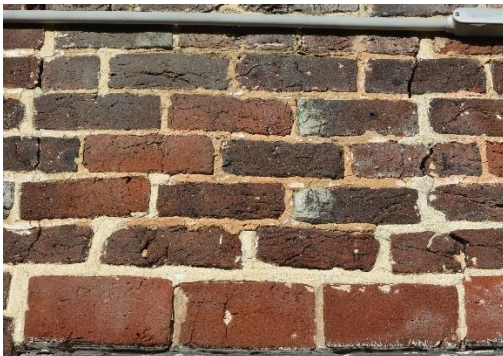
OJ. MB.3

<p>Brick masonry units are cracked or spalled in several locations. This issue occurs with greatest frequency along the base of the walls.</p> <p>Remove cracked or spalled brick unit. Provide matching brick unit and install in concert with wall repointing.</p>	175 brick units

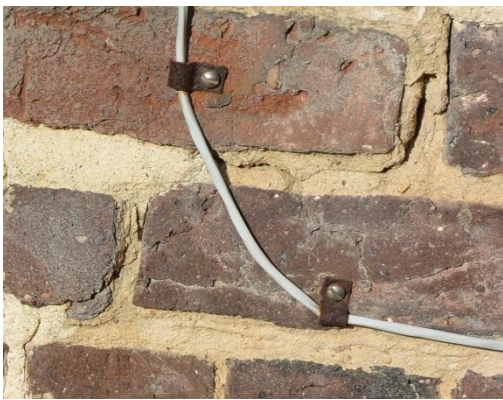
OJ. MB.4

<p>Fasteners are installed into the face of brick for various purposes.</p> <p>Remove all fasteners. Dispose of abandoned elements and remount all active items with appropriate fasteners into the mortar joint. Patch brick with color-matched grout of appropriate mix.</p>	25 locations
OJ. MB.5

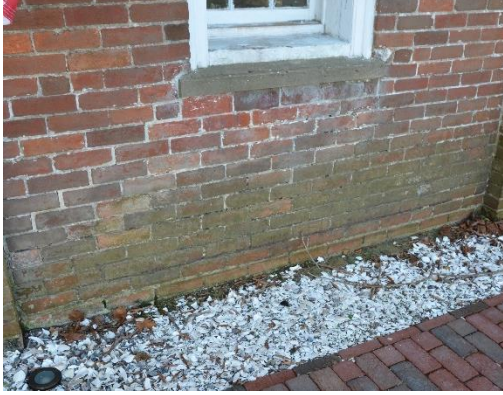
<p>Biological growth is occurring at localized areas of the exterior masonry, typically along the base of the building, and causing staining on the exterior facade.</p> <p>Remove biological growth and staining with architectural antimicrobial biocide. Use gentlest means possible.</p>	200 SF
OJ. MB.6

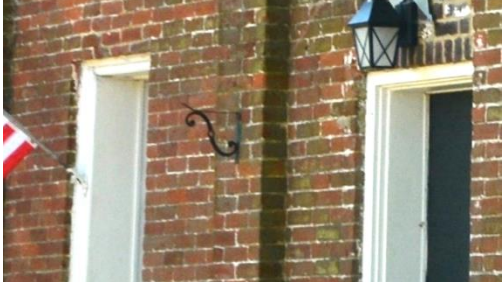
<p>Sign holder is mounted to face of brick pilaster adjacent to entrance.</p> <p>Remove sign and patch and repair brick masonry wall surface with color-matched grout.</p>	1 location
OJ. MB.7

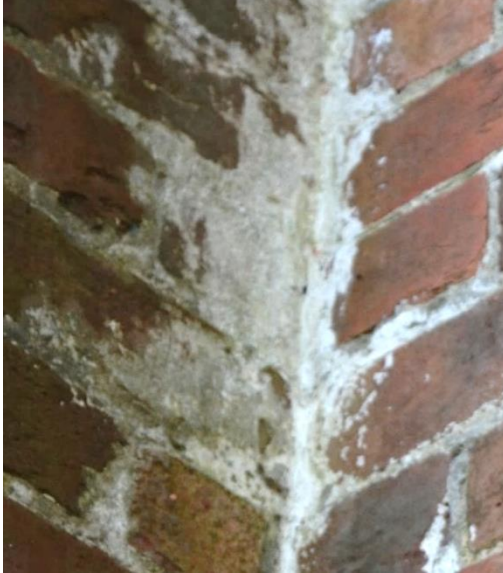
<p>Remnants of paint are present on historic masonry surfaces. Existing exposed brick appearance likely dates to 1950s.</p> <p>Review impact of restoration of the original whitewashed appearance for the two-story portion utilizing breathable paint coatings. If existing brick appearance is to be maintained, remove paint remnants from brick surfaces using the gentlest effective method.</p>	All elevations of historic building

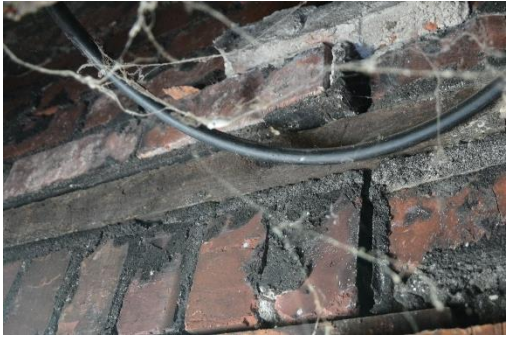
OJ. MB.8

<p>Rear addition wall masonry has displaced at the line of the door head.</p> <p>Shore roof and dismantle upper wall. Perform any remedial repairs. Reconstruct upper wall with salvaged brick.</p>
-------------	---	---

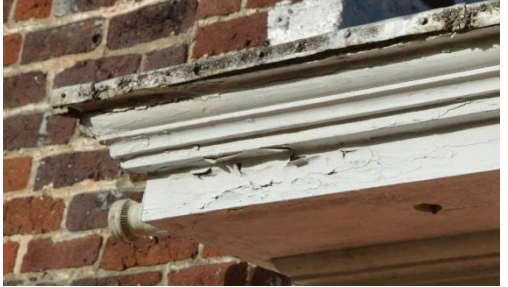
<p>Existing wood cornice and eaves display paint deterioration and localized rot.</p> <p>Strip existing paint. Prepare surface and repaint 100% of wood finishes. Repair/replace deteriorated wood elements.</p>	<p>20 LF of repairs / 120 LF of painting</p>

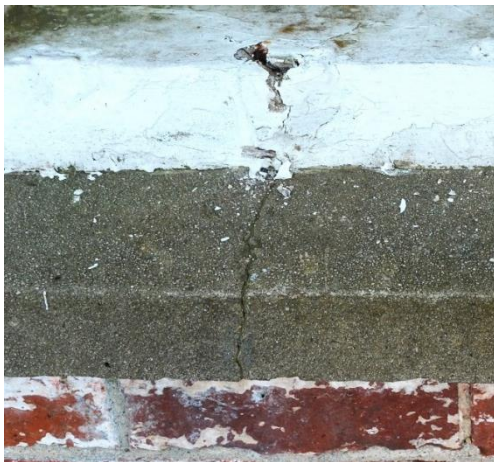
<p>Cast stone sills display cracking and deterioration.</p> <p>In concert with window restoration, consider replacement of existing sills, including upper painted sills and embedded iron bars. If desire is to repair sills, provide injection grout to match color at all cracks. Replace with color-matched precast concrete where required.</p>	Crack repair at 8 locations

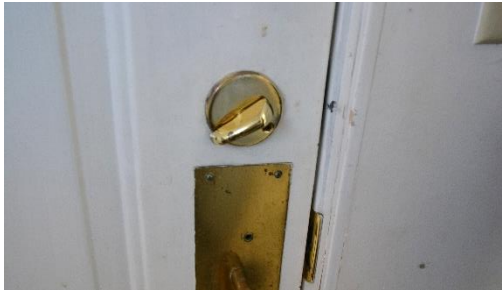
OJ. D.4

Existing thumbturn deadbolt lock allows for operation by members of the public.  Consider replacing deadbolt lock with two-sided key-operated deadbolt lock to prevent improper use.	2 locations
------------	---	--	-------------

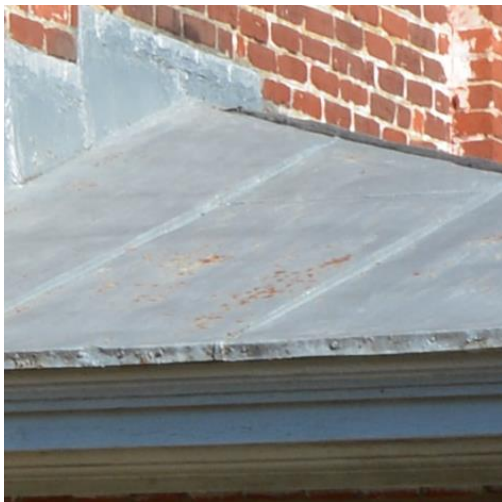
The metal roof on the side additions displays surface corrosion where paint coating has begun to fail.  Assess metal roof to determine full extent of corrosion. If repairable, remove corrosion from face of shingles. Prepare and paint surface of roof to match original design. Remove and replace sealant at face of wall. Replace roof in-kind if not repairable.	30 SF of corrosion removal / 250 SF of painting
OJ. R.2

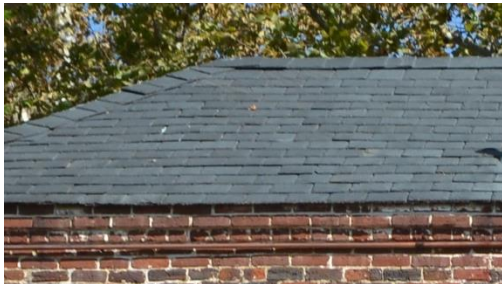
The slate roof could not be fully assessed during the site visit. Limited instances of minor displacement are visible.  Perform lift survey of historic roof. Remove broken slate tiles, and patch as needed.	1 day lift survey / 20 shingles

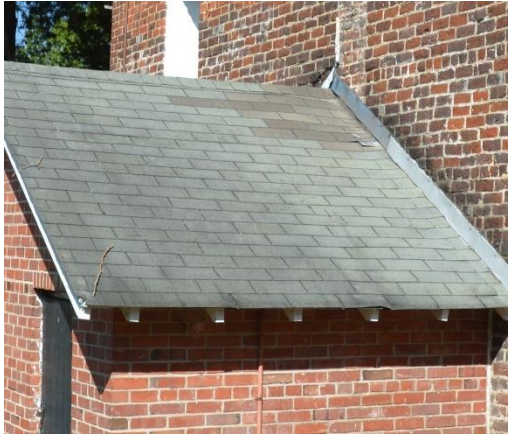
OJ. R.3

<p>Asphalt roofing on rear addition shows age. Sealant at roof flashing is aged and appears to be failing in several locations.</p> <p>Confirm date of installation and plan for replacement within manufacturer's recommendation. Replace flashing and sealant in concert with roofing replacement.</p>	100 SF of roofing / 20 LF of flashing
OJ. R.4

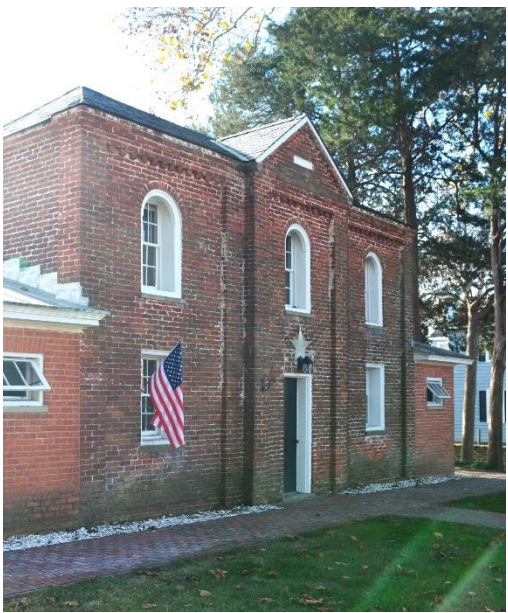
<p>Existing roof does not have method to control storm runoff.</p> <p>As a part of a larger renovation, consider installing gutters, downspouts, and below-grade storm sewer leaders that connect to the public system. The original building did not have gutters and their installation would impact the visual appearance of the building, however controlling stormwater may also help mitigate ongoing maintenance items.</p>	N/A

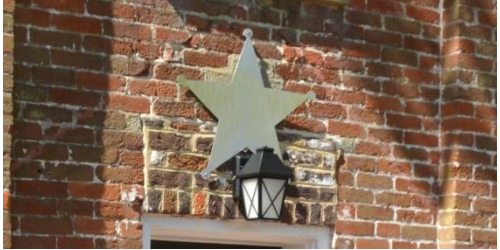
<p>Non-historic star was installed during building's use as a sheriff's office.</p> <p>Remove star and associated mounting hardware. Patch masonry wall as required.</p>	1 location

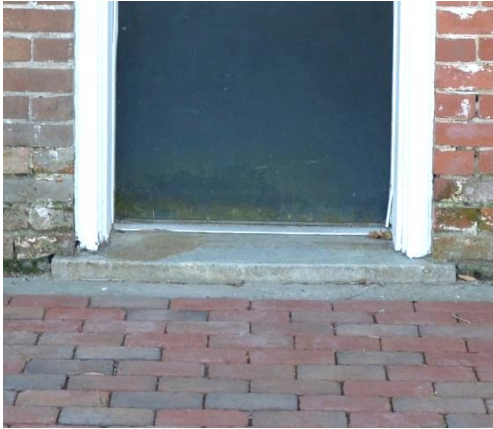
OJ. O.2

The building entrance does not comply with accessibility standards due to height of level change.	N/A
OJ. O.3	 	Historic building sign has been painted over and no longer indicates original building name.  Consider restoring building sign to match that shown in historic photographs.	1 location, approx. 30" w x 6" t
OJ. O.4

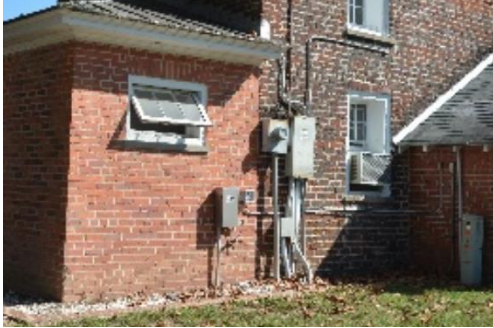
Mechanical units and utilities are visible at rear of building from perimeter of Court Circle.  Consider vegetative or fencing screening options if exterior units and connections are expected to remain in their current location.	1 location
OJ. O.5	 	Electrical conduit is routed on the face of the building.  As a part of larger renovation, consider rerouting all services into building and then to desired location to avoid visible conduit.	4 instances

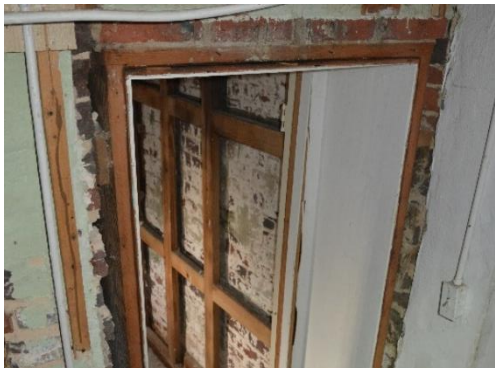
Existing finishes at floors, walls, doors and ceilings are incomplete and/or utilitarian.  Review long-term programming goal and use for the building. Determine if building is intended to be opened to public and the appropriate level of finish.	N/A
OJ. GI.2

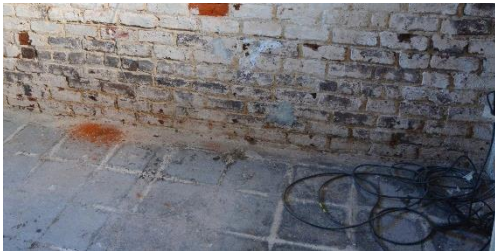
Interior is generally soiled and various defunct systems remain the building.  Fully clean interior and remove all inactive systems and defunct elements.	100% of interior

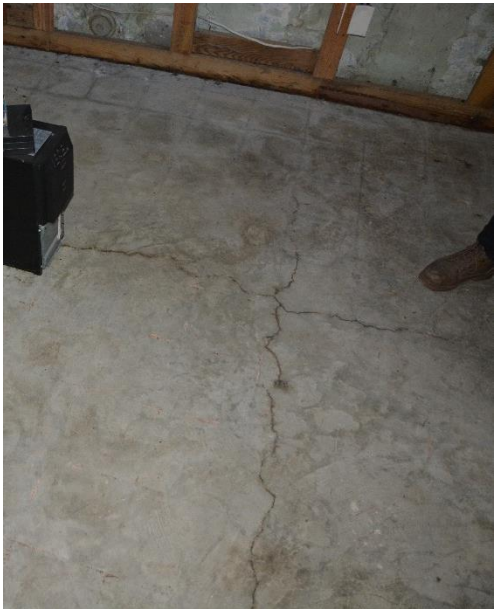
First floor concrete slabs-on-grade in both east and west rooms have settled. In addition, cracking of the slabs is evident. Current slope is not conducive to active use.  Monitor floor slabs to determine if settlement is active. If building is intended for public access or settlement is active, consider performing test pit at southwest corner of one of the first-floor rooms to determine substrate conditions. Remove and replace concrete slab-on-grade.	1 test pit / 300 SF

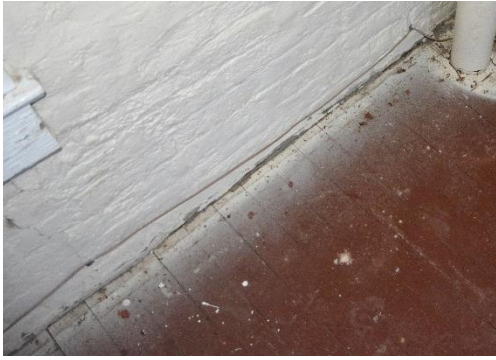
OJ. F.2

<p>Painted tongue-and-groove wood flooring has areas of overpaint from previous application on adjacent wall.</p> <p>In concert with long-term goals for building, prepare surface of flooring and repaint 100% of flooring at stair and second floor.</p>	400 SF
OJ. F.3

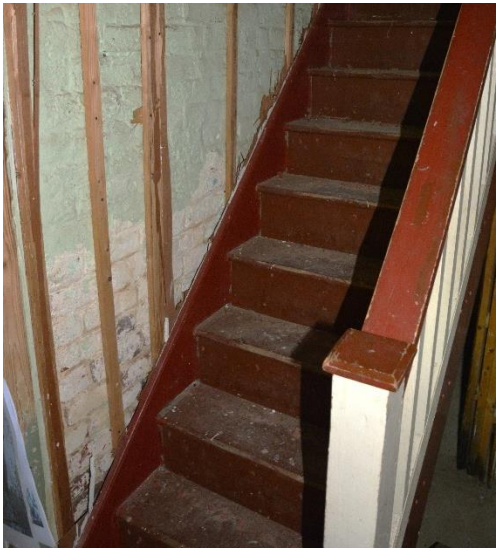
<p>Existing stair treads are 8 1/2" deep and do not comply with current building codes. The stair is tightly bound on sides, but could be extended at the upper landing, which would in turn make the understair room non-occupiable.</p> <p>In concert with the long-term goals for the building, review existing stair with code official and determine extent of changes to make stair to upper level code compliant.</p>	N/A
OJ. F.4

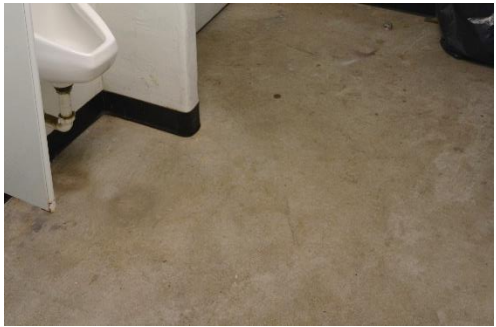
<p>Concrete floor is unfinished and presents an unattractive appearance.</p> <p>Consider applying durable, waterproof coating on concrete floor, such as epoxy resin flooring. Provide new rubber base in concert with refinishing.</p>	250 SF

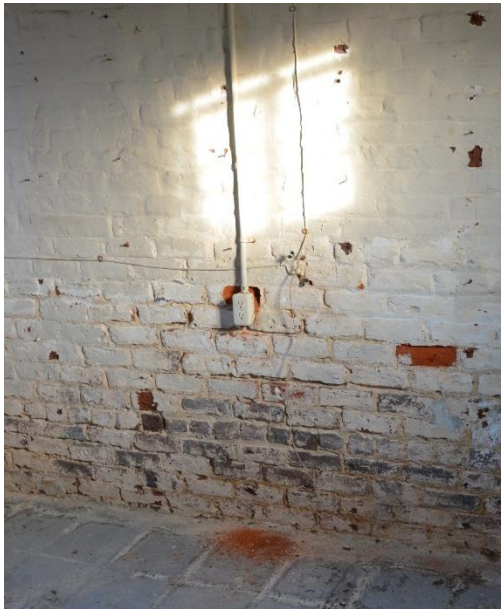
<p>Painted finish and plaster substrate display deterioration and across base of all ground floor walls. This issue stems from routine paint failure paired with rising damp in masonry walls.</p> <p>Strip paint from face of all interior masonry. Perform masonry repairs noted elsewhere. Monitor moisture content. Allow wall to dry prior to application of finishes. Prepare surface and paint 100% of wall surfaces with breathable paint.</p>	2700 SF painting
OJ. WA.2	 	<p>The brick walls have spalled units in various locations, typically on the ground floor.</p> <p>Remove damaged brick units. Provide matching unit and repoint areas. Consider salvaging masonry from attic.</p>	40 units
OJ. WA.3

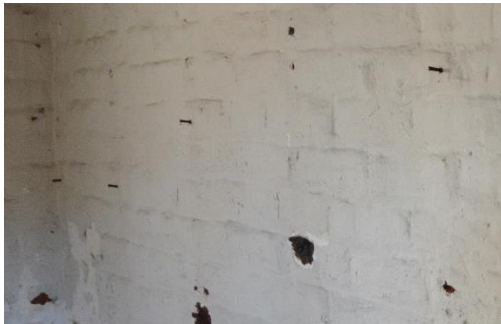
<p>Fasteners embedded into the face of brick were used to install wood furring for since-removed finishes.</p> <p>Remove all fasteners. Patch brick with grout of appropriate mix or repoint wall in concert with other repairs.</p>	300 instances

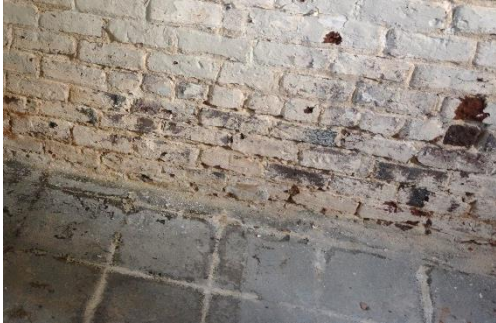
OJ. WA.4

<p>Ground floor walls exhibit mortar deterioration as a result of rising damp.</p> <p>In concert with other repairs, repoint 100% of masonry joints in lower ground floor walls with appropriate mortar mixture.</p>	250 SF
OJ. WA.5

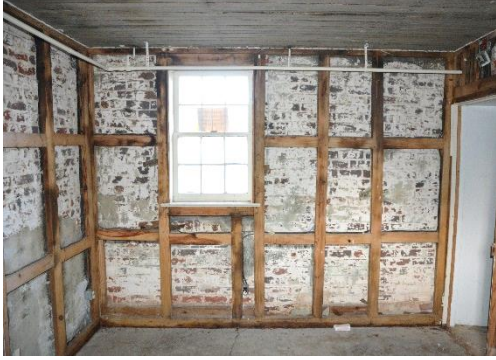
<p>Wood furring remains in several locations on interior of building.</p> <p>In concert with long-term goals for the building, remove all wood furring to full expose original brick walls. Perform masonry repairs at removed fastener locations.</p>	3 rooms
OJ. WA.6

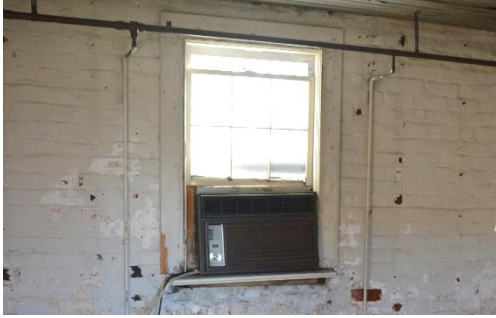
<p>The existing wood wall trim for the first-floor windows is inconsistent and reflects the removal of the wall finishes in much of the building.</p> <p>In concert with long term plans, provide new wall trim on the face of the brick wall.</p>	4 windows
OJ. WA.7

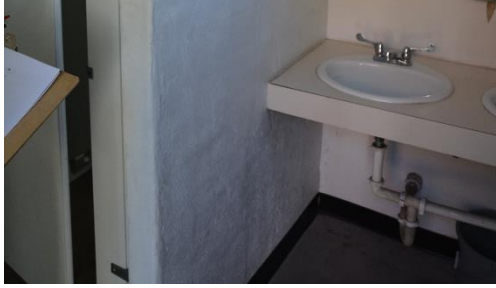
<p>Wing walls in restrooms appear to have several layers of coatings and present an uneven and unattractive appearance.</p> <p>Remove existing plaster finish. Provide new painted wallboard.</p>	100 SF

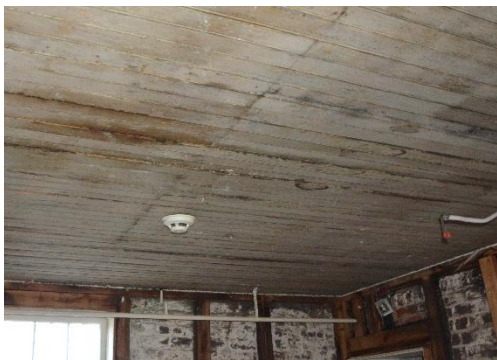
<p>Painted finish on wood beadboard ceiling is deteriorated with localized damage to substrate in various locations.</p> <p>Prepare surface and provide repairs for various damaged areas. Paint wood ceilings 100%.</p>	325 SF
OJ. CL.2
