# FY27 CIP SUBMISSION

# CONDITION ASSESSMENT REPORT

GLOUCESTER COURT CIRCLE PROPERTIES &  
MUSEUM OF HISTORY  
GLOUCESTER COUNTY, VIRGINIA

*95% DRAFT SUBMISSION*

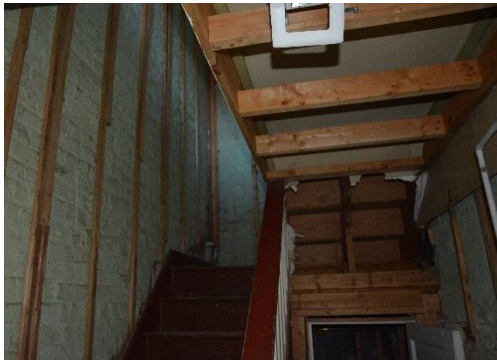
<p>First-floor stair hall and closet do not currently have a ceiling finish and the modern framing is visible overhead.</p> <p>If building is intended to be accessed by the public or serve an official county function, provide painted wallboard on existing framing.</p>	80 SF
OJ. CL.3

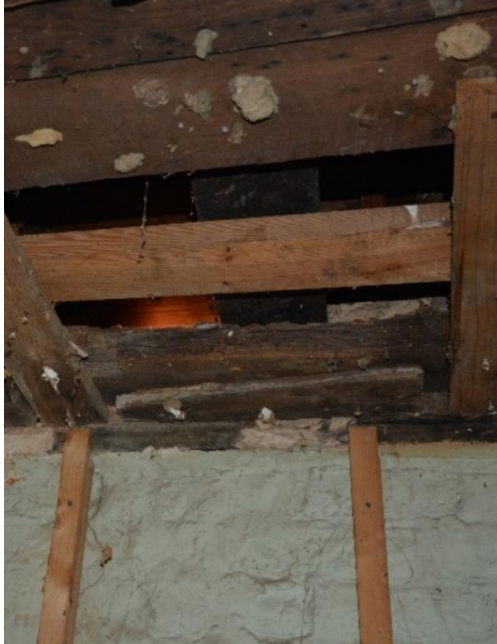
<p>An opening in the ceiling at the intermediate landing along the south wall of the building exhibits deterioration of ceiling timbers. The full extent of damage could not be confirmed during the limited assessment.</p> <p>Complete attic survey to assess roof structure and ceiling timbers. Remove deteriorated areas of timbers and provide replacement or sistered members. Provide removable hatch to facilitate future attic access and fill remaining opening with 3" thick oak timbers to match existing.</p>	20 SF ceiling repairs / 50 LF of roof member repairs

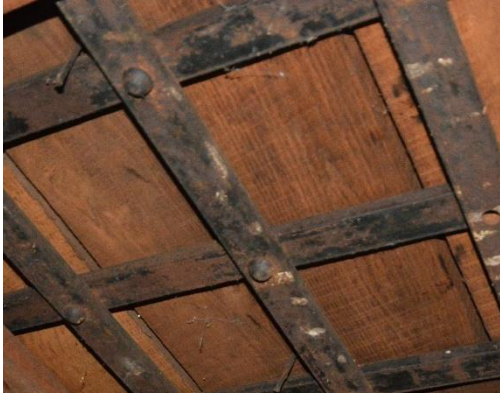
OJ. CL.4

<p>Minor surface corrosion is present on the iron bars at the second-floor east room ceiling.</p> <p>Maintain iron bars. Remove surface corrosion and paint remnants from bars. Prepare and paint 100% of iron bars. If building is intended to be accessed by the public, provide interpretive panel on iron bars.</p>	150 SF / 1 interpretive panel
OJ. CL.5

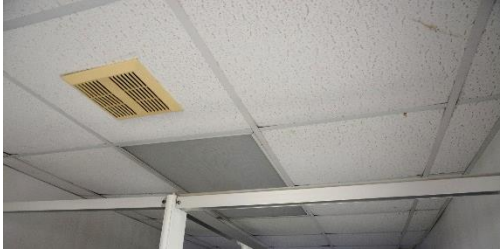
<p>Existing suspended acoustical ceiling exhibits sagging and areas of damage and staining.</p> <p>Replace 100% of acoustical ceiling tile. Paint existing-to-remain track.</p>	250 SF

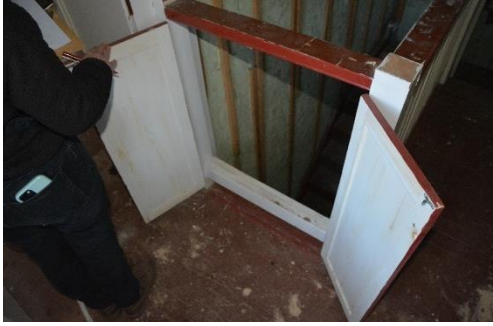
OJ.  
OI.4

Stair railing has an operable panel that allows for a baluster free opening. This location does not meet code and appears to offer only marginal value.

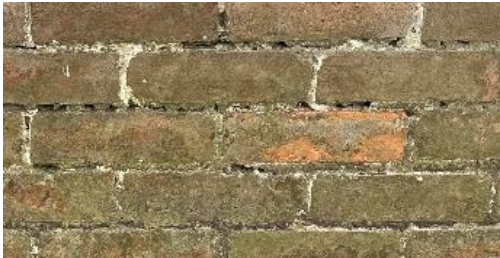
<p>Surface water appears to be wicking up into the wall and is damaging mortar joints.</p> <p>Repointing brick masonry with appropriate mortar. Refer to Architectural for further work.</p>	100 SF
OJ. S.2

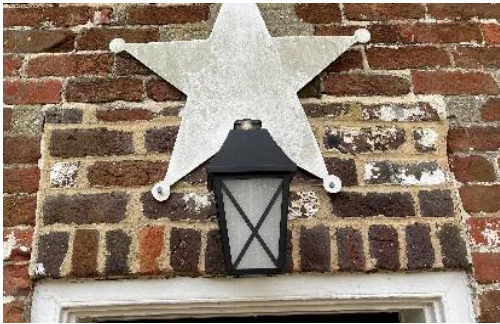
- Vertical cracks occur at the ends of the flat arch at the sides of the entry door. Very little bearing length is present at the ends of the arch. The brick above the arch is not toothed into the adjacent brick at the sides of the opening.

<p>The flat brick arch at the front door is poorly supported and the masonry above is not properly toothed into the adjacent brick.</p> <p>A properly constructed flat arch should be cut into the brick above the door opening.</p>	5 SF of brick reconstruction
OJ. S.3

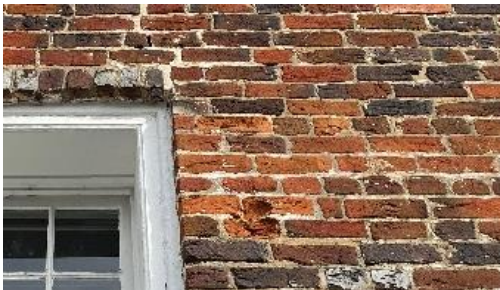
<p>Cracked and spalled brick is present at the side and above the window opening.</p> <p>Spalled bricks need to be cut out and replaced. Repointing with a lime-based mortar is needed.</p>	(2) brick replacement and 10 LF of repointing
OJ. S.4

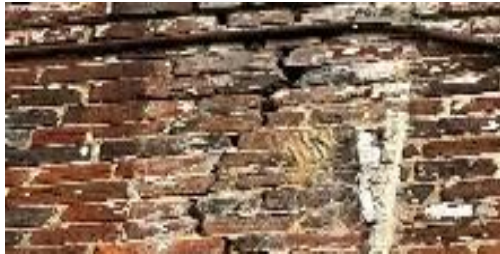
- There are vertical cracks evident in the rear wall of the building where the rear chimney was removed in order to accommodate the rear single-story addition.

<p>A large vertical crack is evident with some loose bricks at the top of the wall.</p> <p>Provide a helical stitch rod repair. Remove and reset brick units.</p>	10 helical stitch rods and 5 LF of brick to removed and reset.

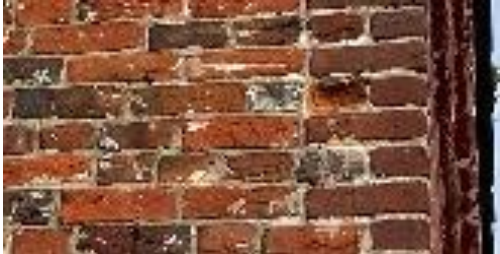
OJ. S.5

<p>At the right rear wall there is one spalled brick and several vertical brick cracks.</p> <p>Remove and replace spalled brick. Repoint all brick cracks with appropriate mortar.</p>	(1) brick replacement and 10 LF of repointing

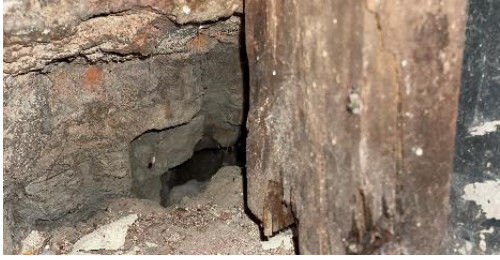
OJ. S.6

<p>There is a hole at the base of the brick masonry wall at the interior stair landing.</p> <p>Fill opening in masonry wall solid with historic brick.</p>	2 SF of brick restoration work
OJ. S.7

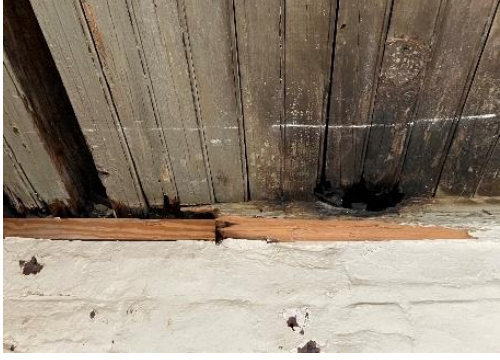
<p>Water damaged and rotted ceiling boards indicate previous water penetration into the interior of the building.</p> <p>Further study is needed to confirm is the source of the water has been properly mitigated.</p>	TBD
OJ. S.8

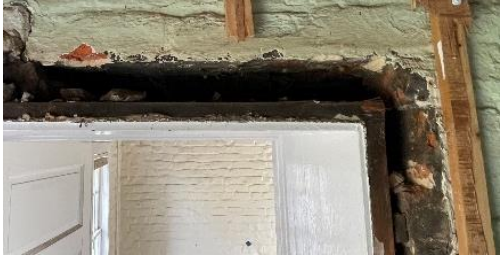
<p>Gaps are present at the top of the interior wood lintels present at the two doorways.</p> <p>Reconstruct displaced masonry is needed.</p>	10 SF of brick reconstruction
OJ. S.9

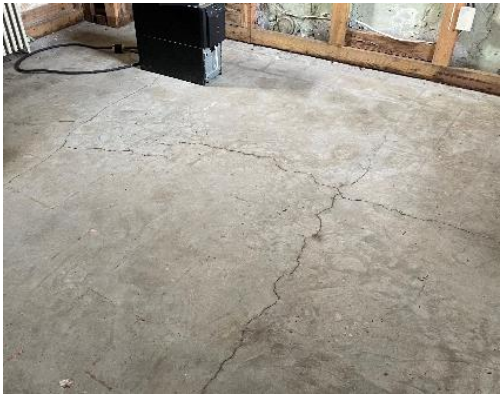
<p>There is a significant amount of slope on the second floor and evidence of cracking in the floor finishes.</p> <p>Remove area of first-floor ceiling finish to expose the existing second floor construction for analysis. Determine extent of repairs required.</p>	5 SF of ceiling removal

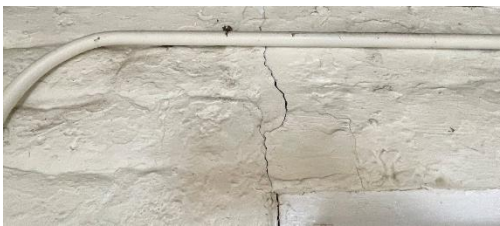
OJ. S.10

<p>There is a vertical crack at the corner of an interior wall opening.</p> <p>Repoint open joint with appropriate mortar.</p>	1 LF

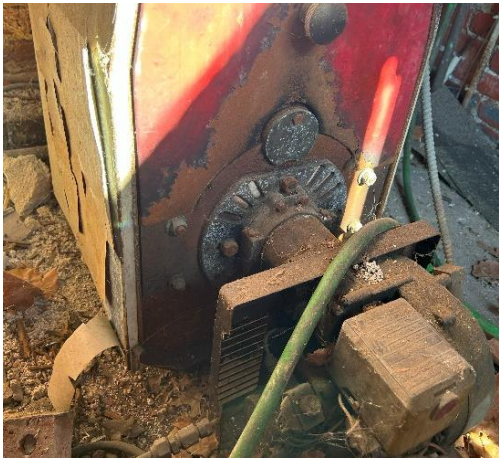
- The HVAC systems appear to not be operational. For any renovation project, the hot water boiler should be replaced and a new central HVAC system should be considered.

<p>The existing hot water boiler appears to be past its ASHRAE life expectancy and not in an operational condition.</p> <p>Replace non-functional HVAC equipment.</p>	1
OJ. E.1

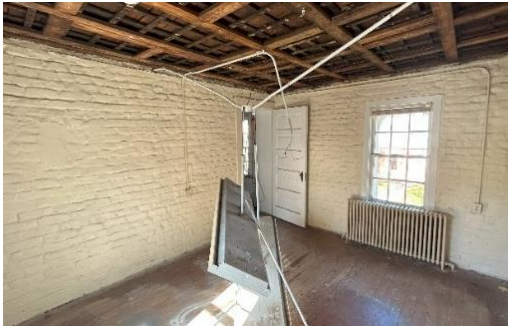
<p>Existing lighting fixtures and lamps are outdated or insufficient.</p> <p>Existing light fixtures should be replaced or relamped with LED fixtures to provide code-required lighting levels and controls.</p>	100%
OJ. E.2

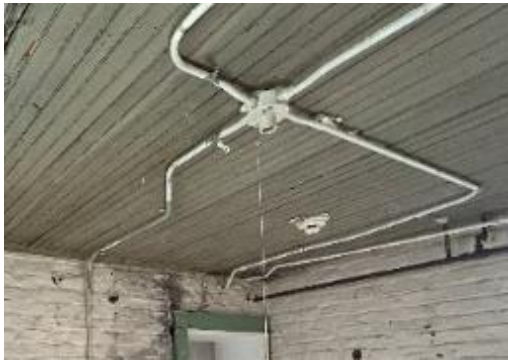
<p>Electrical distribution is deteriorated and surface-mounted in numerous locations.</p> <p>As a part of a future renovation, replace 100% of existing electrical distribution system. Install in concealed location where possible.</p>	100%
OJ. P.1	N/A	<p>Existing plumbing fixtures throughout are aged.</p> <p>During any planned renovation or modernization project, renovate bathroom additions and replace fixtures. Refer to architectural.</p>	3 water closets, 1 urinal, and 4 lavatories total

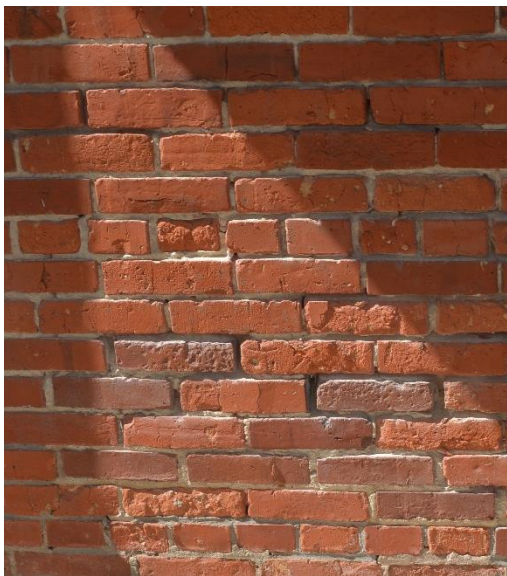
CODE	PHOTOGRAPH	CONDITION/REPAIR	QUANTITY
RB. MB.1

<p>Open mortar joints and mortar deterioration occur on all elevations, primarily along the base of the walls and extending from the upper corners of openings.</p> <p>Due to the number of spalled bricks and open joints paired with the moisture infiltration issues, 100% repoint should be considered. Repoint open brick masonry joints with appropriate mortar mixture using techniques to match original mortar joints.</p>	1,600 SF
RB. MB.2

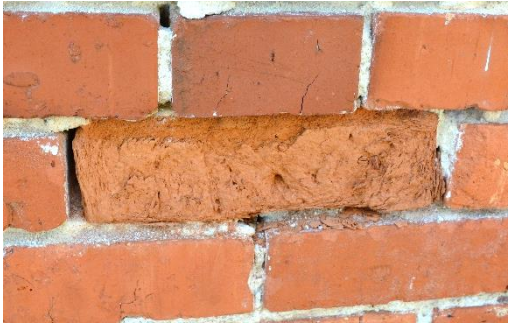
RB. MB.3

<p>Brick masonry units are spalled in several locations. This issue occurs with greatest frequency along the base of the walls.</p> <p>Remove spalled brick unit. Provide matching brick unit and install in concert with wall repointing.</p>	50 brick units
RB. MB.4

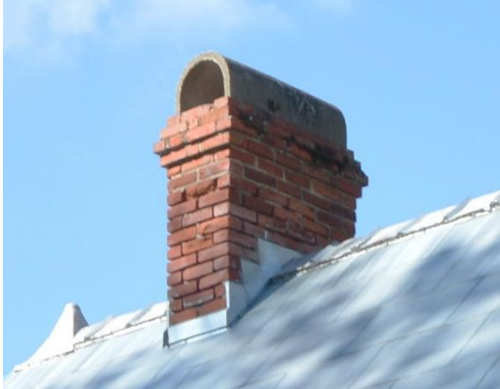
<p>Existing chimney exhibits open joints and spalled units. Concrete chimney cap exhibits cracking.</p> <p>Perform repairs to chimney, including repointing 100% and replacing spalled brick units. Assess chimney cap, flashings, and sealants during repairs; repair/replace as required.</p>	30 SF of repointing / 5 brick units replaced / 15 LF of flashing replacement / 5 SF of concrete patch
RB. MB.5

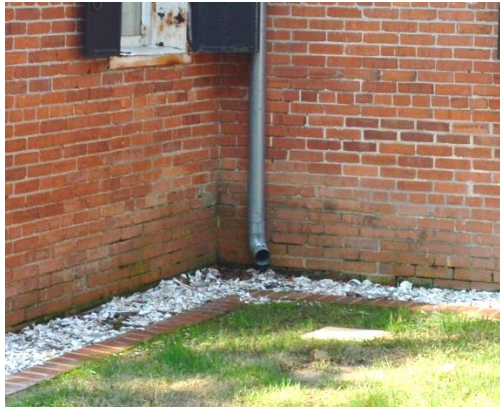
<p>Biological growth is occurring at localized areas of the exterior masonry, typically along the base of the building, and causing staining on the exterior facade.</p> <p>Remove biological growth and staining with architectural anti-microbial biocide. Use gentlest means possible.</p>	400 SF

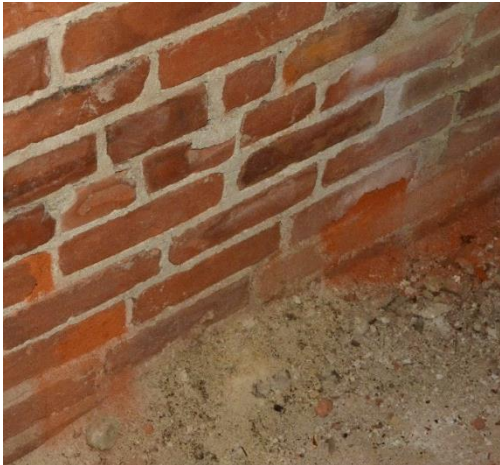
RB. MB.6

<p>Brick units in the attic are displaying evidence of spalling and disaggregation due to moisture infiltration at the chimney above.</p> <p>In concert with chimney repairs, remove spalled bricks. Repoint 100% of chimney in attic and provide new matching units for removed bricks. Determine potential for increased ventilation in attic.</p>	50 SF of repointing / 10 bricks replaced

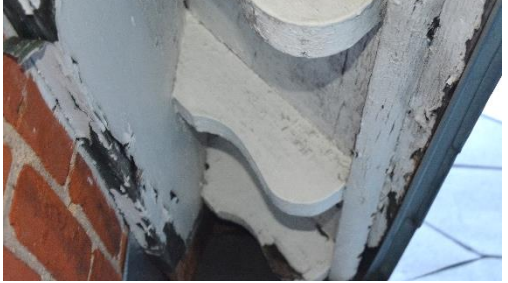
CODE	PHOTOGRAPH	CONDITION/REPAIR	QUANTITY
RB. WD.1

<p>Existing wood eaves display paint deterioration and localized rot.</p> <p>Strip existing paint. Prepare surface and repaint 100% of wood finishes. Repair/replace deteriorated wood elements.</p>	150 LF of cornice / 40 LF of repairs

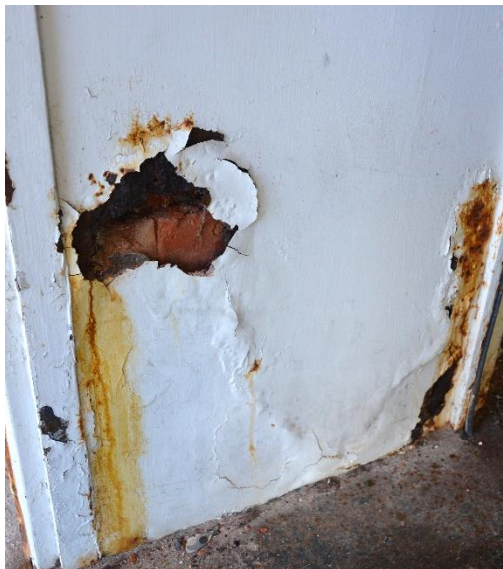
RB.  
D.2

Existing steel frame and shutter display widespread finish and substrate deterioration at various components.

Restore 100% of steel door elements. Remove shutter. Strip paint. Remove corroded areas from sash and frames. Remove perimeter sealant. Provide patch for all surface repairs and dutchman for heavily corroded sections. Paint all sides of frame, sill, sash, and shutter. Reinstall shutter. Provide perimeter sealant.

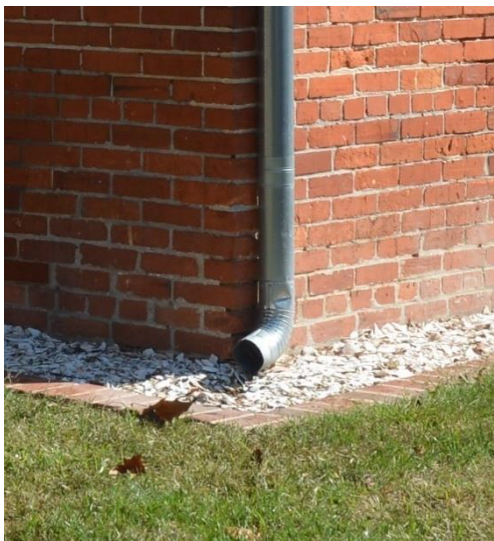
CODE	PHOTOGRAPH	CONDITION/REPAIR	QUANTITY
RB. O.1

<p>Stormwater is transmitted to grade at the base of the building. Given the active water infiltration into the walls and the soil composition, it would be preferable to distribute this moisture away from the building.</p> <p>In concert with recommended analysis of the exterior walls, consider providing storm leaders and below grade piping to transmit water to public storm sewer.</p>	All locations
RB. O.2

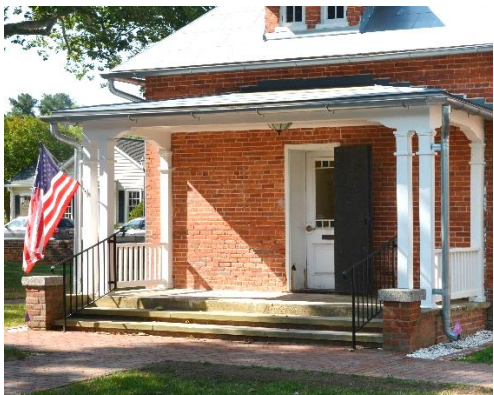
<p>The building entrance does not comply with accessibility standards.</p> <p>Determine the long-term goal for public access to building and impact for providing accessible route to front porch. Accessibility is not likely to be required, but may be desired depending on future use.</p>	N/A

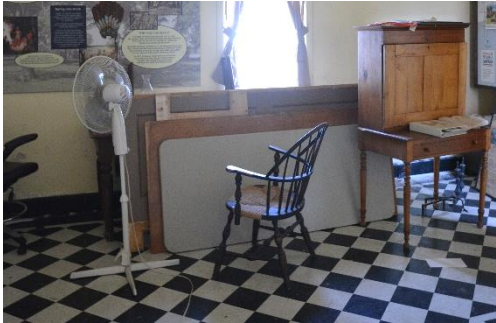
RB. F.3

<p>Southeast room has history of settlement and corresponding repairs.</p> <p>Monitor room over time to determine if settlement of floor is active. Perform investigative test cuts of foundation if settlement persists.</p>	N/A
------------	---	---	-----

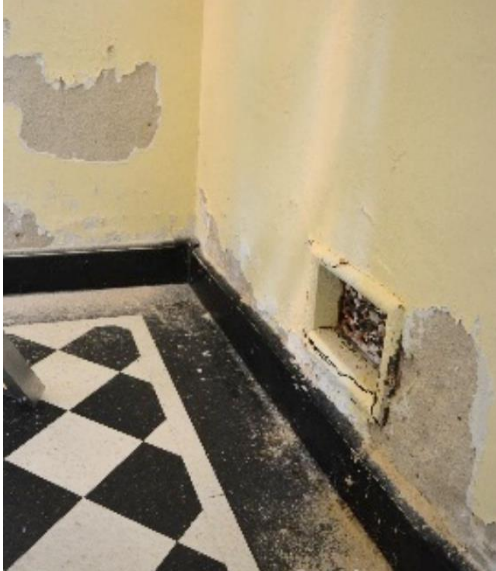
CODE	PHOTOGRAPH	CONDITION/REPAIR	QUANTITY
RB. WA.1

- Interior Wall: There are tide lines of moisture evaporation that correspond with plaster failure at the base of the wall. The evaporation tide line is at a higher elevation than the exterior. The damage is present even on walls with exterior vents.

<p>Painted finish and plaster substrate display deterioration and across base of all walls. This issue stems from rising damp in masonry walls.</p> <p>In concert with investigations of walls noted elsewhere, perform test cut into wall surface to confirm assembly and condition. Complete interior paint analysis if desired. Remove deteriorated plaster surfaces. Prepare surface and repaint 100% of wall surfaces per findings of analysis.</p>	300 SF plaster repairs / 100% painting
RB WA.2

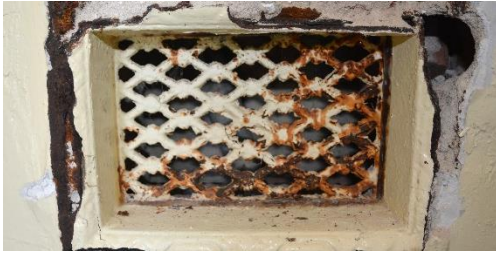
<p>Steel vents are corroded and display paint deterioration.</p> <p>Remove paint from surface of steel vent. Repair areas of corrosion. Prepare and paint surface.</p>	8 locations
RB. WA.3

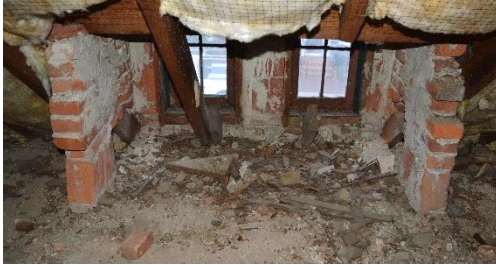
<p>The brick dormer side walls in the attic have displaced masonry and require repointing.</p> <p>Reinstall displaced masonry and repoint 100%.</p>	50 SF of repointing

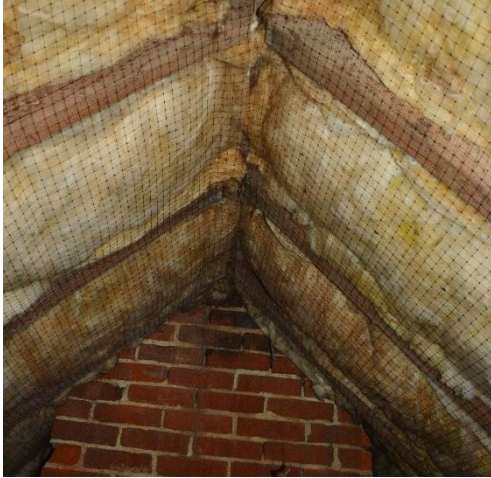
CODE	PHOTOGRAPH	CONDITION/REPAIR	QUANTITY
RB. CL.1

<p>Insulation is mounted within the roof joist pocket in the attic. This arrangement is typically not recommended due to the potential for developing condensation on the surface of the wood members.</p> <p>Monitor wood structure and insulation for areas of moisture. If issue is found, remove insulation and provide new insulation on attic floor.</p>	N/A

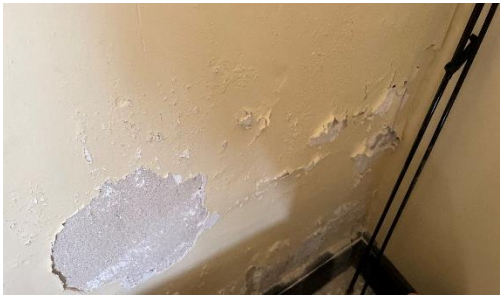
CODE	PHOTOGRAPH	CONDITION/REPAIR	QUANTITY
RB. S.1

A close-up photograph of an interior wall showing significant water damage. The paint is peeling and cracking, revealing a lighter-colored substrate underneath. A black cable or pipe runs vertically along the right side of the damaged area.	Extensive water damage at base of interior partition walls. Refer to Architectural for additional information.  Additional investigation is needed to determine the cause of the water infiltration.	TBD
RB. S.2

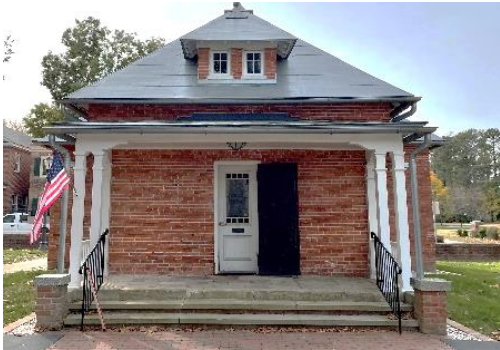
- There are a series of what appear to be settlement related cracking at the front entry porch. Brick cracking, a vertical separation crack, a crack in a stone sill, and a settlement depression on the top of the porch slab were all observed.
- Open mortar joints are present at the around the perimeter of the building at each face of the brick walls as well as at the chimney.
- Spalled brick was observed at the left side of Room 1 and the front face of Room 3.
- A stepped diagonal exterior brick crack was observed at the corner of the front window at Room 3.
- The interior walls at their base, show significant signs of water damage. This appears to have been caused by water wicking up into wall damaging the finishes.
- Corrosion is present at varying degrees where the metal window sill and jamb closures occur at each of the exterior windows locations.

A photograph of the front entrance of a brick building. The porch has a small roof supported by white columns. The brickwork shows signs of cracking and settling. An American flag is visible on the left side of the porch.	Potential settlement related cracking is evident at the front entry porch brick and stone masonry.  The open cracks should be repointed to prevent future water penetration into the joints.	10 LF of repointing

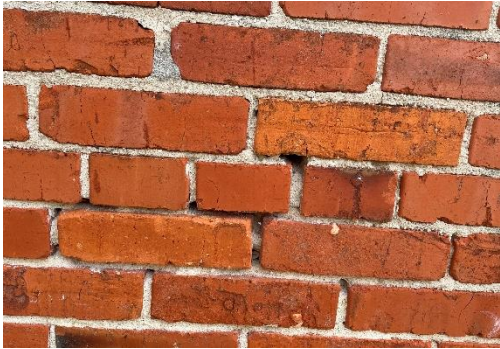
RB. S.3

A close-up photograph of a brick wall. The bricks are reddish-brown, and the mortar joints are visible. There are some signs of wear and potential mortar loss in the joints.	Open mortar joints were observed at exterior wall at the front entry porch.  Full depth repointing is needed at several locations.	5 SF
RB. S.4

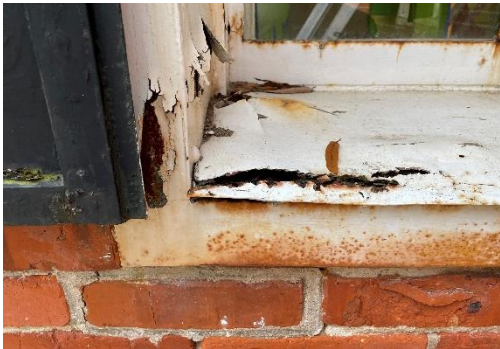
A photograph showing a close-up of a metal sill or window frame. The metal is heavily corroded and rusted, with a large section missing or broken. The surrounding brickwork is visible at the bottom.	The metal sills are no longer in a serviceable condition due to extensive corrosion.  Removed and replace sills in concert with recommendations per Architectural.	Ref. Arch.

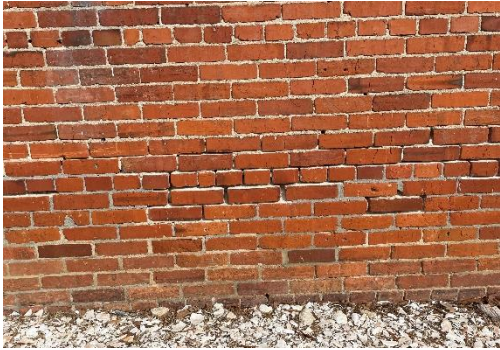
RB. S.5

<p>Open mortar joints are present at multiple locations around the perimeter of the building.</p> <p>Complete extensive repointing using appropriate mortar.</p>	Ref. Arch.
RB. S.6

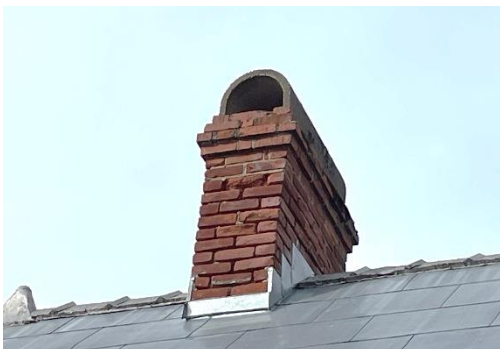
<p>Open mortar joints at top of chimney requiring repointing.</p> <p>Complete repointing using appropriate mortar.</p>	Ref. Arch.
RB. S.7

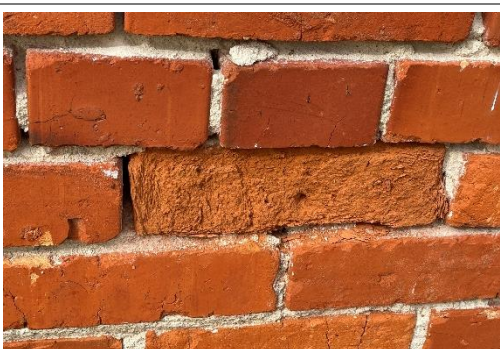
<p>Spalled brick was observed at two different locations in the façade.</p> <p>Cut brick units out from wall. Remove and replace with salvaged brick units.</p>	2 brick units
RB. S.8

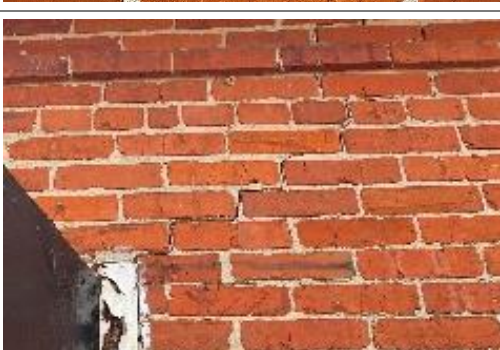
<p>A stepped diagonal brick crack occurs at the corner of a window opening.</p> <p>Provide stitch rod repair above the opening to stabilize masonry.</p>	Insert (3) stitch rods spaced at 8-inches on center.

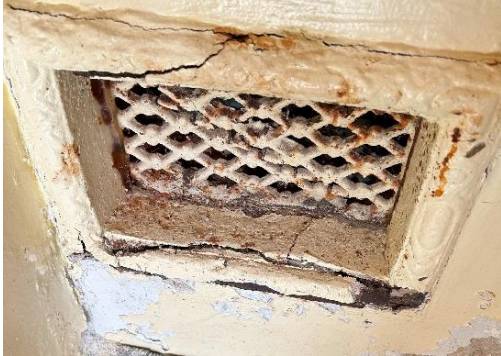
CODE	PHOTOGRAPH	CONDITION/REPAIR	QUANTITY
RB. M.1

<p>The air register openings into the perimeter wall cavity show signs of water/humidity damage.</p> <p>Determine long-term strategy for utilizing original vented wall arrangement.</p> <p>Repair/replace grilles in concert with larger strategy.</p>	6 locations
RB. M.2	N/A	<p>Existing vented cavities are believed to be propagating moisture within the exterior assembly.</p> <p>Determine long-term use goals for building. Develop strategy that reduces moisture in short- and long-terms. Refer to Architectural for additional work. Consider sealing exterior vent and providing conditioned air into existing cavity.</p>	6 locations
RB. E.1	N/A	<p>Localized areas of the electrical distribution system does not meet current standards for building type.</p> <p>As a part of a future renovation, replace 100% of Romex wiring in distribution system.</p>	100%

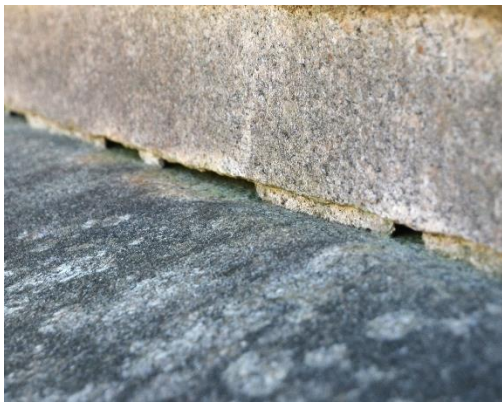
CODE	PHOTOGRAPH	CONDITION/REPAIR	QUANTITY
CM. MS.1

<p>Open mortar joints and mortar deterioration occur on all elevations.</p> <p>100% repoint should be pursued in concert with other repairs. Repoint open brick masonry joints with appropriate mortar mixture, using techniques to match original mortar joints.</p>	100% of joints

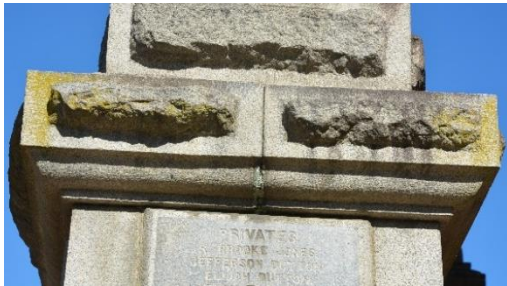
CM. MS.2

<p>Biological growth (lichens) and staining are occurring on all elevations.</p> <p>Remove biological growth and staining with architectural anti-microbial biocide. Use gentlest means possible.</p>	100%
CM. MS.3

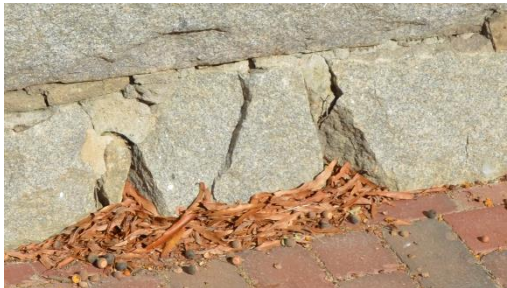
<p>The exposed masonry foundation has cracked stones.</p> <p>Remove loose stones and assess to determine extent of structural impact. Provide pin at stone to stabilize foundation for long-term.</p>	4 locations

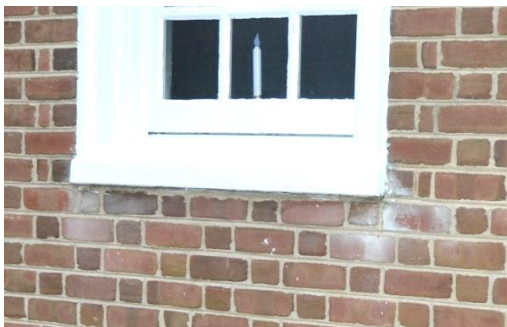
CODE	PHOTOGRAPH	CONDITION/REPAIR	QUANTITY
A. MB.1

<p>Deteriorated paint from an adjacent painted surface has stained the masonry walls.</p> <p>Remove paint staining from surface of masonry walls. Perform tests on masonry and pursue the gentlest effective method.</p>	40 SF

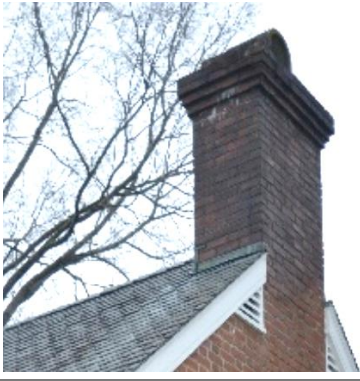
A. MB.2

<p>Brick chimneys display extensive water staining. Detailed assessment was not possible during fieldwork.</p> <p>Clean staining from face of chimneys and assess existing mortar joints. Use gentlest means possible. Repoint as required.</p> <p>2 locations, assume 75 SF of cleaning and 40 SF of repointing</p>
A. MB.3

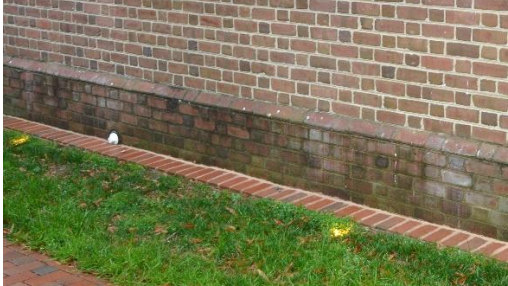
<p>Biological growth is occurring and causing staining along the base of all elevations.</p> <p>Remove biological growth and staining with architectural anti-microbial biocide. Use gentlest means possible.</p> <p>400 SF</p>
A. MB.4

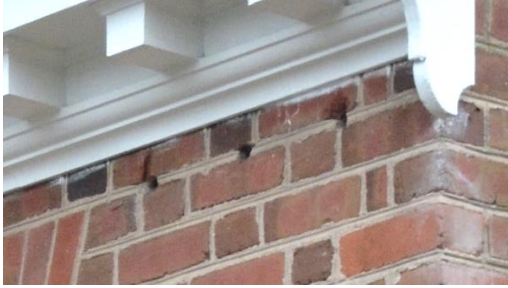
<p>Abandoned holes are present in the surface of the brick masonry walls.</p> <p>Repoint mortar joints with compatible mortar and patch brick with matching unit or color-matched grout.</p> <p>4 locations</p>

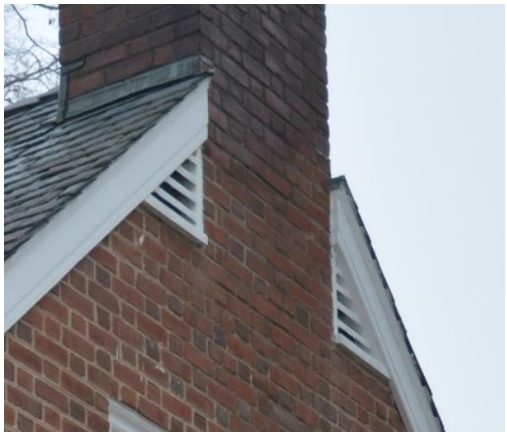
CODE	PHOTOGRAPH	CONDITION/REPAIR	QUANTITY
A. WD.1

<p>The wood rakeboards at the side gables have exposed end grain where cut at the chimney. This arrangement is susceptible to rot.</p> <p>Monitor condition of wood. Prepare and repaint 100% of wood finishes on schedule with recent efforts. Repair/replace deteriorated wood elements.</p>	<p>200 LF of cornice and rake board / 20 LF of repairs</p>

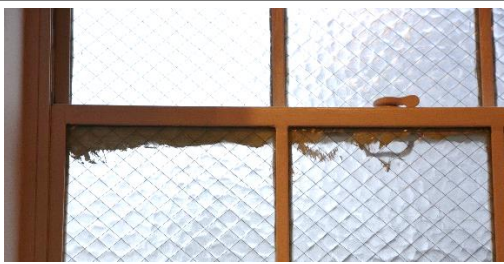
<p>Steel windows display minor finish deterioration and utilize textured wire glass.</p> <p>Prepare and paint 100% of steel windows. Consider reglazing with clear glass.</p>	100% prepare and paint 6 steel windows

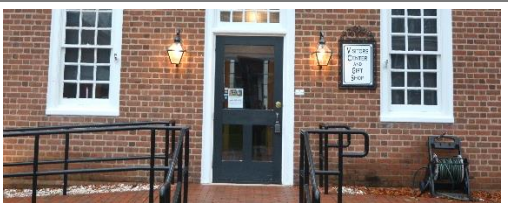
CODE	PHOTOGRAPH	CONDITION/REPAIR	QUANTITY
A. D.1

<p>Front door exhibits minor paint deterioration.</p> <p>Prepare and paint door.</p>	1 door

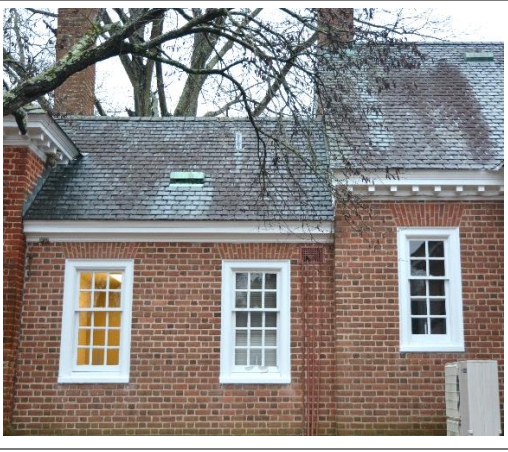
CODE	PHOTOGRAPH	CONDITION/REPAIR	QUANTITY
A. R.1

<p>Existing slate roof shingles exhibit staining, likely biological growth, on the north elevation.</p> <p>Clean stains from slate shingles. Review cleaning methods. Complete tests to determine impact on adjacent fabric, including downstream surfaces, before full cleaning. Use gentlest effective method.</p>	800 SF
A. R.2

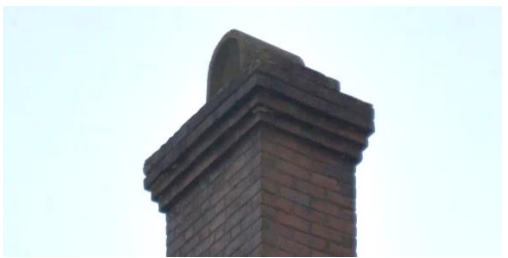
<p>Concrete chimney caps could not be assessed from grade.</p> <p>Use man lift to review chimney caps in detail. Determine any deficiencies and develop treatment recommendations.</p>	2 locations

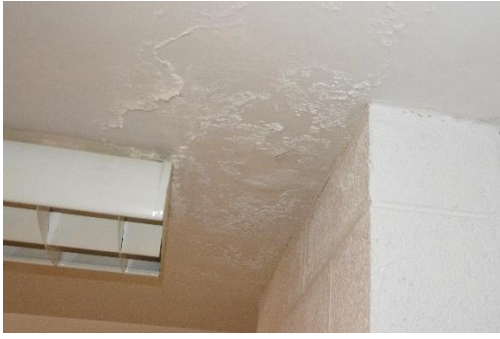
A. R.3

<p>The ceiling of the west room on the second floor exhibits damage due to water infiltration, suggesting a roof leak at the west chimney.</p> <p>1 location, assume flashing replacement at chimney</p> <p>Inspect roof and flashings at west chimney. Determine source of leak and repair.</p>
-----------	---	--

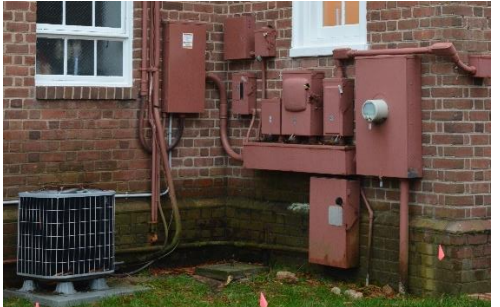
CODE	PHOTOGRAPH	CONDITION/REPAIR	QUANTITY
A. O.1

<p>Mechanical units and utilities are visible at rear of building from perimeter of Court Circle.</p> <p>Consider vegetative or fencing screening options if exterior units and connections are expected to remain in their current location.</p>	2 locations
A. O.2

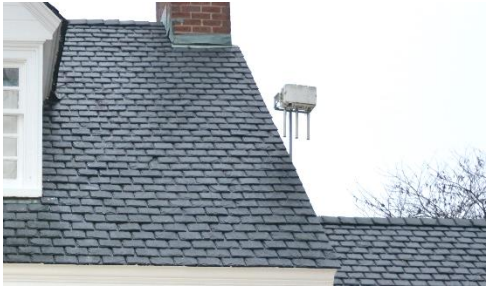
<p>Cisco networking box is visible above roofline where it extends from the east side gable.</p> <p>Consider relocating device to less auspicious location if quality of service can be maintained.</p>	1 location

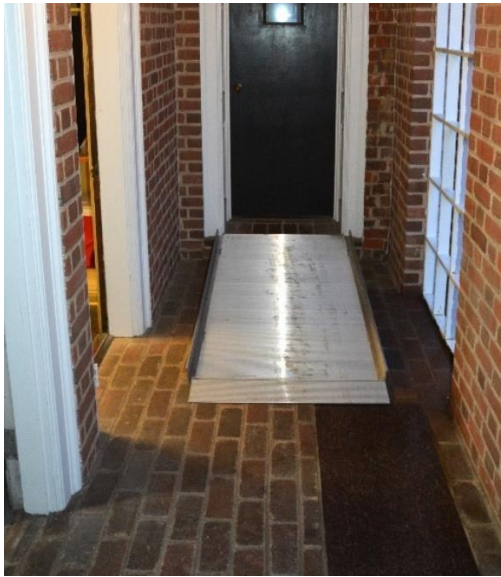
CODE	PHOTOGRAPH	CONDITION/REPAIR	QUANTITY
A. F.1

<p>Temporary metal ramp has been installed between the Courthouse side door and the hyphen of Annex building. The ramp obstructs an adjacent door.</p> <p>Consider long-term plan for hyphen area of Annex. There are several accessibility issues in the hyphen, including the bathroom. A renovation which rearranges this area would offer a permanent accessible route and improve the adjacent spaces.</p>	100 SF renovation of restroom, storage area, and accessible ramp

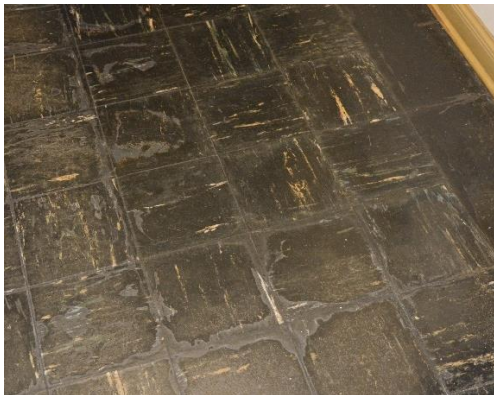
A. F.2

<p>The tile flooring in the hyphen lounge area is heavily worn.</p> <p>Determine potential for renovation of hyphen as referenced above. If not likely to happen within short term, test flooring to confirm presence of asbestos. Abate if necessary. Provide new resilient tile flooring.</p>	85 SF

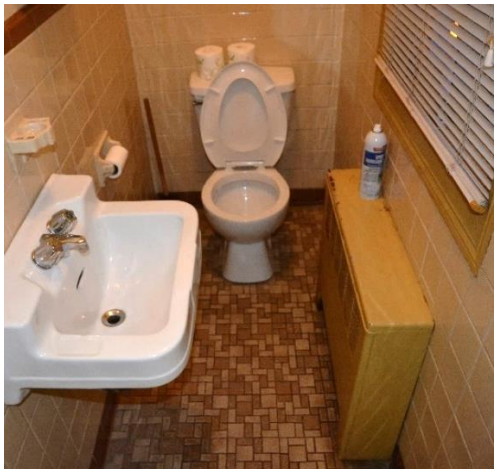
A. F.3

<p>Existing hyphen restroom serving courthouse is not accessible. The ceramic tile flooring and wainscot finishes in the hyphen restroom area are aged.</p> <p>Determine potential for renovation of hyphen as referenced above. If renovation is not likely to happen within short term, clean ceramic tile to remove staining.</p>	75 SF

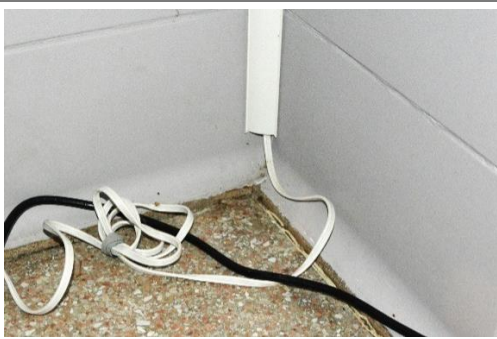
A. F.4

Existing terrazzo floor has settled approximately ½" at southwest corner of first floor.  Monitor location to determine if settlement is active. If settlement is active, perform removals at flooring to allow for assessment of substrate.	N/A
A. F.5

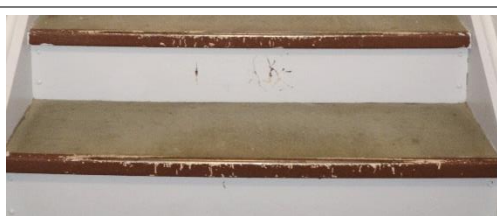
Existing metal stair nosing exhibits paint deterioration.  Prepare surface and paint all metal surfaces of stair.	17 risers

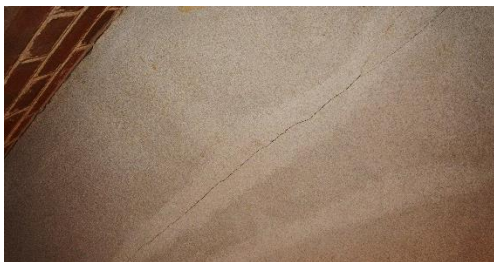
Stucco ceiling in hyphen arcade has cracking and finish deterioration.  Rout out cracks in stucco. Patch stucco with compatible mixture. Prepare surface and paint.	80 SF
A. CL.2

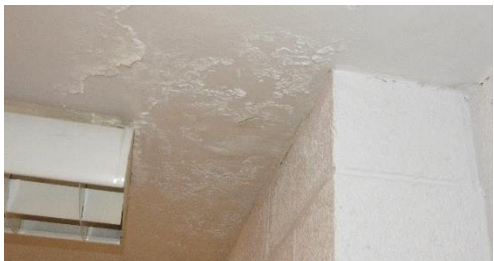
Second floor ceiling in west room displays water damage.  In concert with any necessary roofing repair, remove damaged wallboard and provide new wallboard. Paint.	15 SF

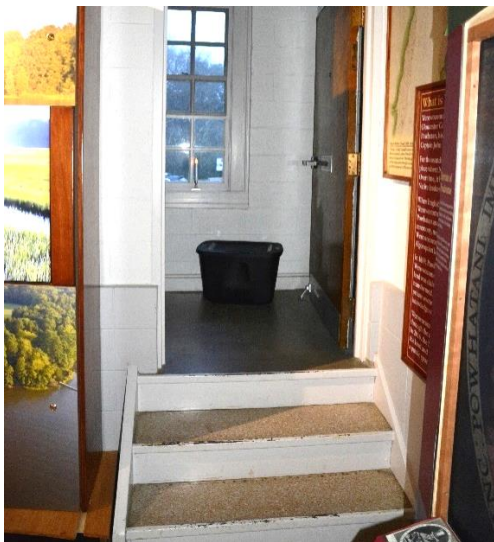
The door which leads onto the stair to the second floor does not have a code-compliant landing at the short run which connects to the first-floor level.  Review current arrangement with county building official to determine urgency for alteration. In any substantial future renovation, remove three-riser concrete and steel stair and provide compliant landing and stair at existing door opening.	1 location
A. OI.2

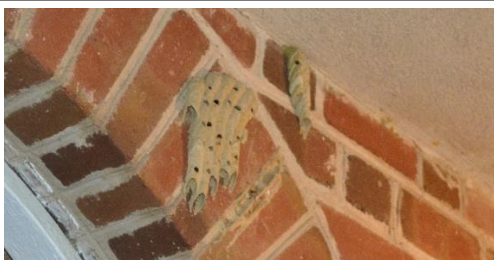
Mud dauber wasp nests are present on the south side of the hyphen arcade.  Remove infestation and clean face of masonry with gentlest means possible.	1 location

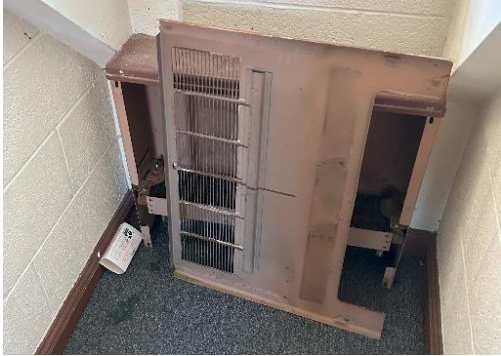
Dismantled existing hot water radiator located on the 2 <sup>nd</sup> floor of the Annex.  Remove/replace non-functional HVAC equipment.	3
A. M.2

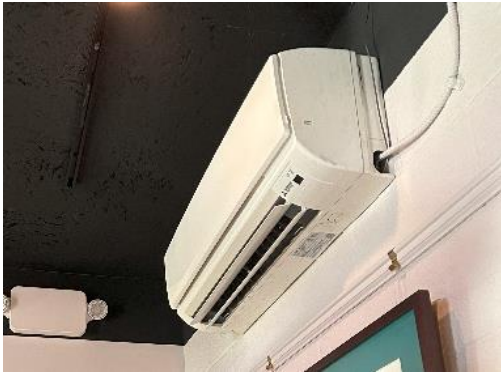
Ductless split-system units provide conditioning of the 1 <sup>st</sup> floor of the Annex but do not have any ventilation air capabilities.  Consider installing a central mechanical ventilation system for any building modernization project.	N/A
A. E.1

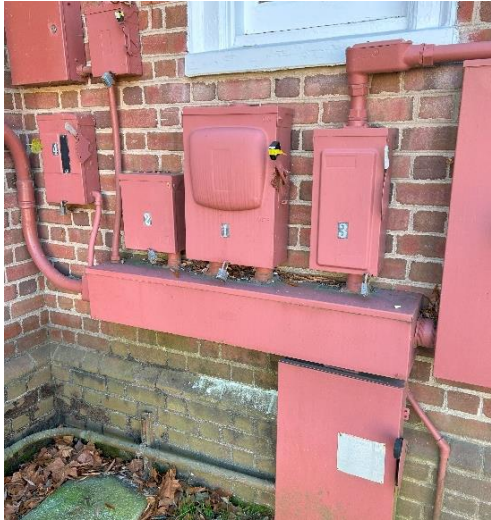
Electrical service distribution labels and identifications have been painted over. Only the number of individual service disconnects can be identified.  Provide appropriate labels to identify disconnect capacities and equipment/panels served.	All equipment

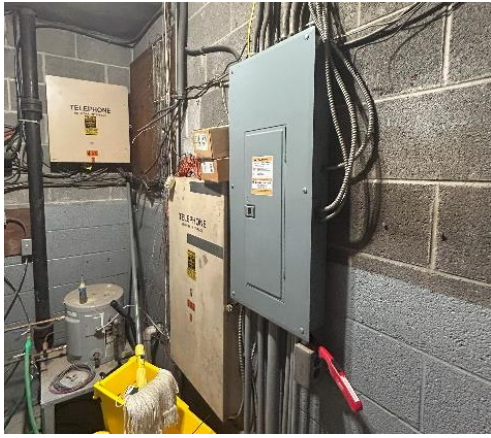
A. E.2

<p>A small number of electrical circuits from the distribution panel OCH-BASE-PNL in the utility room use insulated ROMEX wiring.</p> <p>Replacement of ROMEX with metal clad armored cable (MC) or power wiring conductors in conduit (EMT) should be considered for increased protection of the building.</p>	TBD

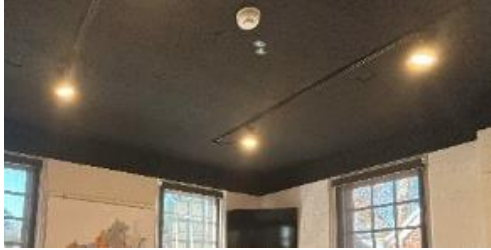
A. E.3

<p>Existing track lighting systems on 1<sup>st</sup> floor with incandescent PAR bulbs.</p> <p>Consider replacement with LED fixtures for increased efficiency.</p>	15 instances

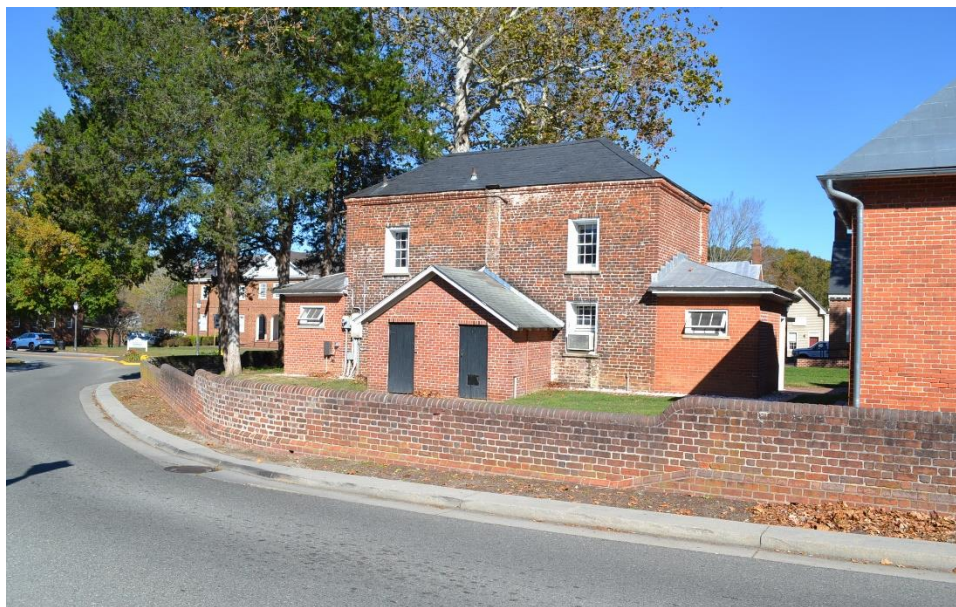
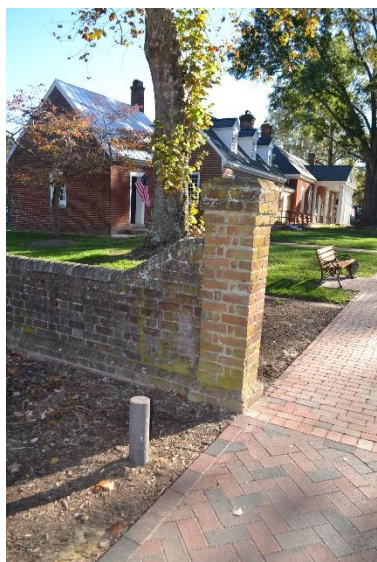
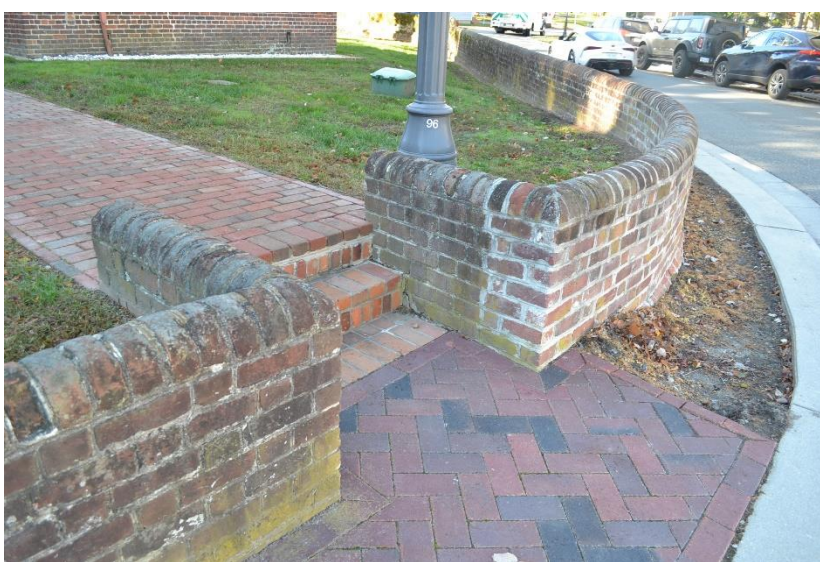
*Views of perimeter wall*

Multiple condition issues were observed in November 2023 in association with the wall. These include cracking and obvious mortar repairs, and biological growth. A section of the wall had been damaged just before the field visit by a vehicle hitting the structure. Damage from vehicular traffic is a regular occurrence.

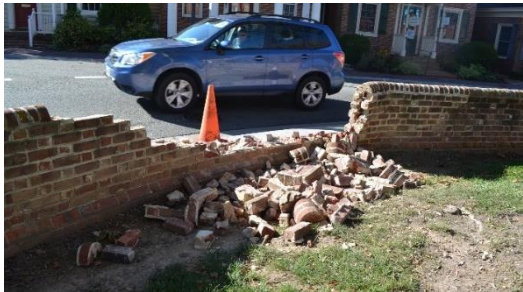
CODE	PHOTOGRAPH	CONDITION/REPAIR	QUANTITY
CC. L.1

<p>A vehicle ran into the wall, damaging a section. This has occurred in the past.</p> <p>The wall needs to be rebuilt in this section with materials and workmanship that matches the historic wall.</p>	Section shown and any other places where not completed properly in the past.
CC. L.2

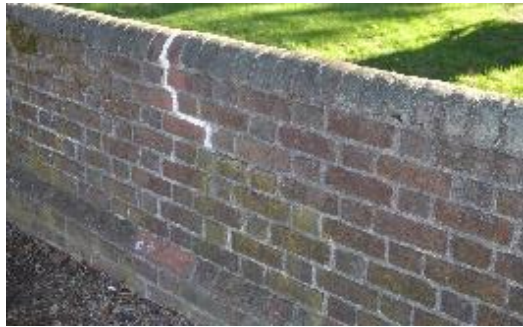
<p>Brick perimeter wall exhibits cracking and evidence of past repairs that are not compatible with the materials of the original wall.</p> <p>The wall should be repointed as part of a larger rehabilitation effort.</p>	Entire wall
CC. L.3

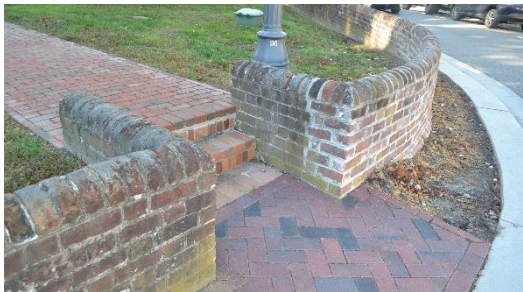
<p>Example of previous repair that may not match the original wall.</p> <p>The entire wall should be repaired to address various conditions using historic materials and workmanship.</p>	Entire wall
CC. L.4

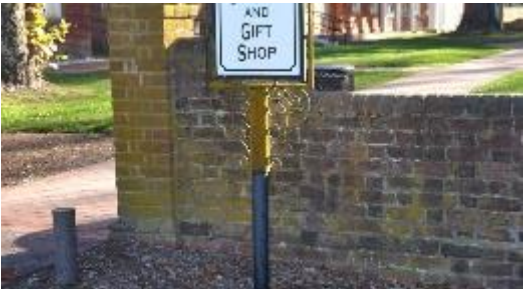
<p>Biological growth is a problem in association with the wall.</p> <p>Careful cleaning of the wall should be conducted in the short term before the entire wall can be repaired.</p>	Cleaning the wall where biological growth is present

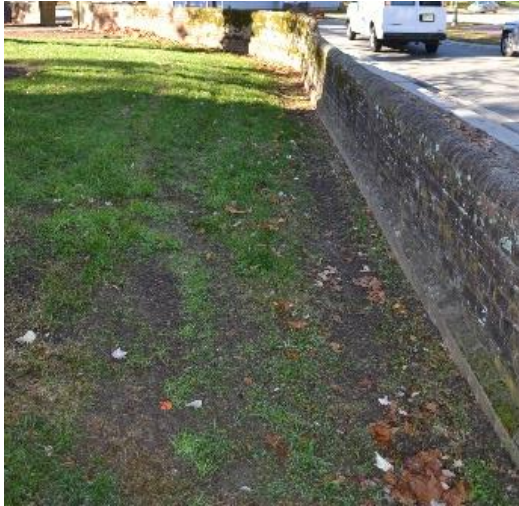
CC.  
L.5

Ponding of stormwater appears to be occurring along the inside edge of the perimeter wall.

Careful cleaning of the drainage systems built into the base of the wall might improve the situation. Regrading to direct stormwater away from the wall might be necessary if positive drainage cannot be effected otherwise.

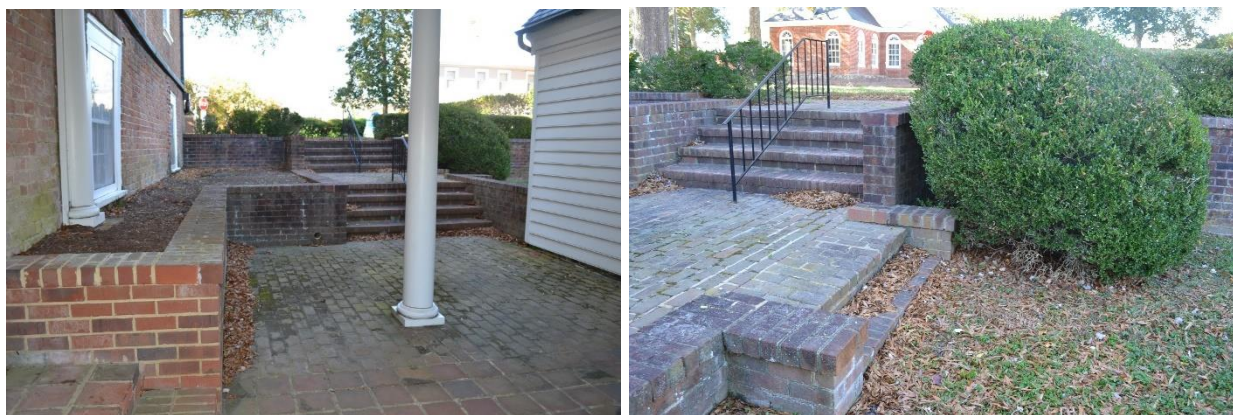
*Views of sunken plaza*

wooden columns set into the plaza space. The walks to the east and west are composed of brick landings and two flights of brick stairs, each with four risers. At the middle landing, visitors can turn to the north and follow another brick walk associated with a two-riser stair that leads into the walled sunken garden. The retaining wall that frames the plaza and stairs to the south edges a mulched planting bed area that does not contain any plants. A large clipped boxwood edges the walk to the north. The brick walk is edged by cheekwalls that connect to the retaining wall system. Condition issues observed in association with the brick walk, stairs, and sunken plaza include biological growth due to the very shady condition of the space and lack of air circulation.
