# FY27 CIP SUBMISSION

# CONDITION ASSESSMENT REPORT

GLOUCESTER COURT CIRCLE PROPERTIES &  
MUSEUM OF HISTORY  
GLOUCESTER COUNTY, VIRGINIA

*95% DRAFT SUBMISSION*

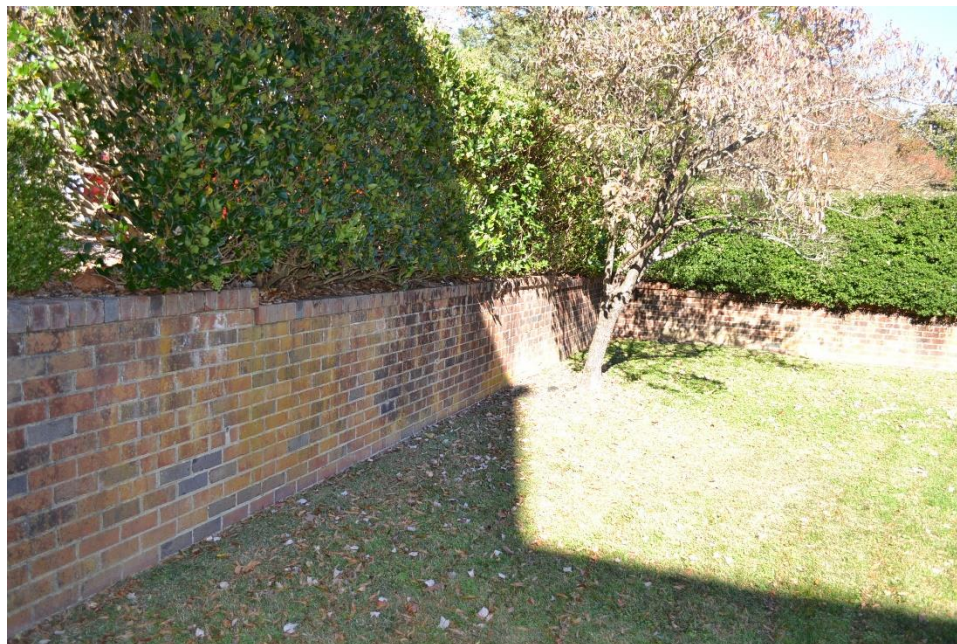
*View of sunken garden retaining wall*

The sunken garden behind the Botetourt Building is framed by a brick masonry retaining wall, roughly three feet in height, that forms a U-shape and connects to the brick walk, stairs, and sunken plaza wall system. The wall steps down with the grade in several locations. The top of the wall has a rowlock brick course. Condition issues observed in association with the brick wall include biological growth in sections where the wall is shaded by the hedge or trees planted in the sunken garden.

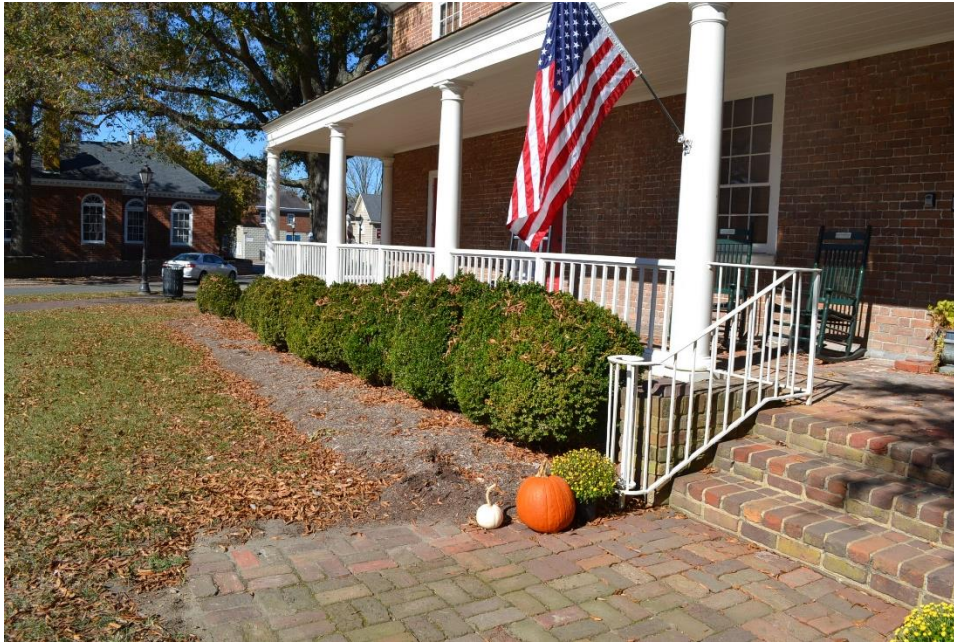
*Plantings along front porch*

There are ten boxwoods planted along the front porch of the Botetourt Building. Two are dead or dying, while others exhibit evidence of dieback and yellowing due to an unknown condition that might be associated with a pest infestation, disease, or insufficient water. The bed in which the boxwoods are planted is maintained with mulch.

Some of the shrubs may need replacement, such as boxwoods missing from the row in front of the porch, while others may need rejuvenative pruning where they have become leggy or have lost foliage. The hedges along the top of the sunken garden retaining wall are dense and may be limiting air circulation and light from reaching some of the walls, which are being impacted by biological growth. The shrubs currently growing along the northeast side of the building could be removed or replaced with a lower-growing shrub to prevent further biological growth.

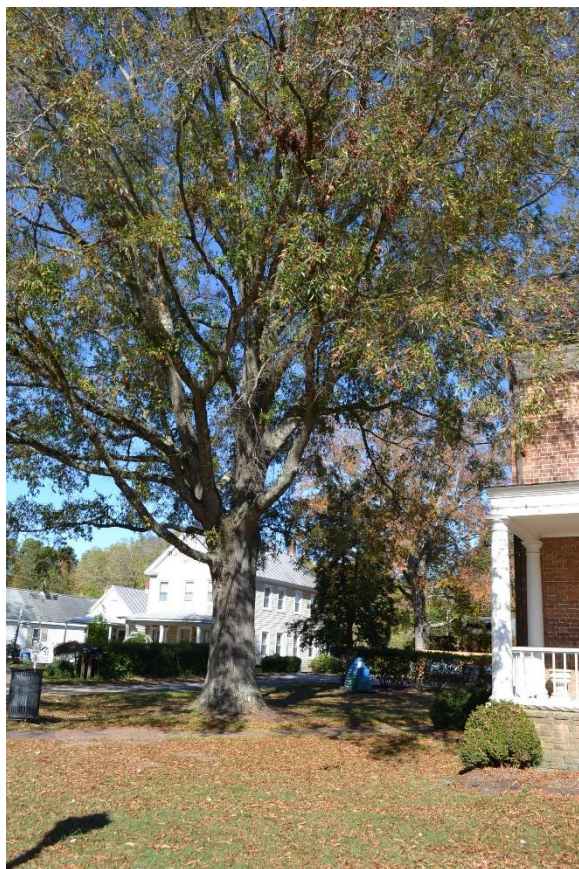
*View of Willow oak tree to west of building*

A large willow oak tree stands approximately 15 feet from the Botetourt Building near its western side. The brick walk that extends around the building closely edges the tree. The lower branches of the tree have been limbed up to allow passage along the walkway. The willow oak tree appears relatively healthy. Willow oaks can have water seeking and invasive root systems; the foundation and basement of the building should be monitored to ensure that roots from the tree do not cause structural problems.

The trees are generally in good condition. The willow oak located near the western façade of the Botetourt Building may pose a threat where roots invade the building foundation.

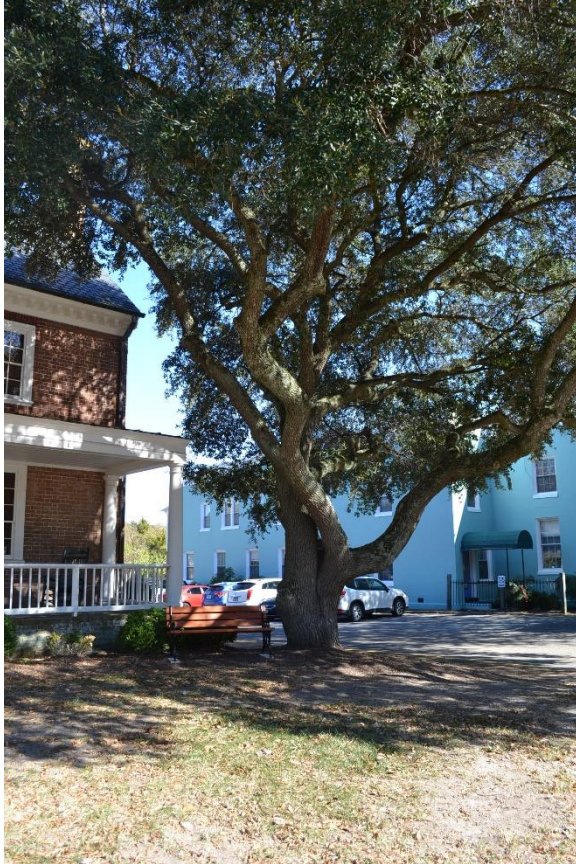
*View of live oak tree to south of building*

A large live oak tree stands approximately 8 feet from the Botetourt Building porch near the corner of the principal façade. The tree provides shade for a bench set in front of the porch. It is located in close proximity to the brick gutter that conveys stormwater flowing from the porch roof, as well as the sidewalk along Carriage Court. The tree appears to be in healthy condition. The shade cast by the tree has led to the loss of turf underneath. Mulch may be needed to protect the soil from erosion.

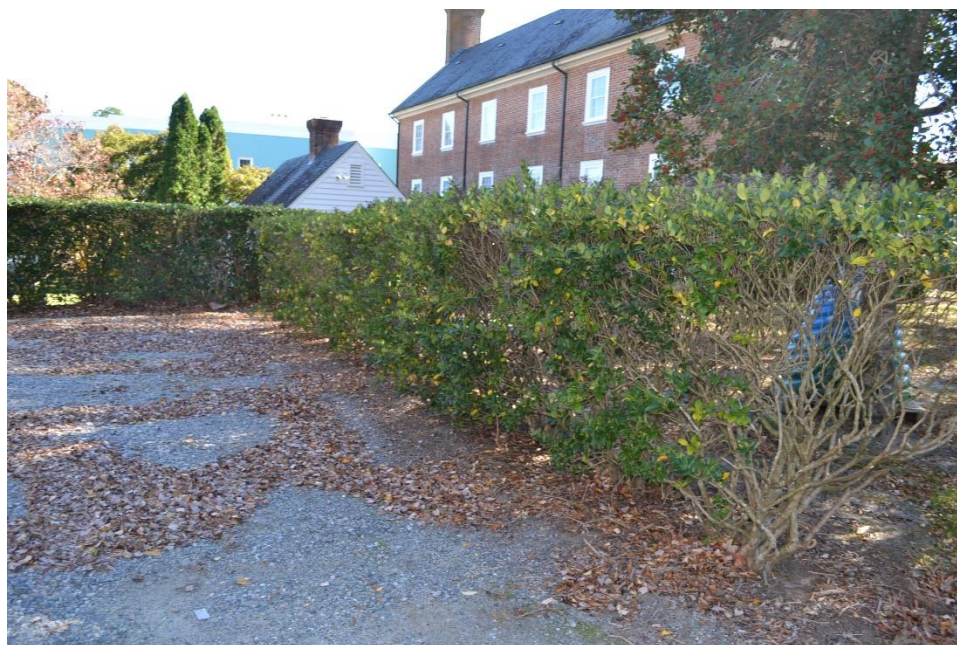
*Hedge screening at parking area*

A hedge of glossy privet shrubs edges the parking area northwest of the Botetourt Building. The hedge is maintained at a height of approximately 4 feet. A section along the northern edge is missing foliage where additional shrubs appear to have been recently removed. The foliage is anticipated to grow back in this area. Sections of the hedge are thin and becoming leggy. A more extensive pruning may be required to rejuvenate these sections.

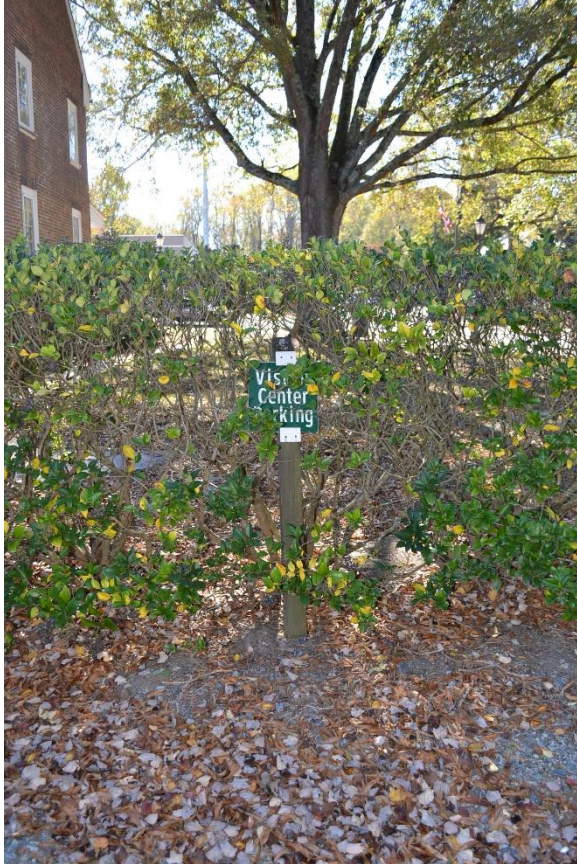
### **Sign at parking**

*Visitors Center parking sign hidden behind foliage*

A metal sign mounted to a wooden 4x4 post edges the parking area northwest of the Botetourt Building. The sign is green with white lettering and reads "Visitor Center Parking." The sign is partially obscured by the foliage of the adjacent privet hedge. The bench is in good condition.

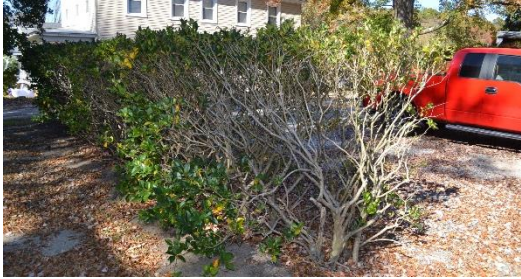
CODE	PHOTOGRAPH	CONDITION/REPAIR	QUANTITY
BL. L.8

<p>Shrubs display thinning in various areas.</p> <p>Perform rejuvenative pruning.</p>	<p>Hedge along parking area, approximately 6 shrubs</p>
BL. L.9

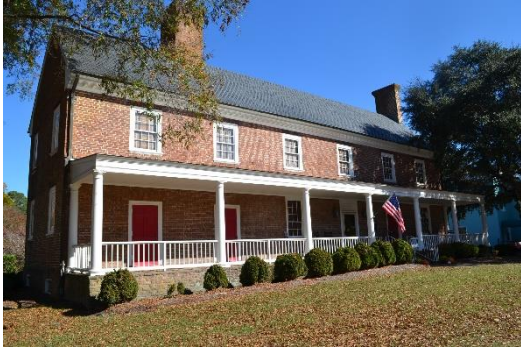
<p>The boxwoods in front of the porch need to be evaluated</p> <p>Replace all shrubs which are dead, dying, or in critical condition.</p>	<p>Up to 10 shrubs.</p>
BL. L.10

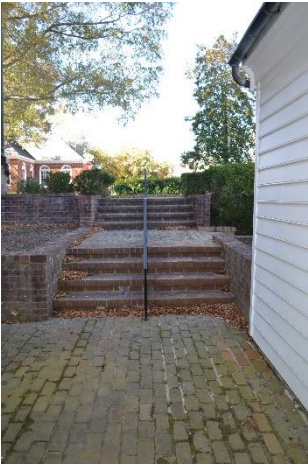
<p>Biological growth is occurring at the walls and walks in the sunken terrace area.</p> <p>Refer to Architectural for short-term cleaning solutions; reducing shade and increasing air circulation should be a longer term goal.</p>	<p>Refer to Architectural</p>
